## **Riparian Evaluation for Baffin Bay Tributaries**

Final Report

Publication CBBEP – 132

August 2019

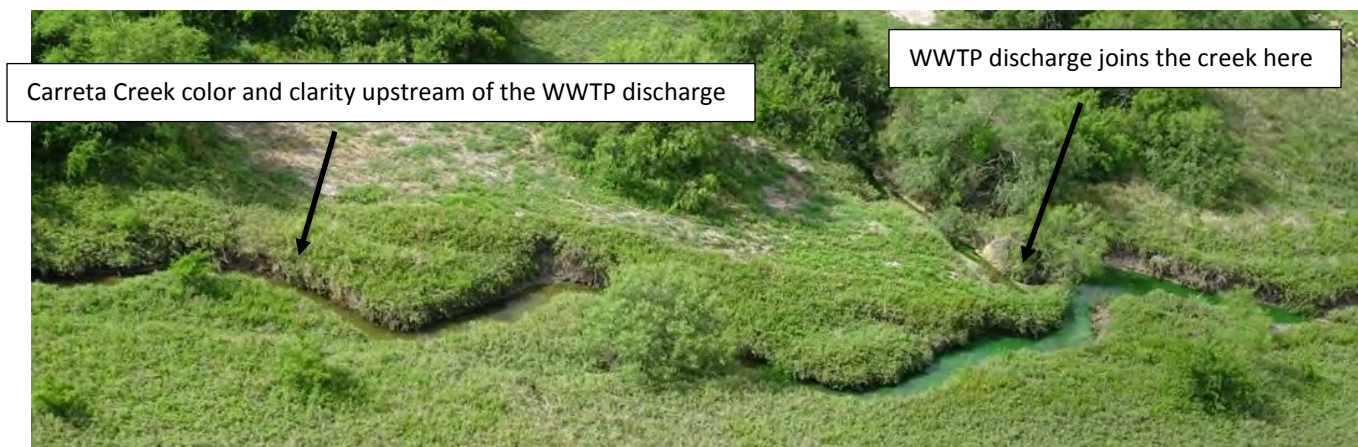
**Figure 13** At the discharge location for the Bishop WWTP there is a distinct change in the water's color and clarity. An algal bloom was observed beginning at this location.

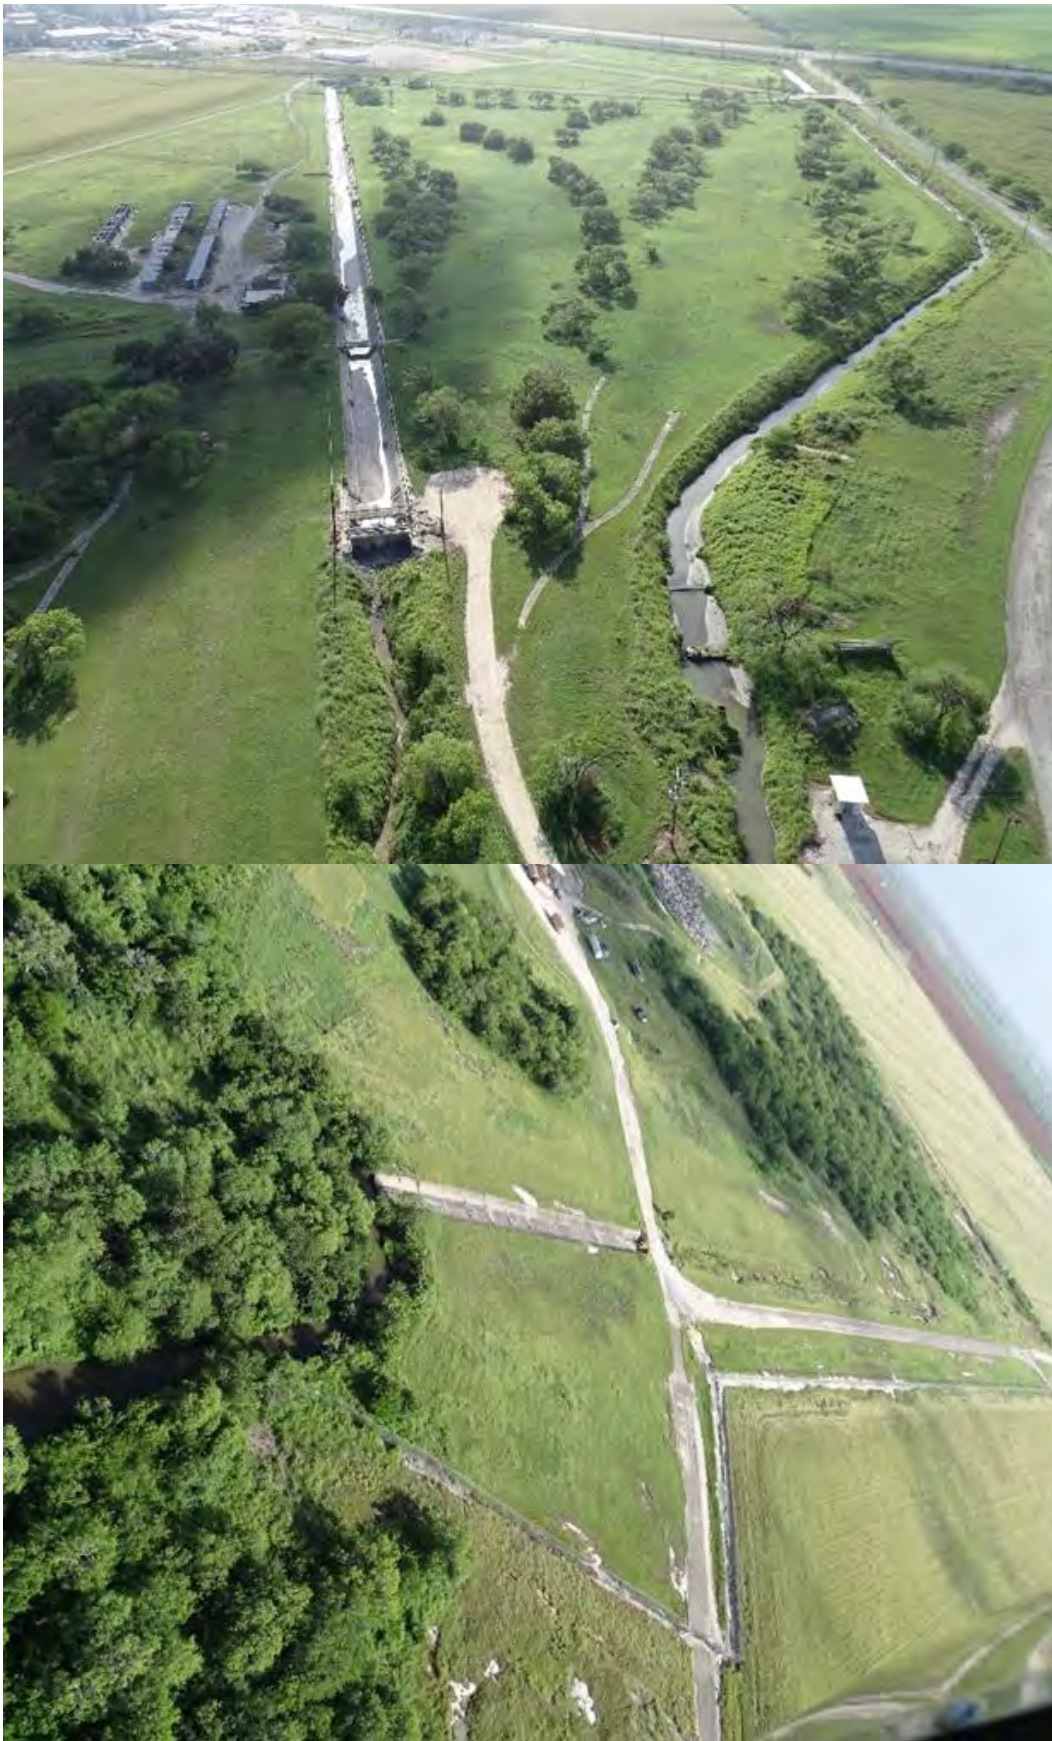
**Figure 27** Stormwater runoff ditches entering the creek.

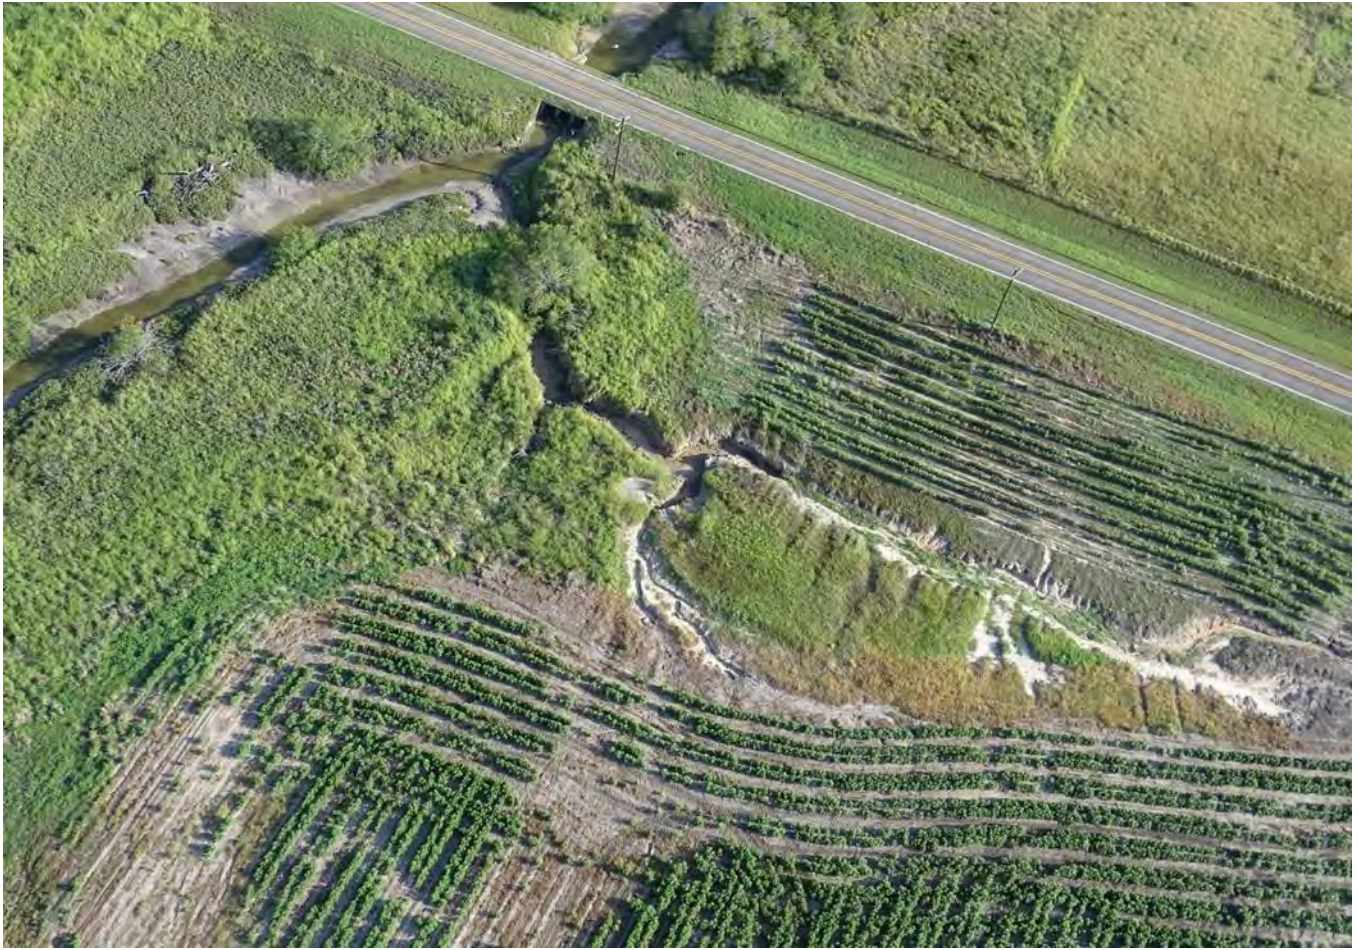
**Figure 35** Image illustrates the most common hindrance on the creek and gully formation.

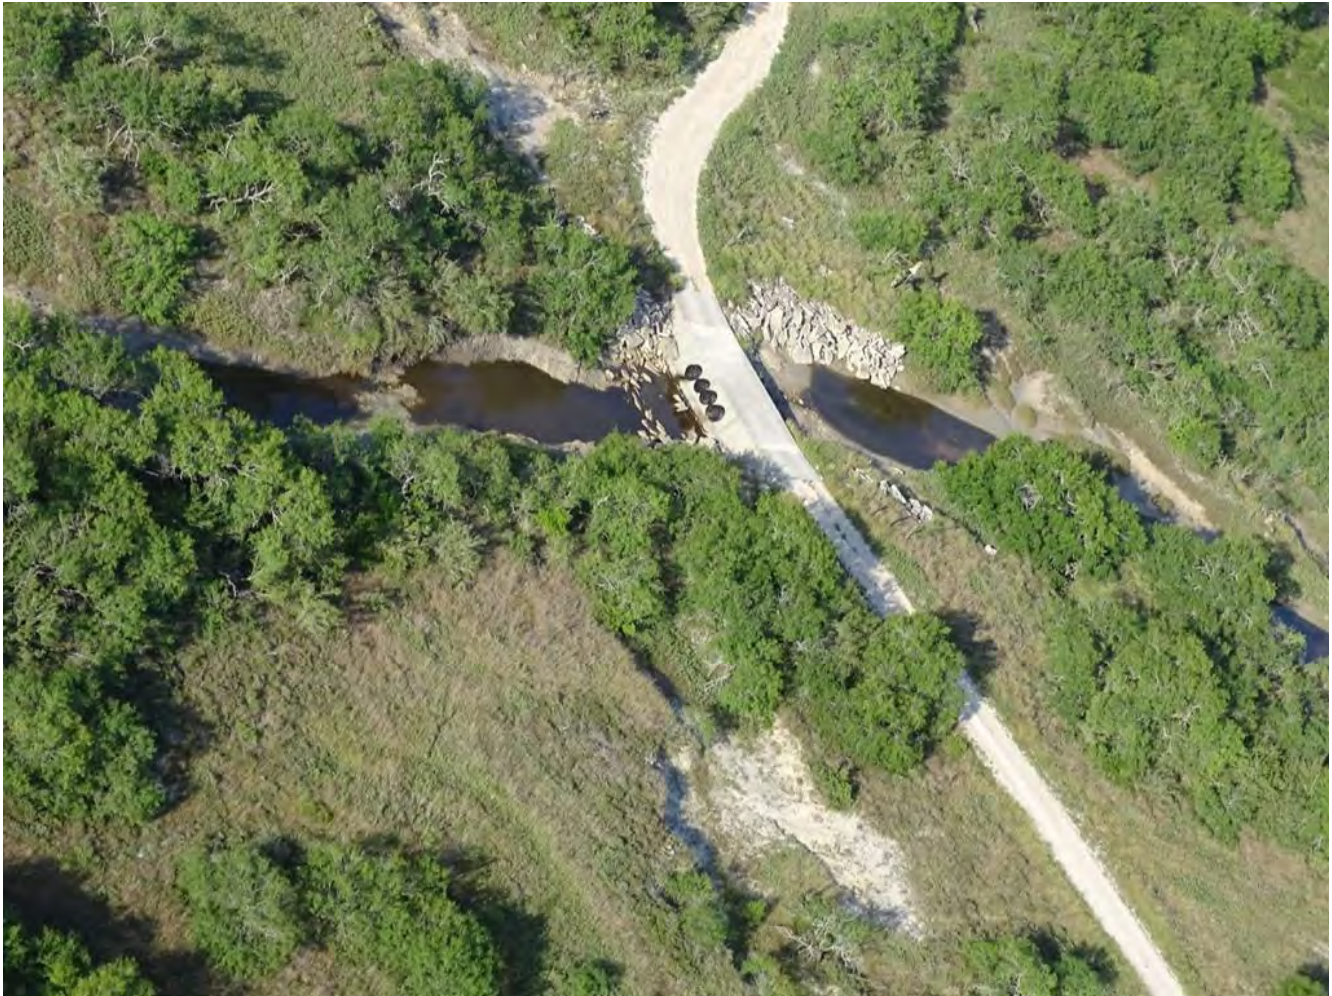
**Figure 37** This image shows a poorly designed crossing on Jaboncillos Creek. It appears that the creek has down cut around the crossing and left its conduits high and dry. Piles of cement debris can be seen dumped along the channel around the crossing in an apparent attempt to dissipate stream energy. Stream crossings should always be located on a straight section of channel to avoid excessive stream energy being directed at the crossing.

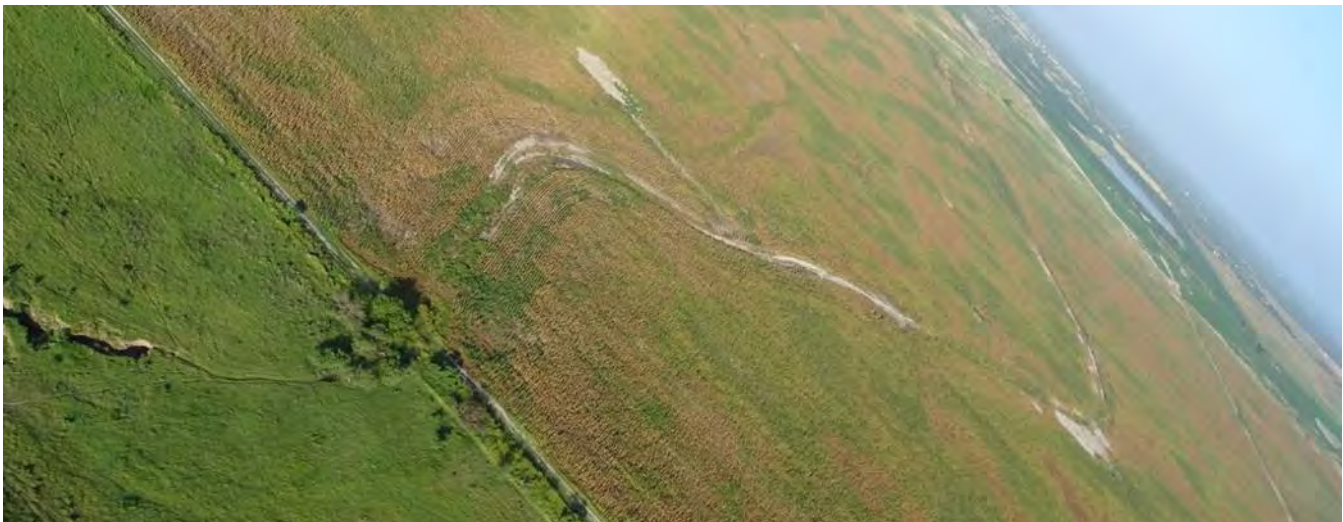
**Figure 46** Looking west at Trib A to Radicha Creek south of FM 2220. This image illustrates the hindrance of farming too close to a drain way and the opportunity for enhanced function with a setback of disturbance.

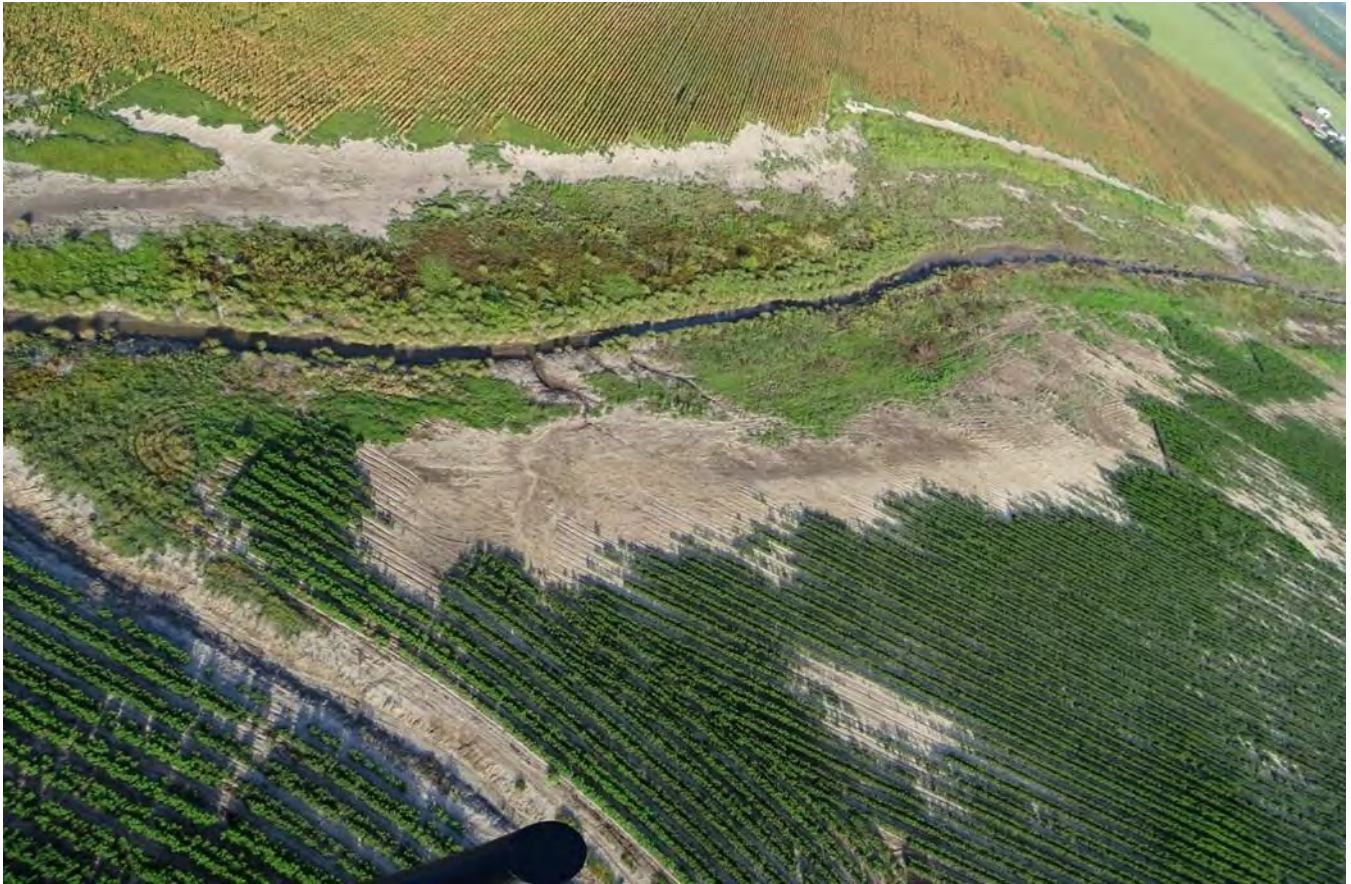
**Figure 52** This image shows a fairly well vegetated riparian area with Cordgrass and Spiny aster despite the farming infringement on the riparian area and the gully formation. This small area of functional condition seems to indicate the creek's readiness for recovery.

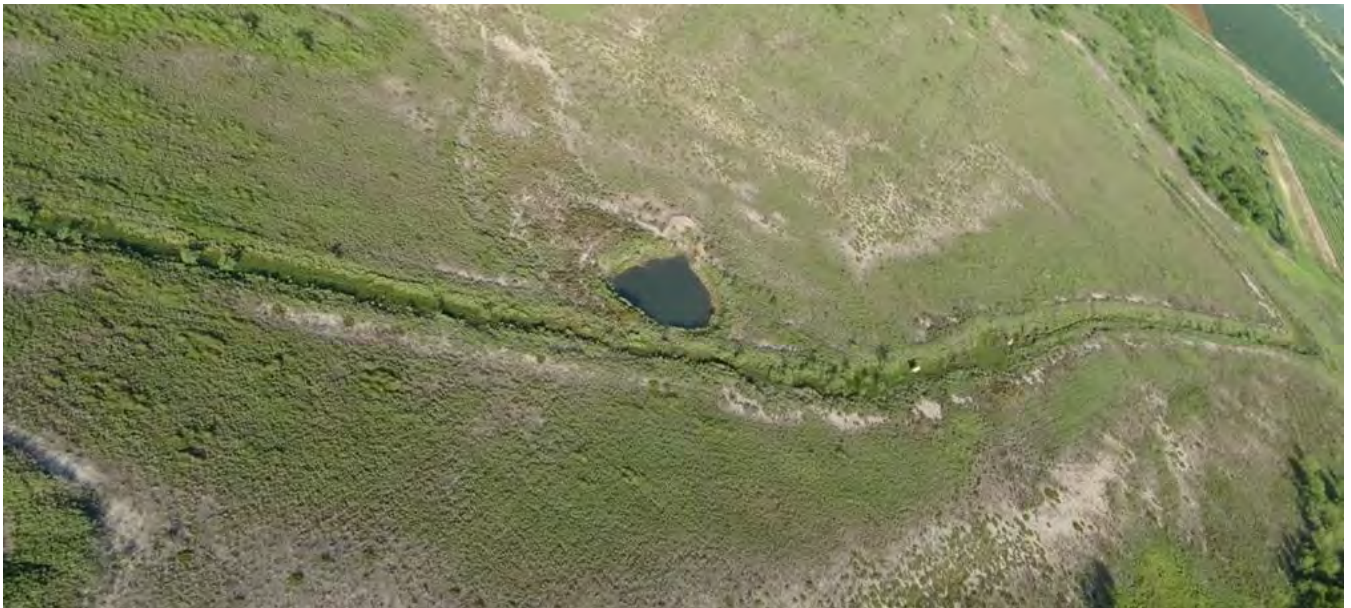
**Figure 53** In this image the riparian area is hindered by farming/grazing too close. Further upstream, near the top of the image, the channel has been manipulated and straightened.

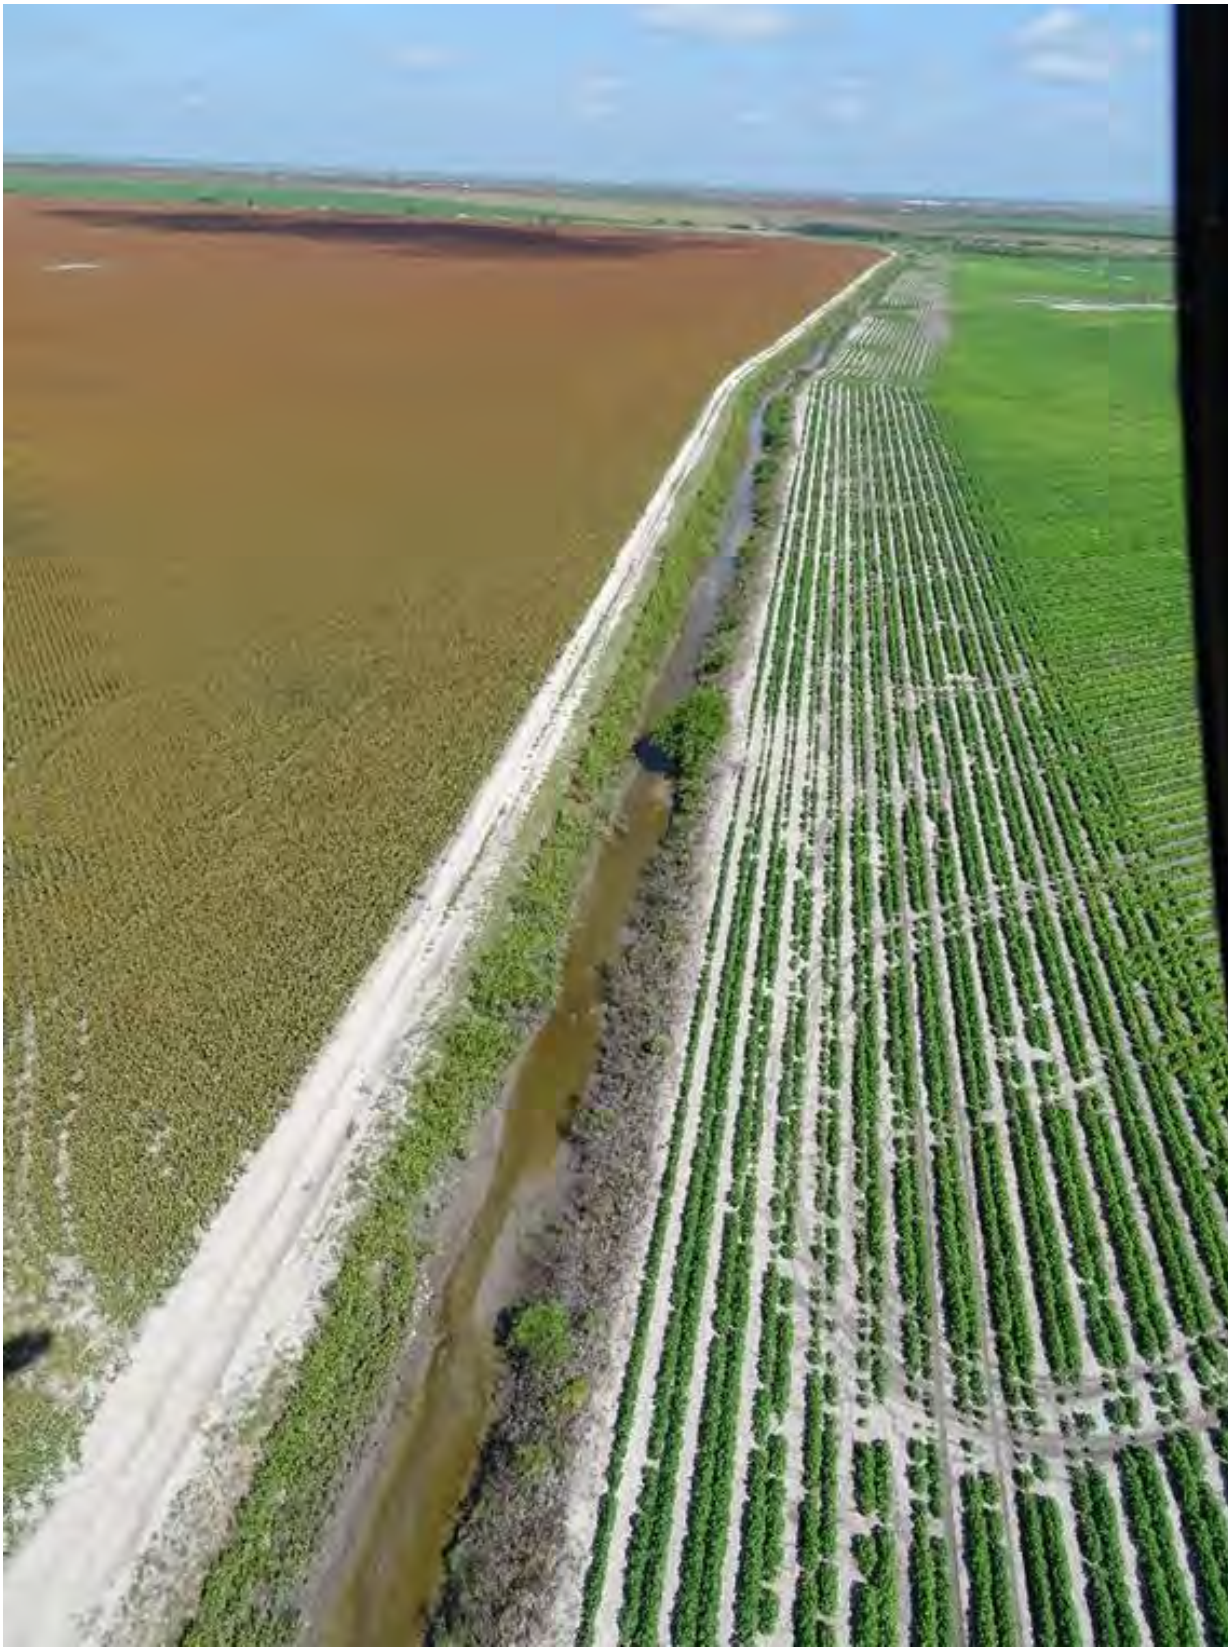
**Figure 68** In this image you can see the Lost Creek Ditch as it runs through farmland. The creek appears to be attempting to recover by growing vegetation, trapping sediments, and holding water, but may be hindered by attempts to curtail vegetation. In the image, vegetation on the right appears to have been sprayed with herbicide.

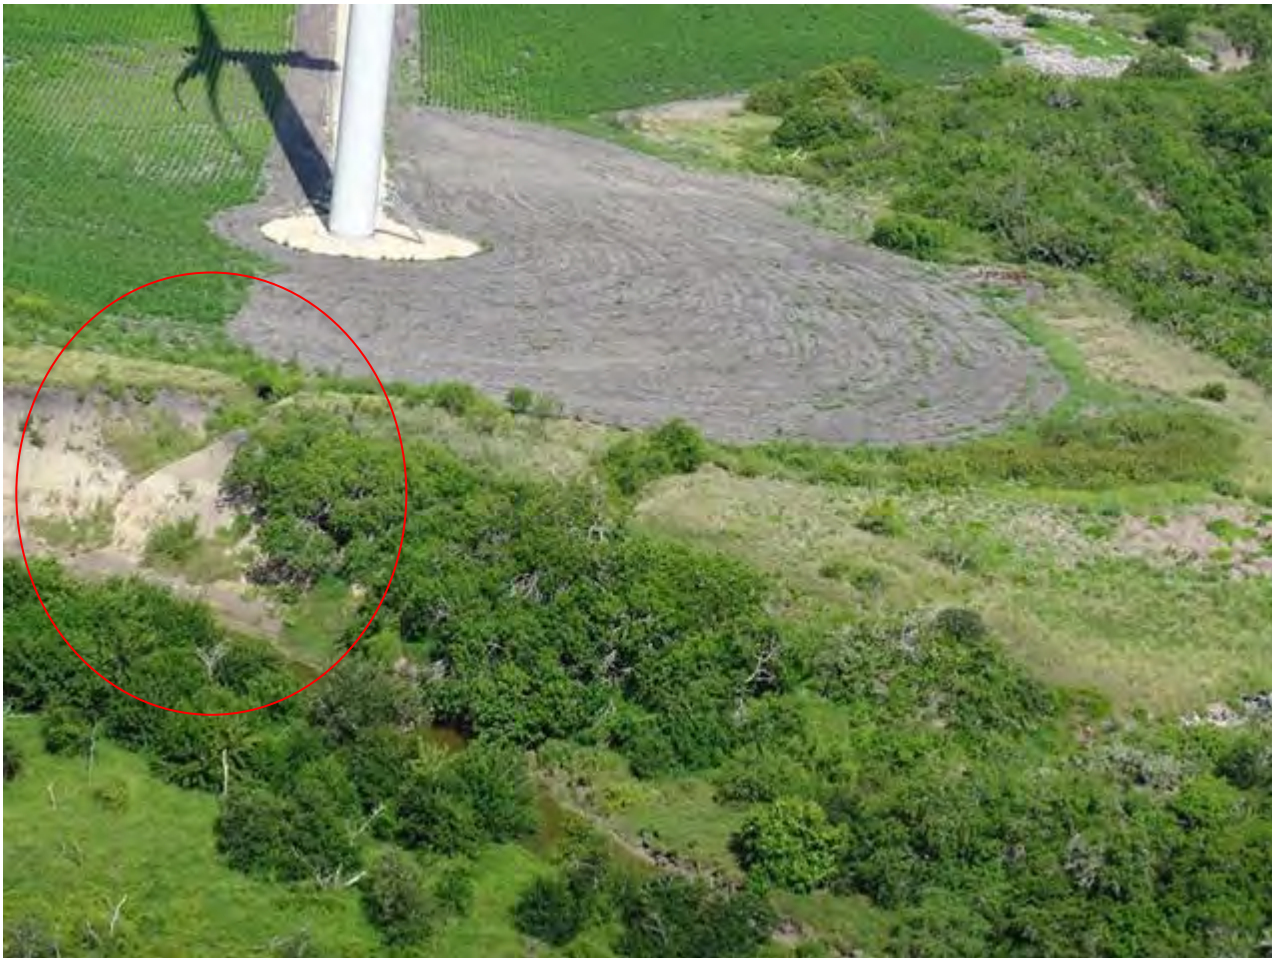
**Figure 74** Wind-farm development too close to the creek can also hinder riparian recovery by increasing and focusing runoff. This image shows the bank erosion apparently as a result of enhanced runoff from a tower cited too close to the creek bank without an adequate buffer.

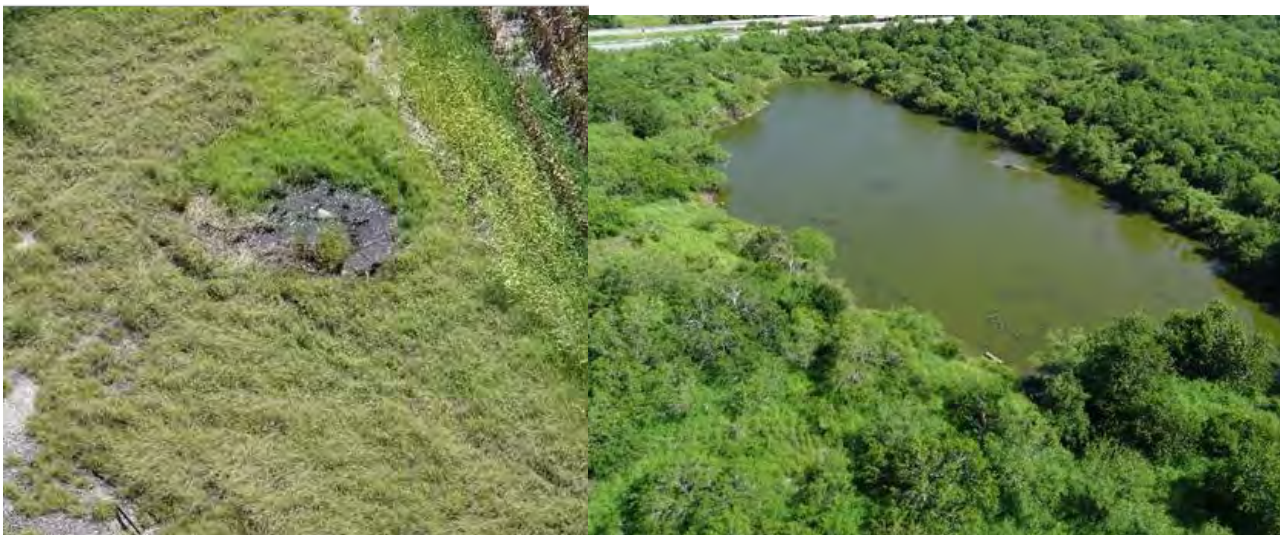
**Figure 75** Both a new and older, dismantled waste water treatment plant (WWTP) were observed near Driscoll on the bank of Petronila Creek. The discharge location for newer WWTP was not distinctly visible in the creek, however a pond and a seep (pictured here) are located adjacent to the site of the dismantled plant and appear to be experiencing an algal bloom.

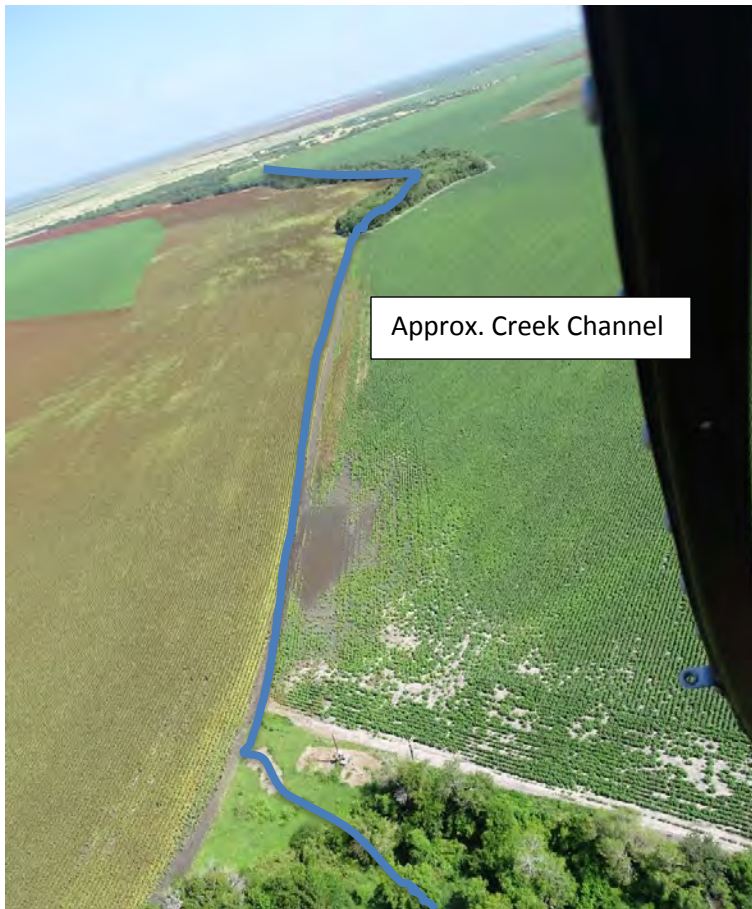
**Figure 90** This image illustrates the riparian recovery hindered by farming too close to the creek.

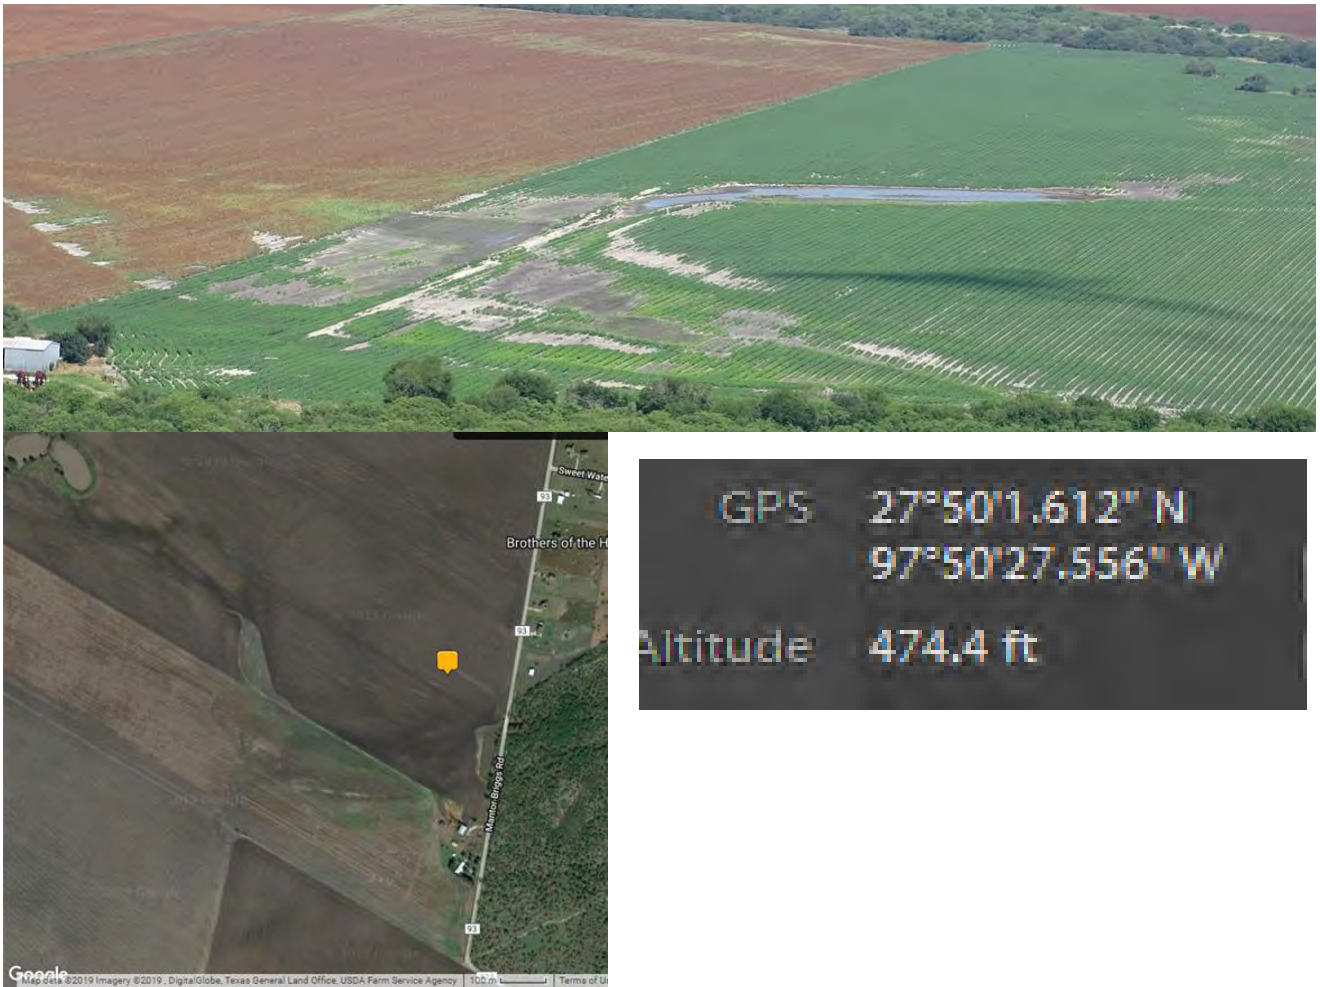
**Figure 91** This image is a possible aerial photo point. It shows a meander bend of the creek included in a field. Visible in the distance is the tree lined Aqua Dulce Creek. If the identified hindrance, i.e. farming too close, was addressed here, riparian recovery could be expected along with water quality benefits.

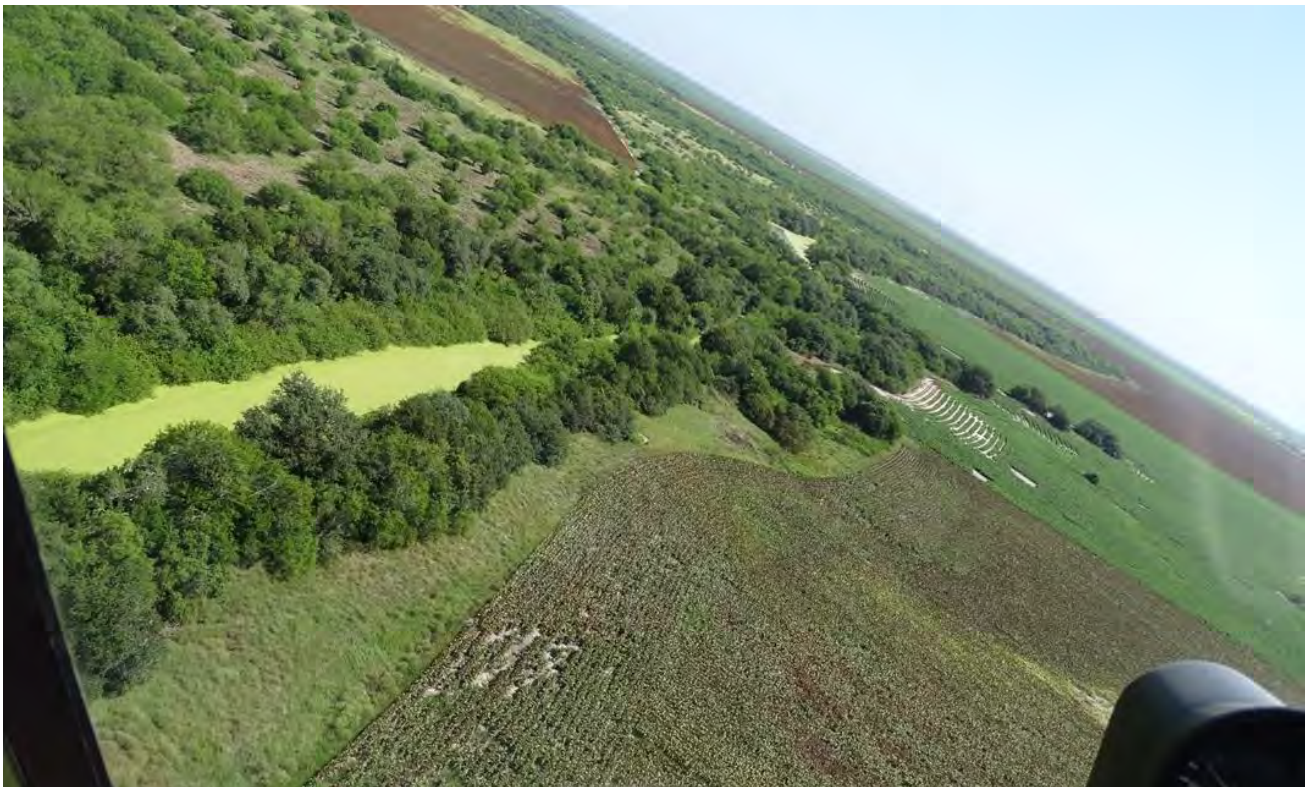
**Figure 95** Further upstream on the lower reach of Aqua Dulce Creek, Duck weed covers the water's surface. Duck weed is quick to respond to nutrients in a stream and could indicate some nutrient addition. It is actually an aquatic plant and can

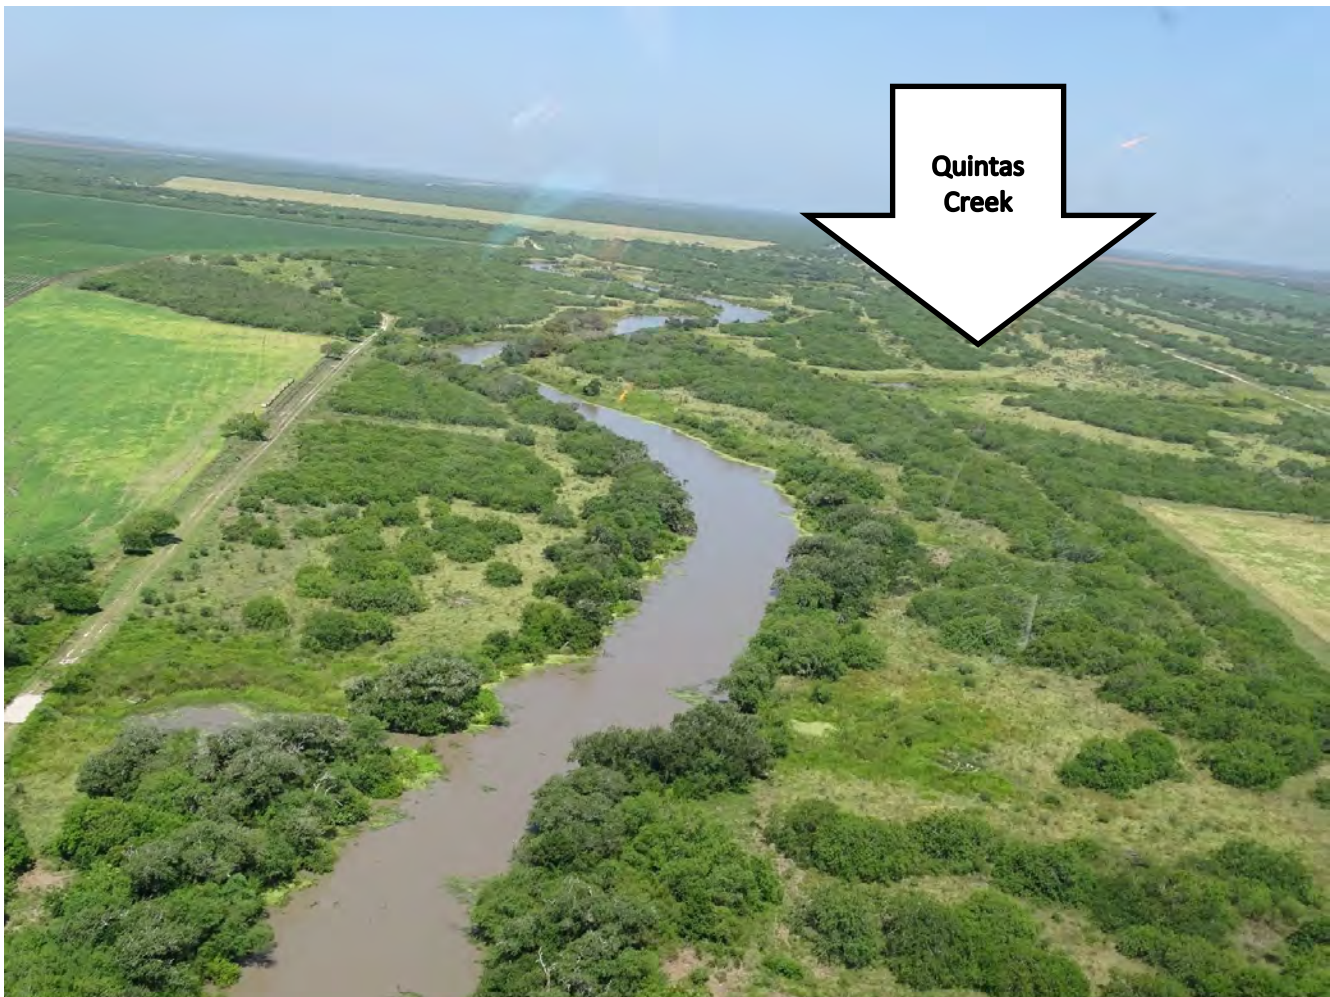
**Figure 96** Further upstream on Aqua Dulce Creek, shown in this image, the water becomes brown and cloudy and Duck weed can be seen colonizing the surface. This photo was taken near the confluence with Quintas Creek, a tributary that may deliver treated effluent from the town of Orange Grove.

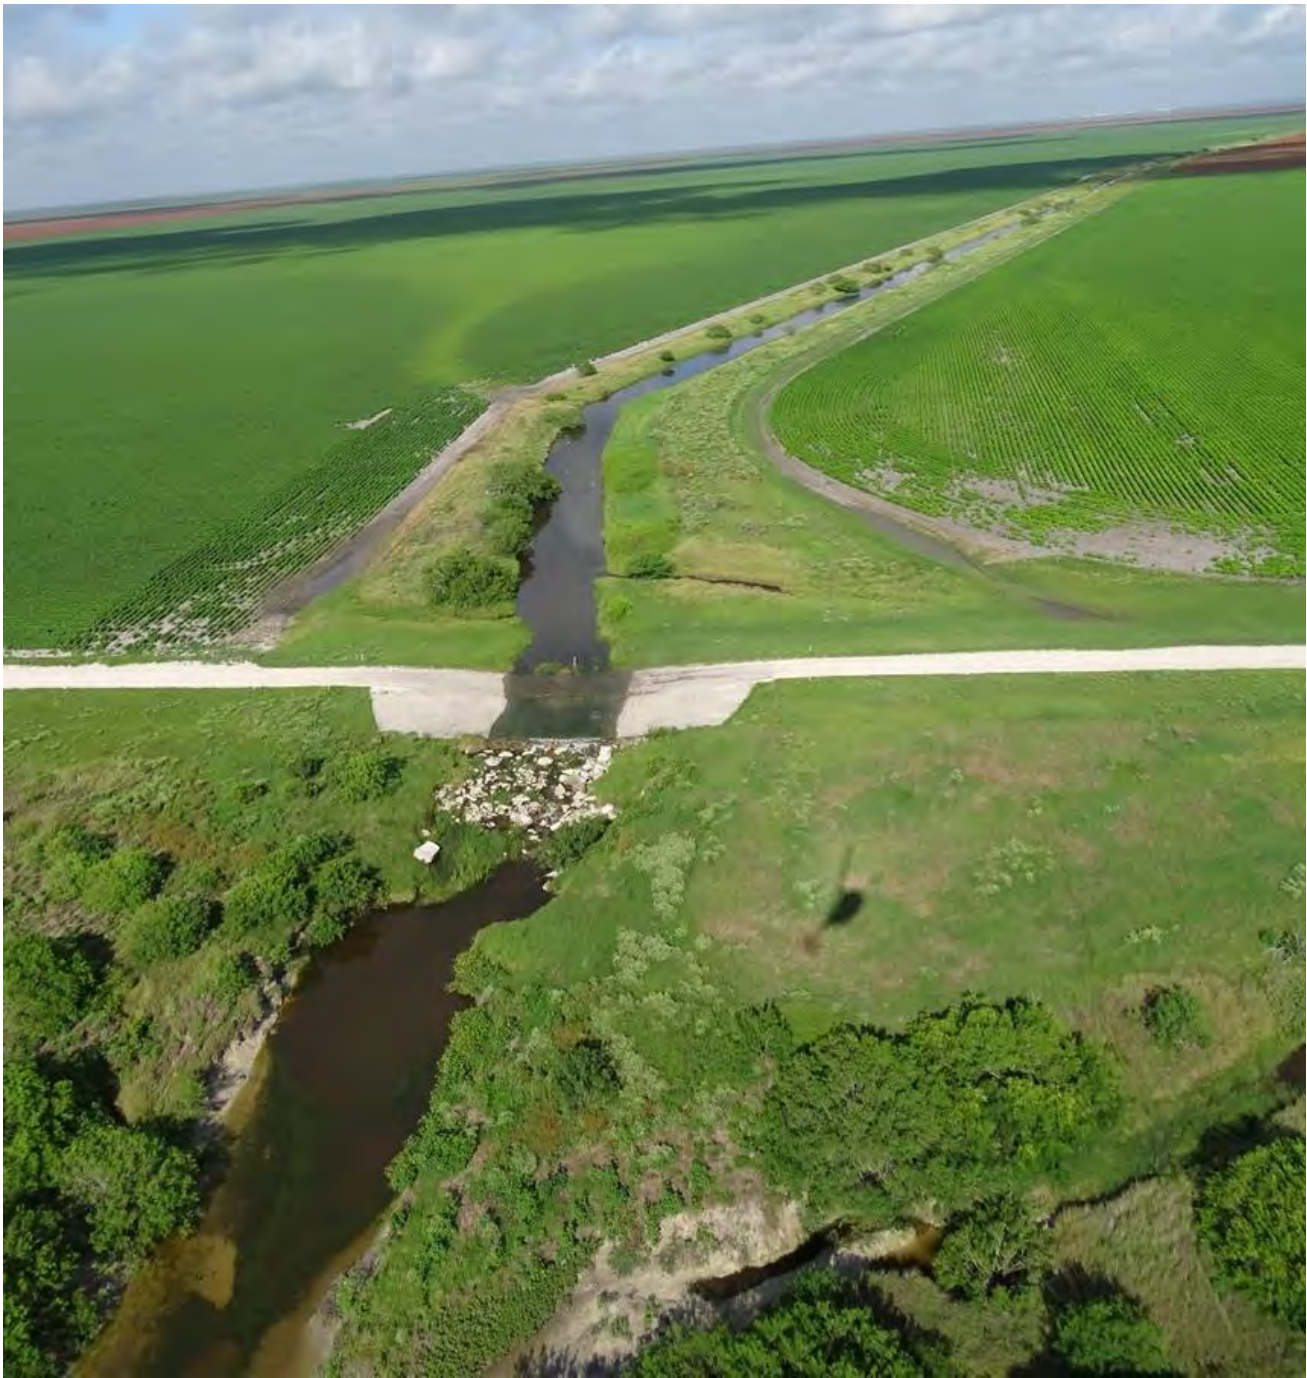
**Figure 112** Upstream the creek has been channelized and is more ditch like, straight and narrow. Still the riparian area is marginally functional and well vegetated. Farming activities are beginning to encroach on the creek and its floodplain. The poorly designed crossing pictured here is acting as a gradient control structure and is a source of erosive energy evidenced by a scour pool and head cut.

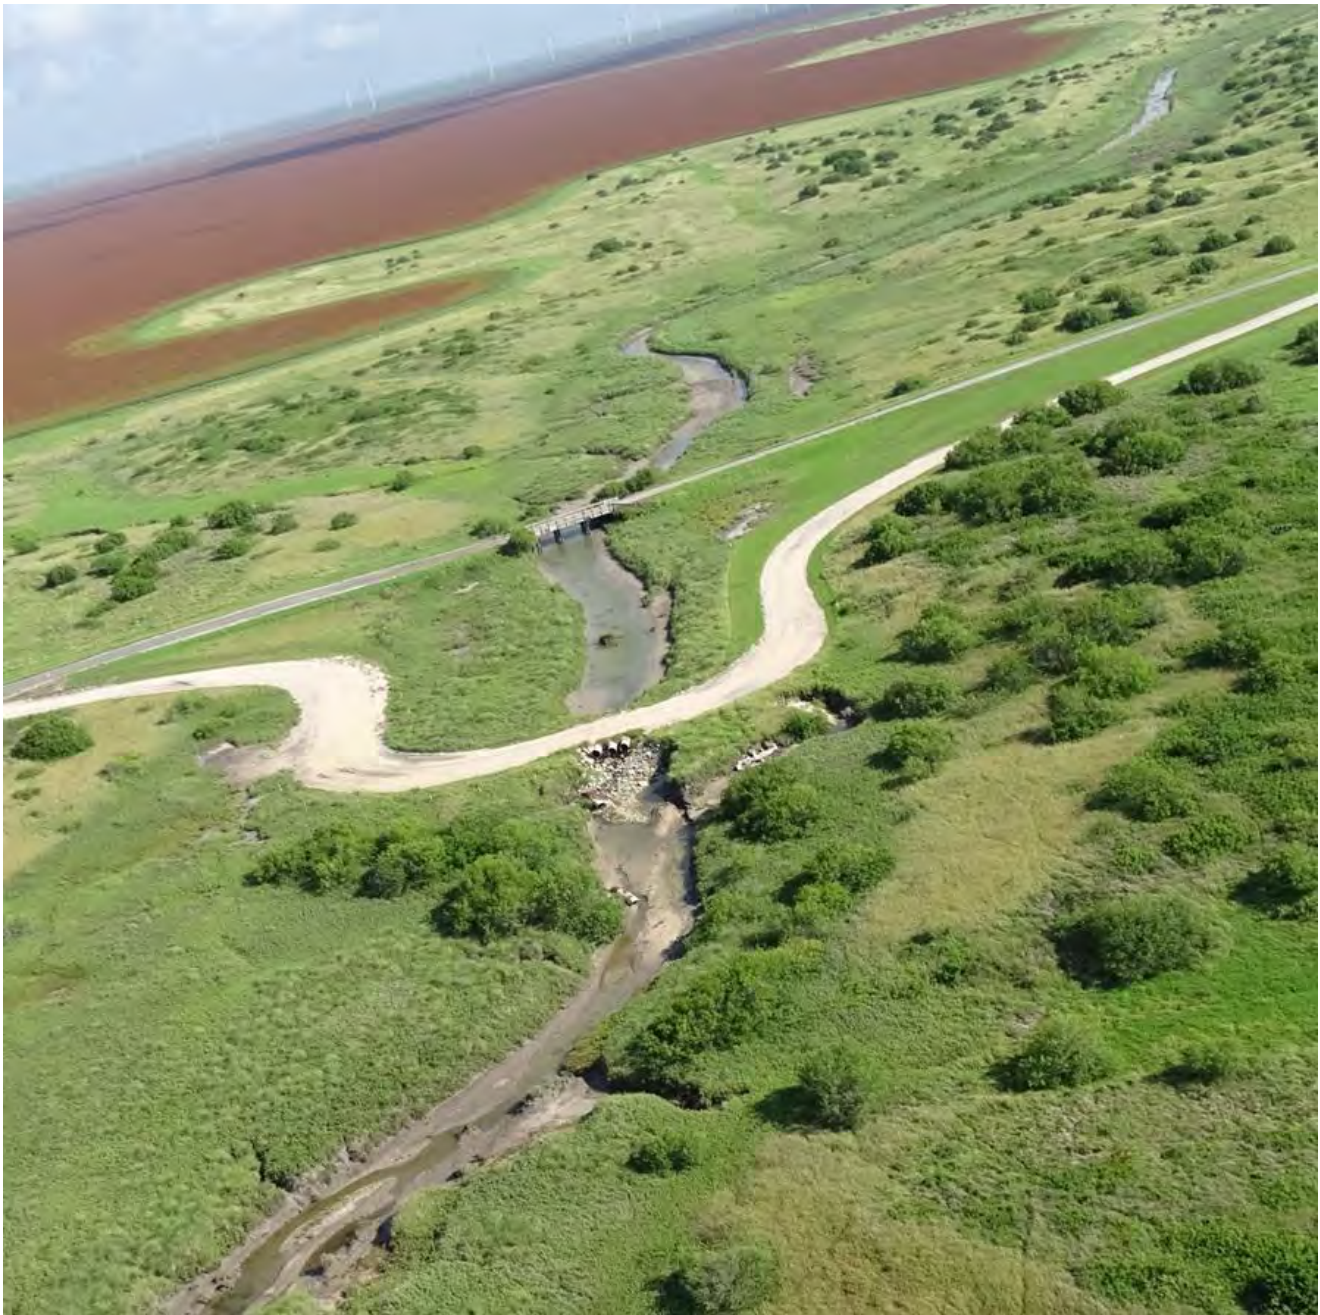
**Figure 118** The poorly designed crossing pictured in the foreground is acting as a gradient control structure and is a source of erosive energy evidenced by scoured banks and gully formation. In contrast, the crossing pictured in the background is well designed to allow passage of sediment and water without enhancing the streams erosive energy.

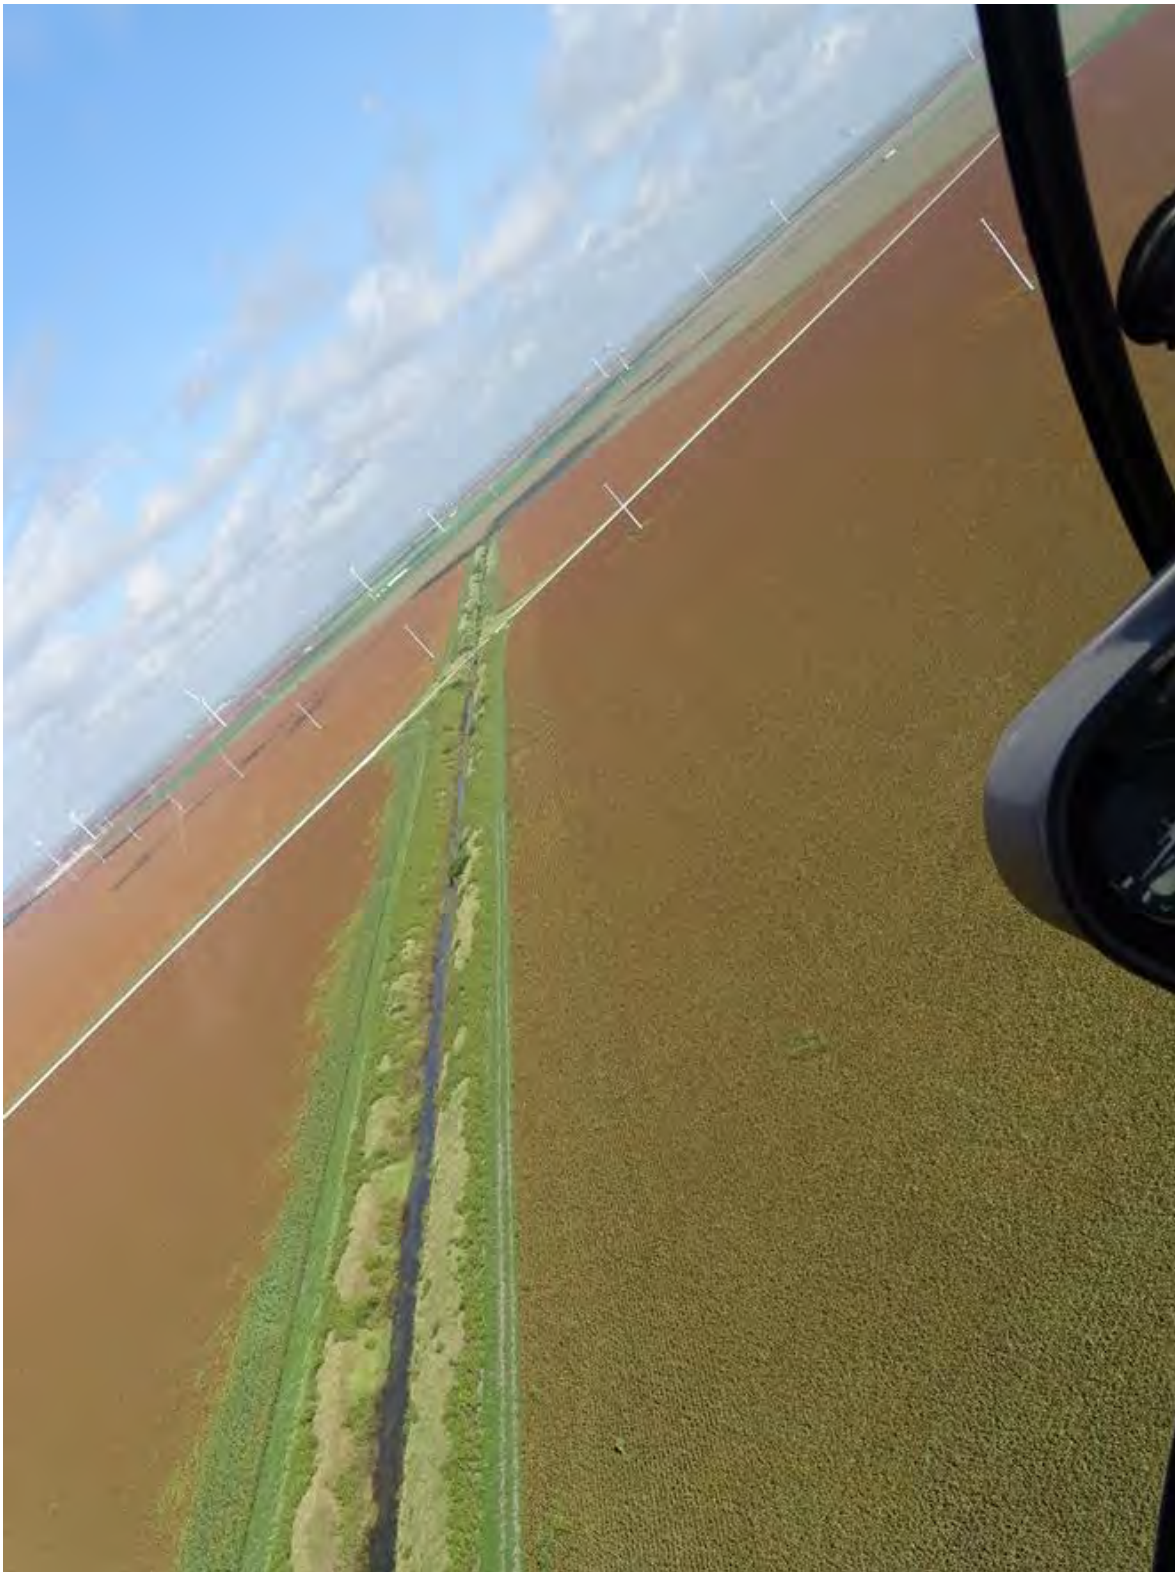
**Figure 119** Upstream, the creek has been channelized and is more ditch-like, straight and narrow. Still the riparian area is marginally functional and well vegetated. Farming activities are beginning to encroach on the creek and its floodplain.
