## **Riparian Evaluation for Baffin Bay Tributaries**

Final Report

Publication CBBEP – 132

August 2019

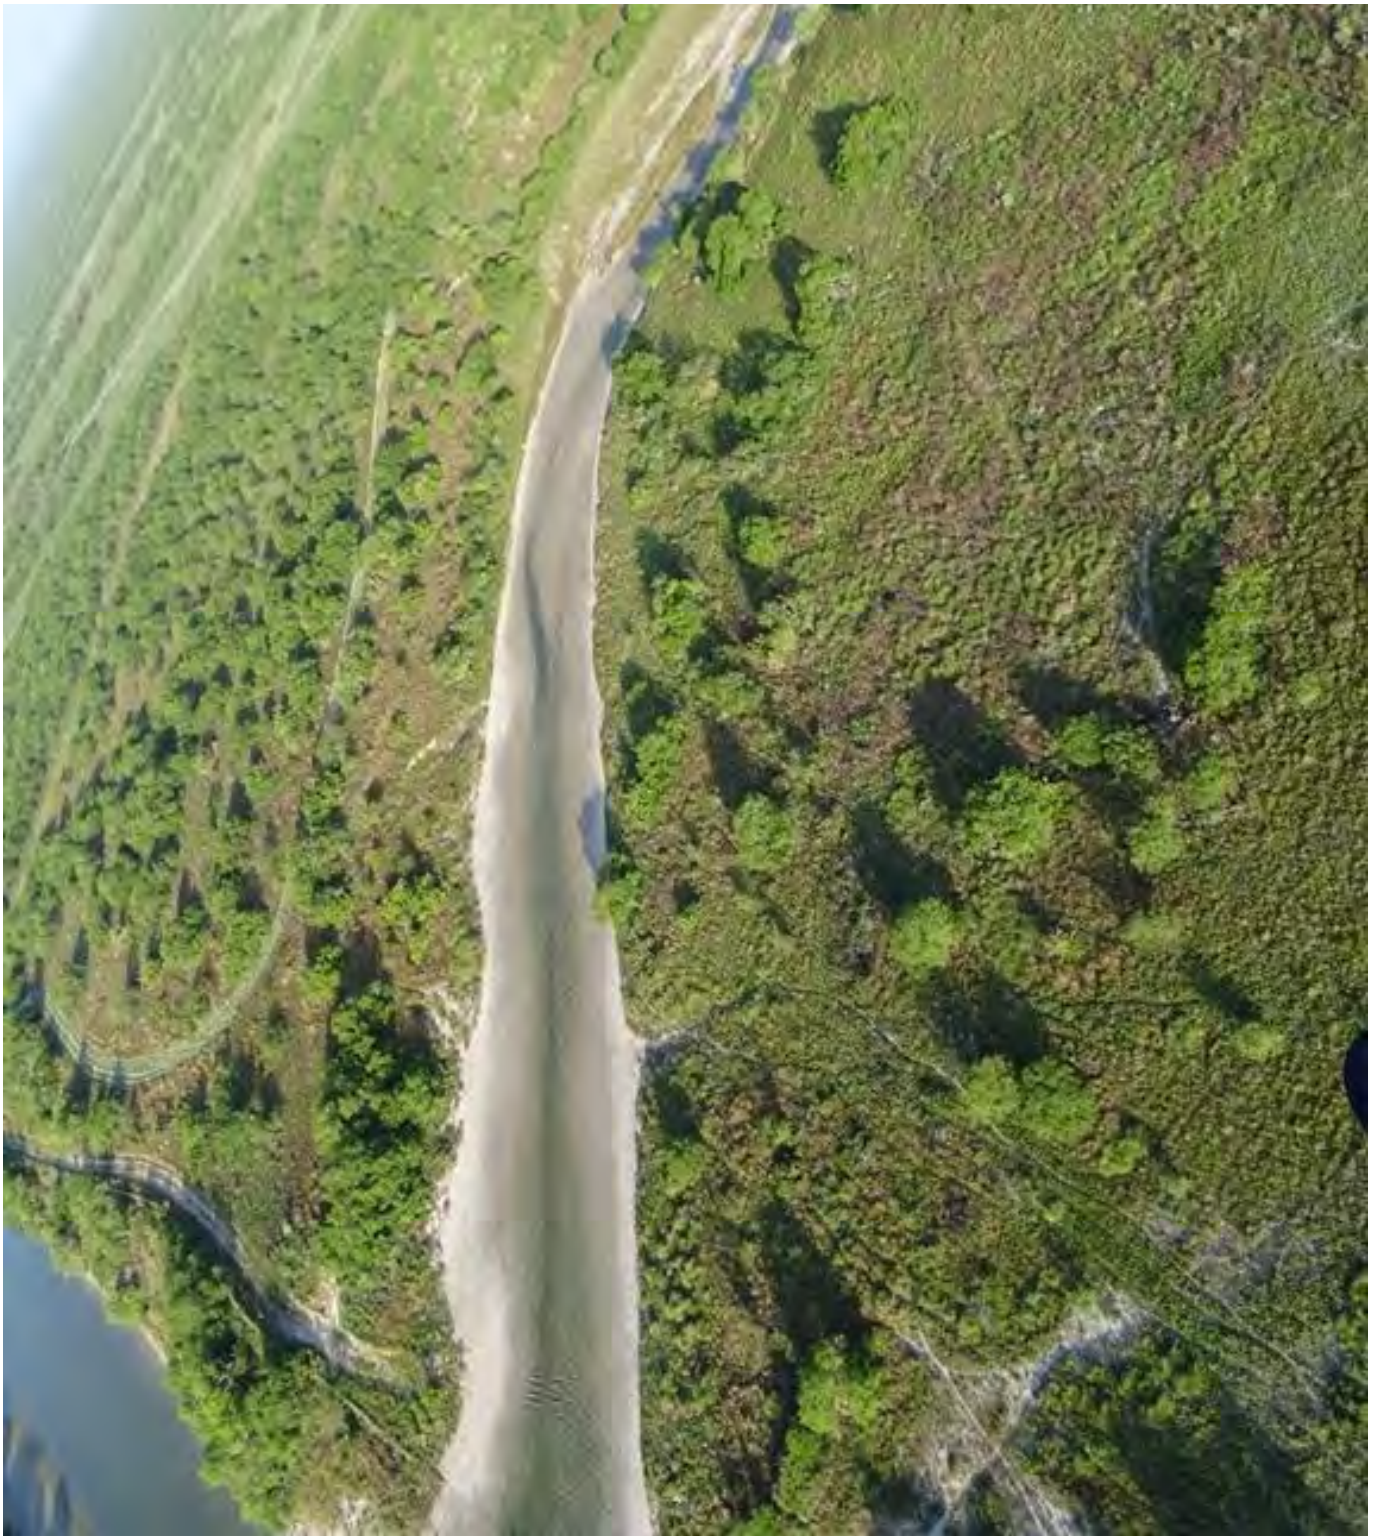
**Figure 126** In this image you can see the Salado Creek near its confluence with Los Olmos. The creek appears to be attempting to recover by growing vegetation, trapping sediments, and holding water but may be hindered by livestock and/or wildlife grazing. In the image, animal trails on the lower right corner and the condition of plant vigor are clues to the presence of a hindrance.

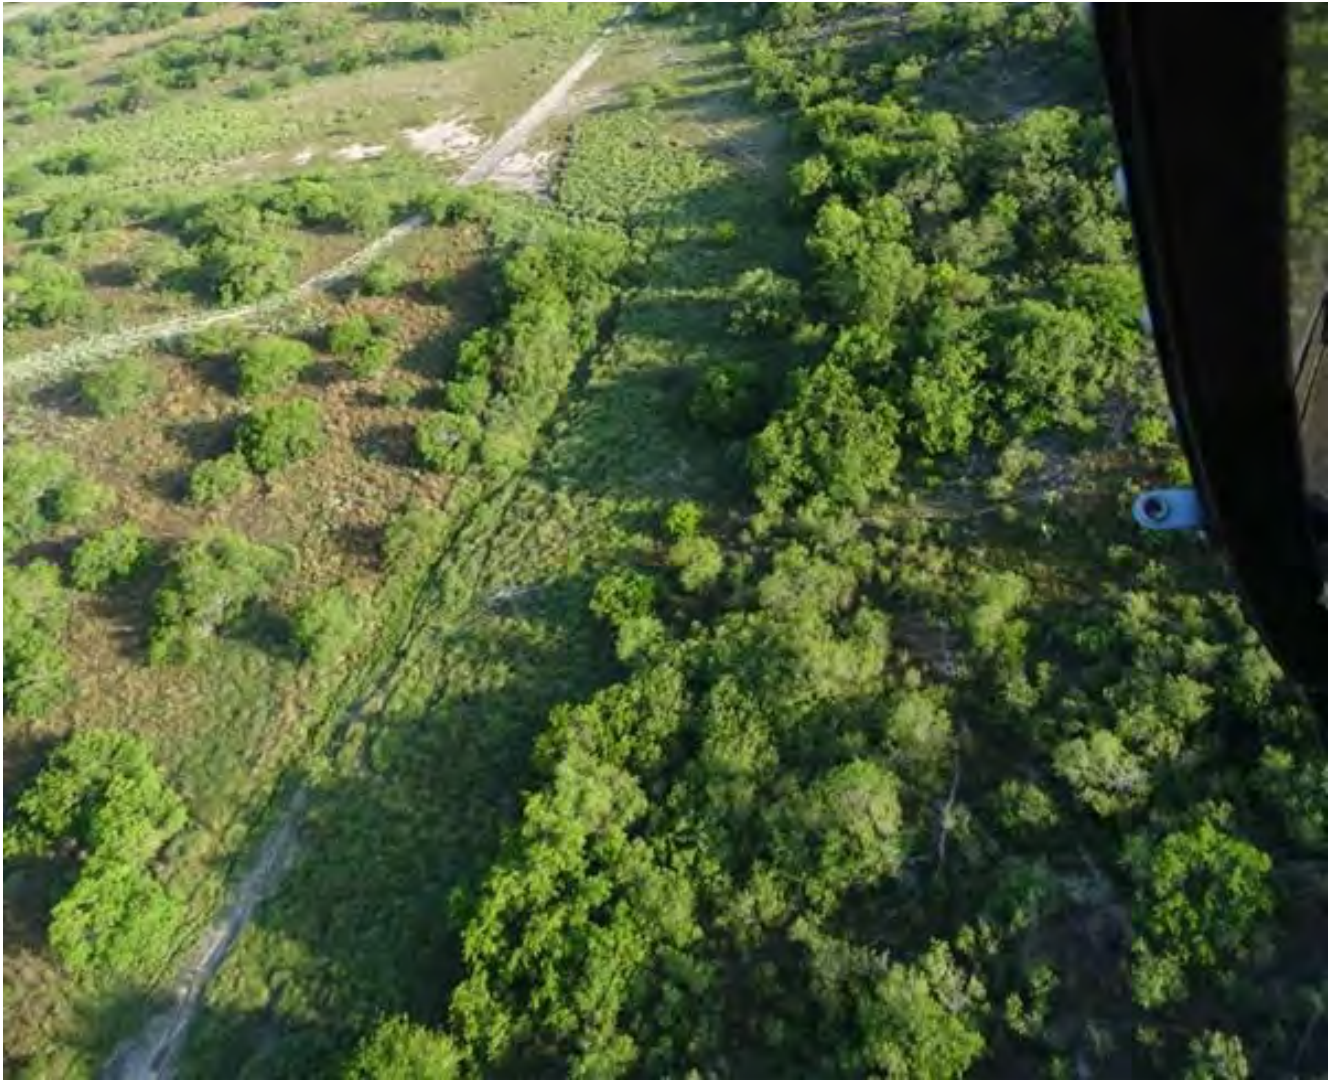
**Figure 127** Further upstream, the creek appears to have the good riparian vegetation present (Cordgrass, Spiny aster were identifiable), but the plant vigor appears to be hampering its contribution.

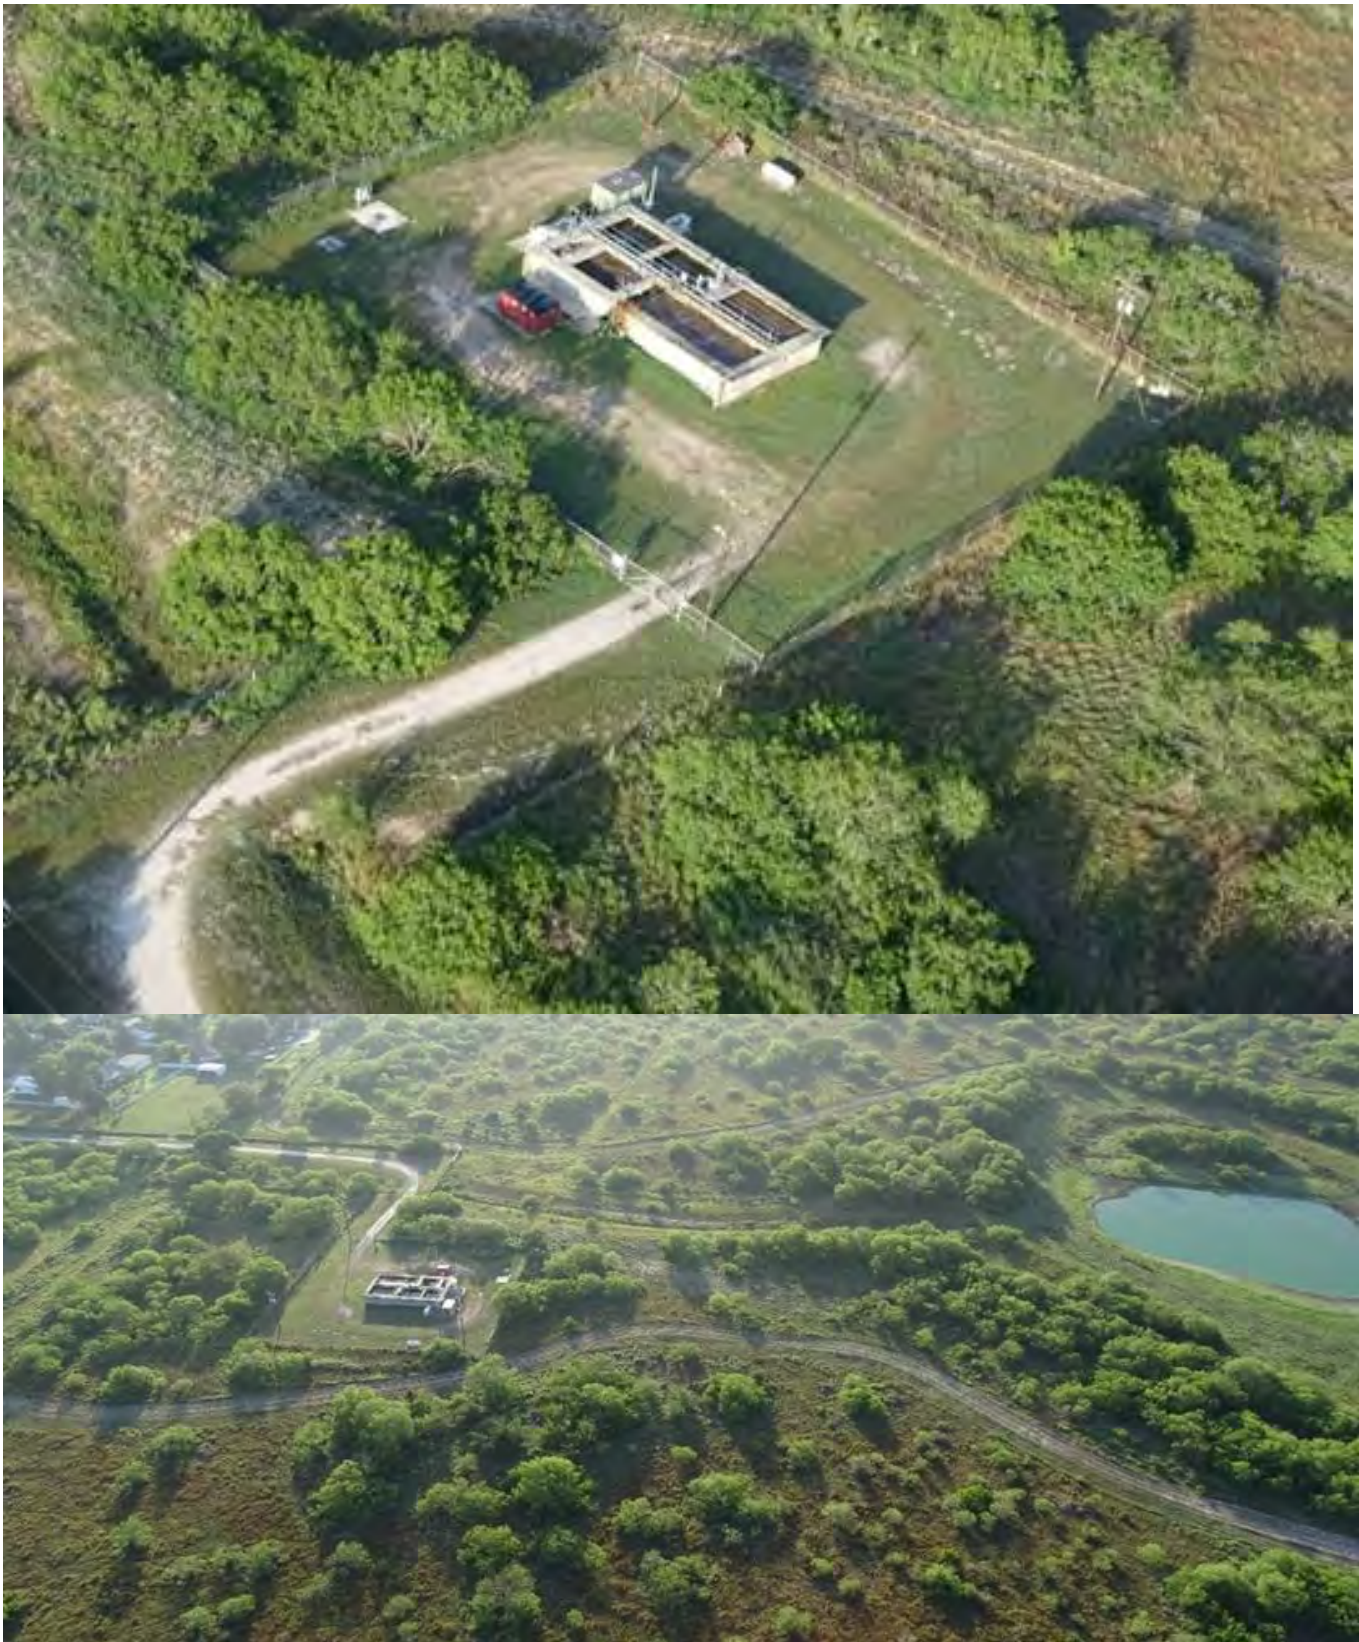
**Figure 128** In this image the WWTP and a pond are shown. It is difficult to tell the relationship of the pond to Salado Creek as the creek's floodplain and channel appear to have been highly altered. Installed wetlands and riparian enhancement offer potential for improved water quality in Salado Creek prior to its confluence with Los Olmos Creek.
