## **Quantifying Plastic Debris Loading and Accumulation in Corpus Christi Bay to Improve Stakeholder Awareness**

**Publication CBBEP – 125**

**August 2018**

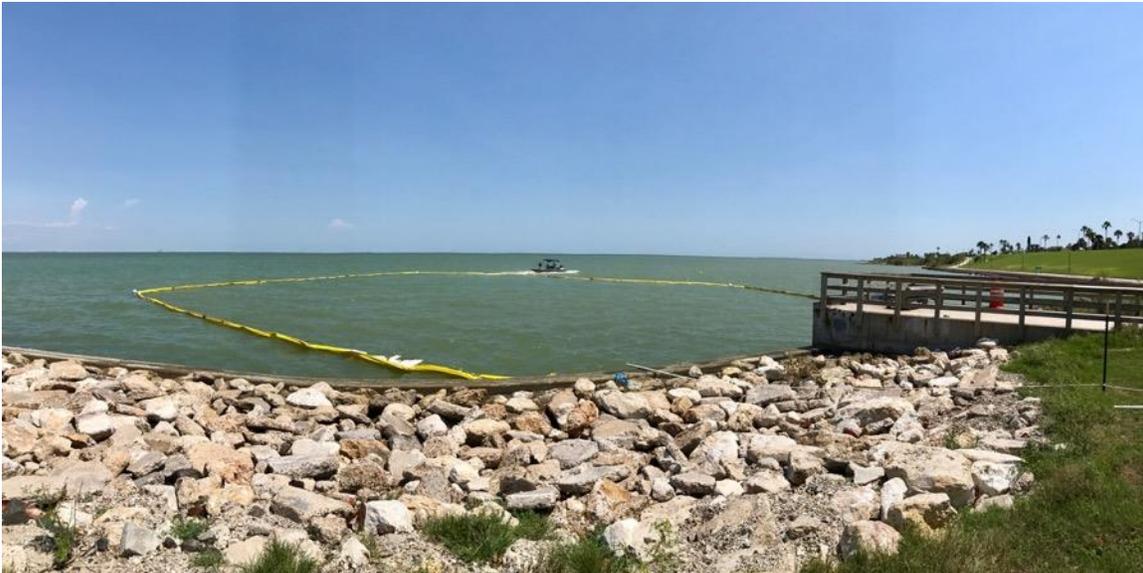
Figure 2. Boom installation at Cole Park (09/01/2017)

The floating debris collection system utilized standard harbor class oil spill response boom extending 30 to 60 m (100 to 200 ft) into the bay from the shoreline at Cole Park and Oleander Point in an open trapezoidal configuration (Figure 3). This configuration allowed for potentially strong discharge currents to flow under the boom while capturing floating debris.
