Nutrient Sampling in Petronila Creek

Final Report

Publication CBBEP – 151 Project Number – 2133 August 2021

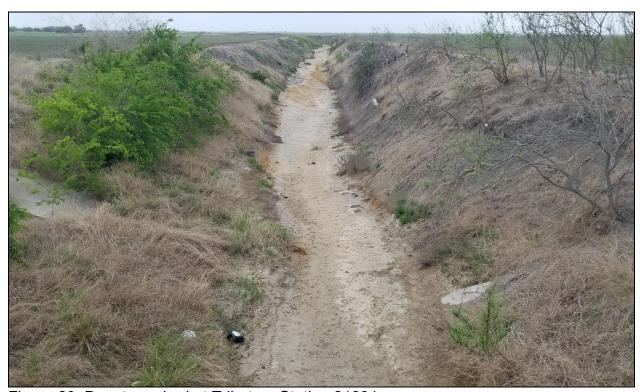
Data collected for the project from February through April coincided with drought conditions where streamflow rates in the main stem stations were lower than normal (1.0 to 4.0 ft³/s). The USGS streamflow gage on FM 665 near Driscoll recorded streamflow values below 1.0 ft³/s during much of this time. Streamflow in the main stem of the creek was dominated by effluent from the WWTPs and extremely high conductivity groundwater seeps (>30,000 µmhos/cm). Many of the tributaries sampled for the study were either not flowing or dry. In February and March, six out nine tributaries sites had flowing water. By late April, only 4 tributary stations had flow. Those flowing stations include: 13030, 18642, 18484, and 21594. Streamflow at stations 13030 and 18642 were attributed to groundwater seeps. Station 18484 and 21594 are sourced by a combination of WWTP effluent and groundwater.

Figure 29. Dry streambed at Tributary Station 21931
