Monitoring Success of Dredged Material Placement in the Nueces Delta

Final Report

Publication CBBEP – 199
Project Number – 2404
February 2026

2025 Post-Construction Monitoring Report

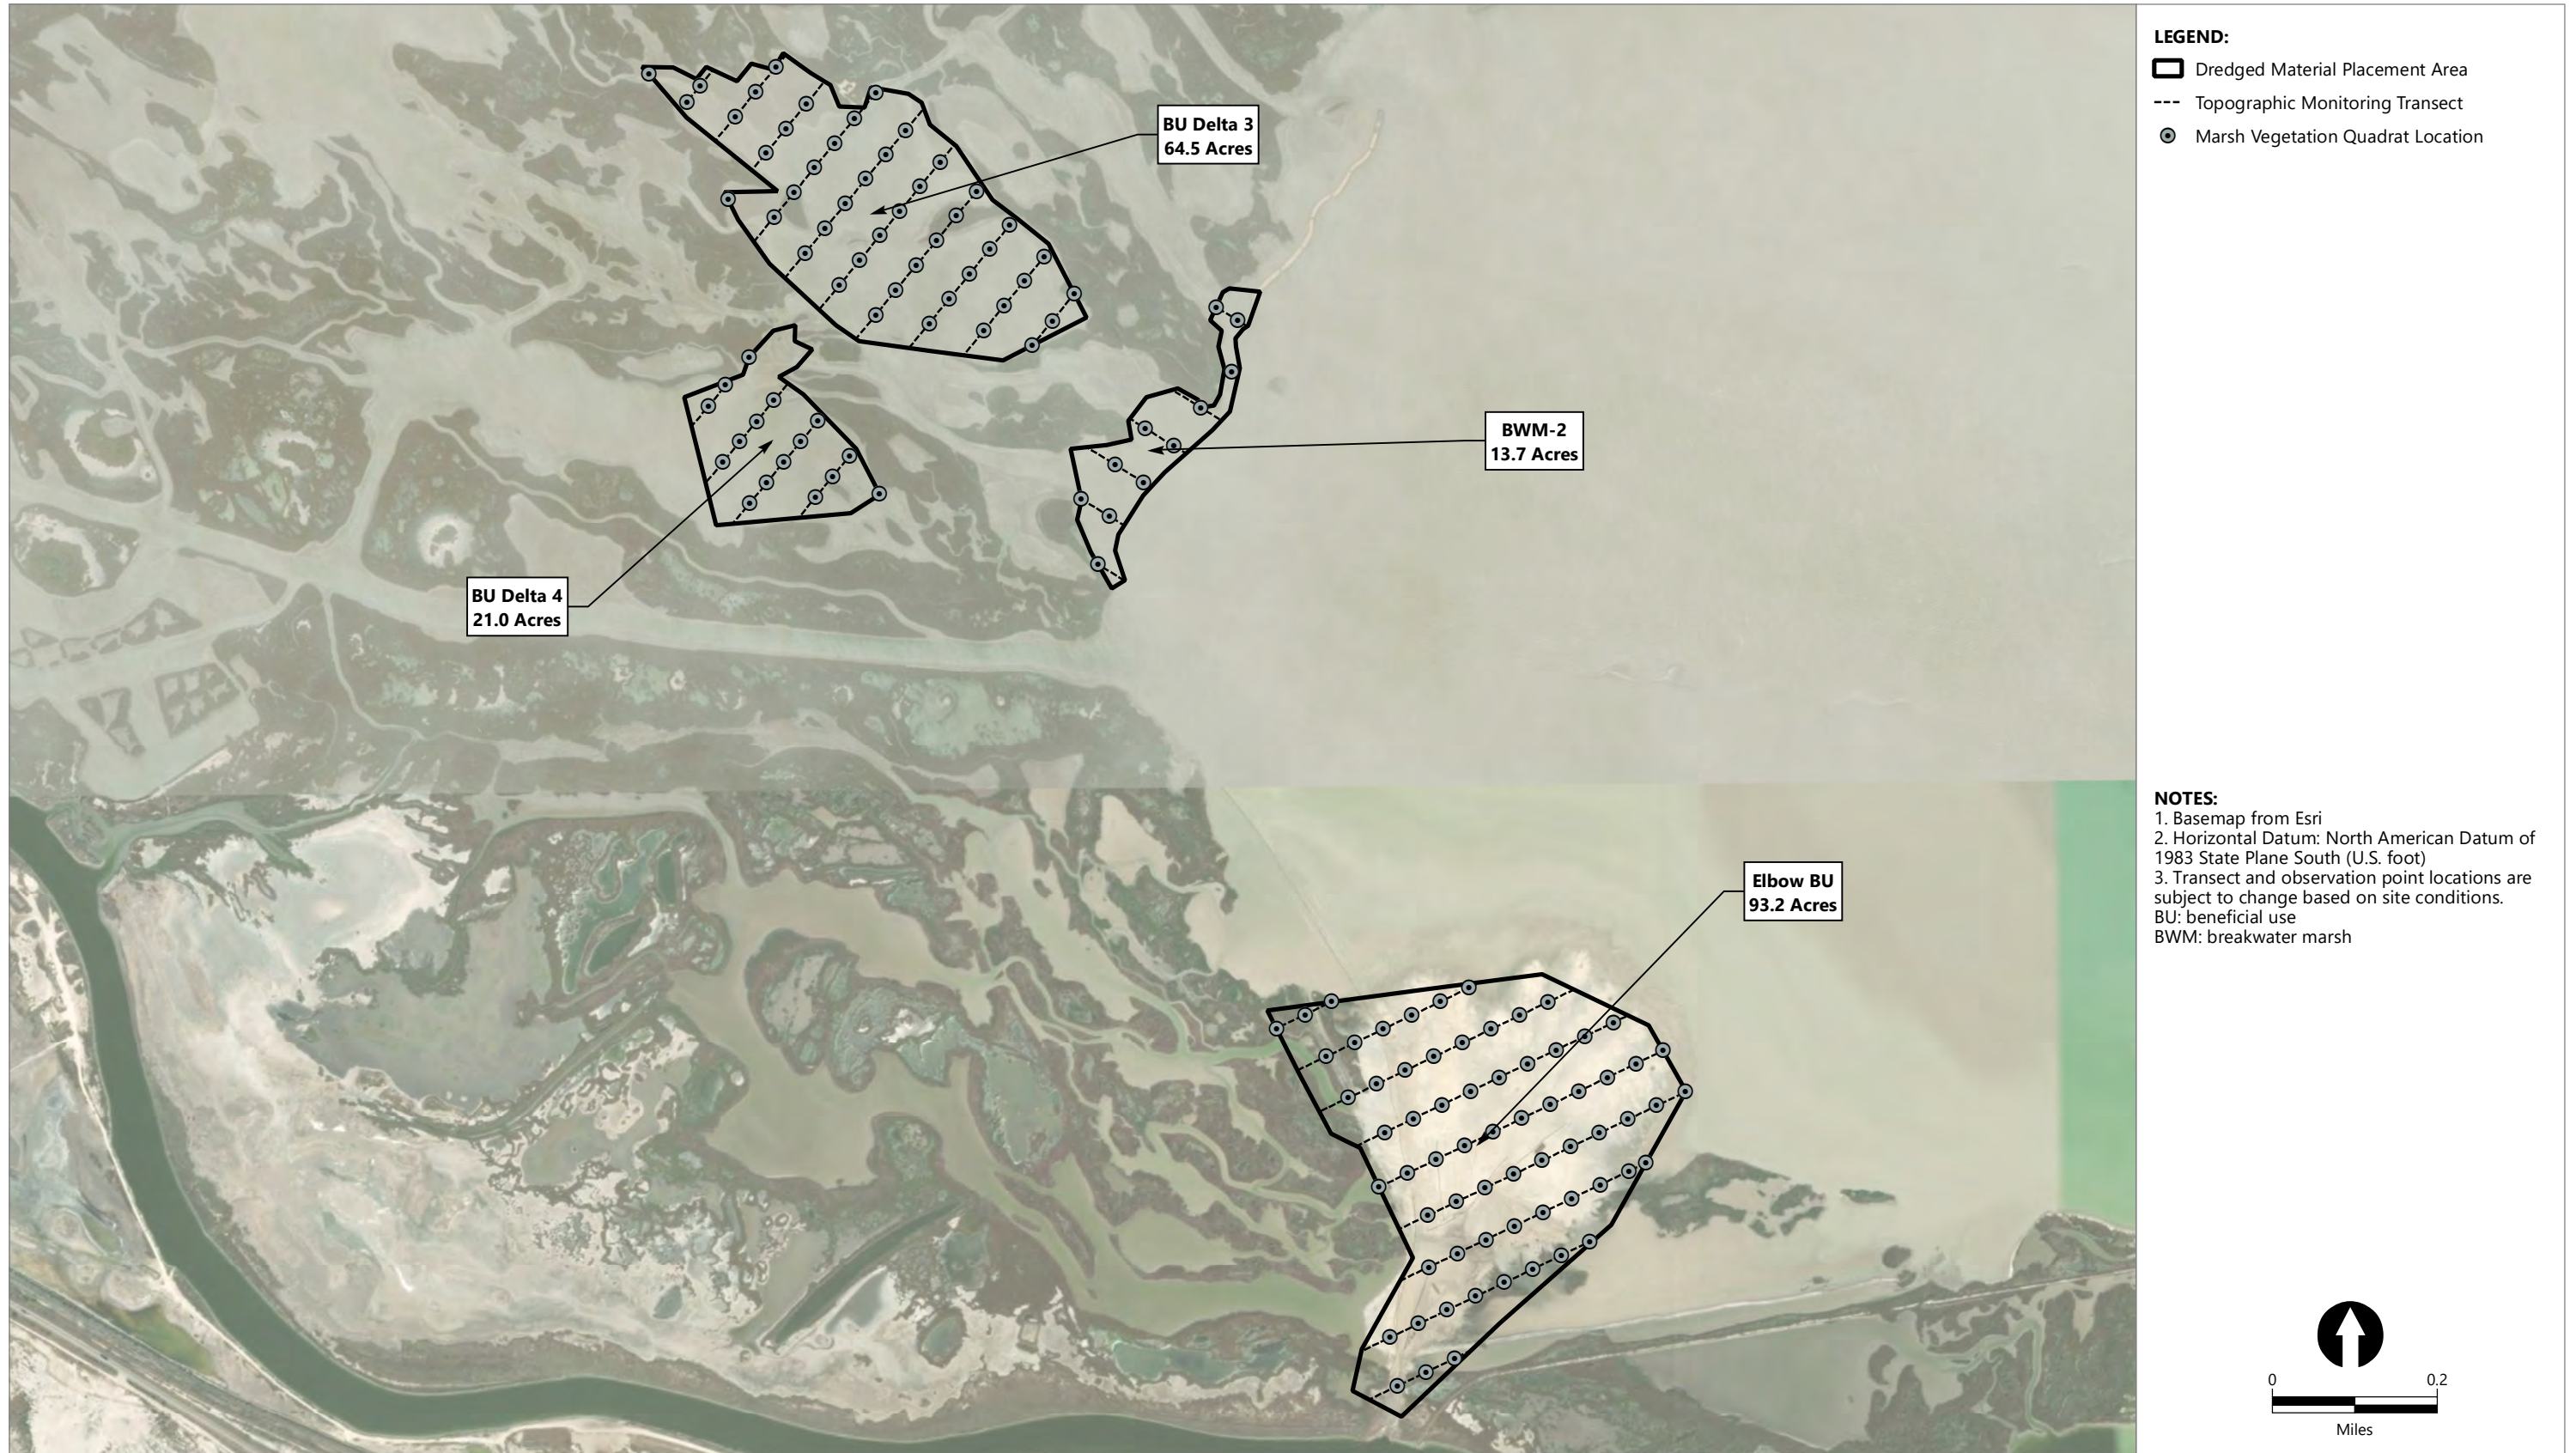
Figure 3
Preliminary Marsh Vegetation Monitoring Plan

Marsh vegetation monitoring was conducted using a 1-meter quadrat, and 140 preliminary quadrat observation points were established across the site. The 140 quadrat points were distributed proportionately among the placement areas based on the preliminary size of each placement area. Within each placement area, quadrat points were distributed evenly based on total transect length to ensure proportionate distribution within each placement area. The quadrat points were limited to topographic transects to better characterize spatial trends across vegetative coverage and to inform adaptive management opportunities. Figure 3 shows the approximate location for each quadrat

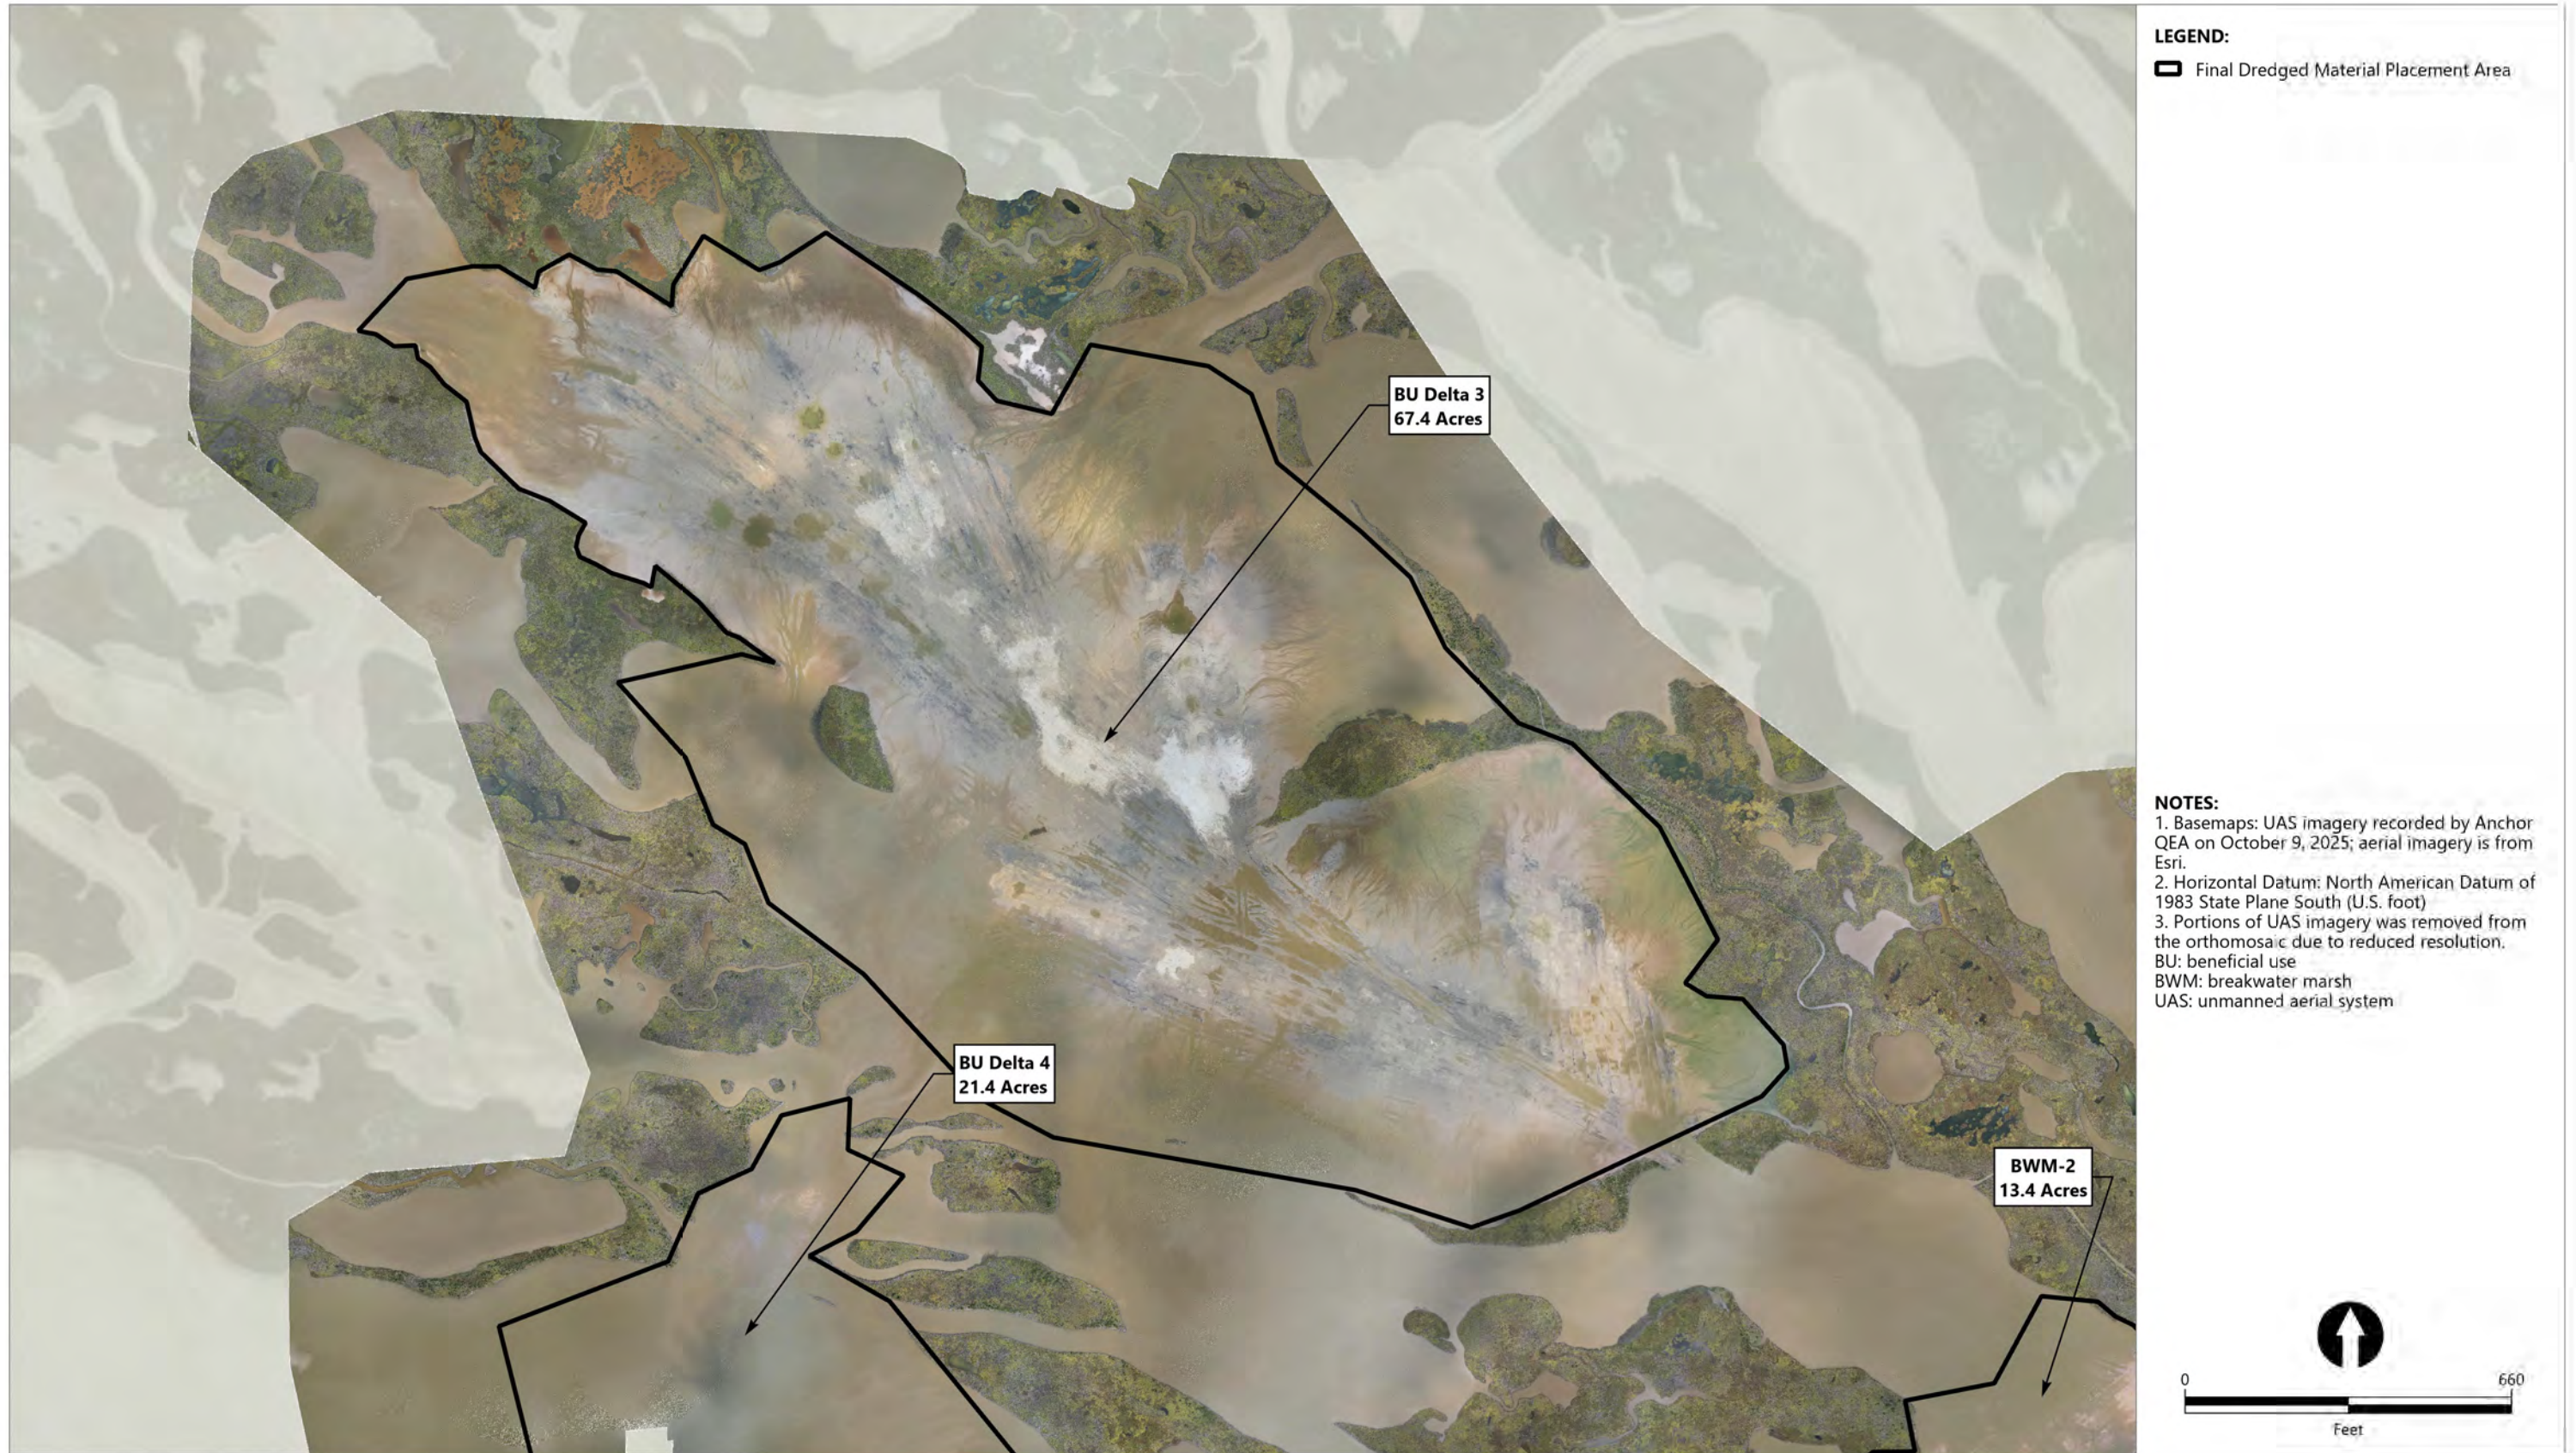
Figure 4.2
UAS Aerial Overview Map (BU Delta 3)

Topography encountered at BU Delta 3 was generally flat but included a gentle ridge running southeast to northwest. This slight ridge may have been created by a dredge pipe's outfall location. Based on the hydraulic placement methods used, it is possible that heavy sandy or clay sediments settled closer to the center ridge with finer silt sediments traveling farther from the outfall location. This potential settling process may have caused softer substrate to migrate toward placement area boundaries. Heavy machinery tracks were also visible throughout BU Delta 3. Evidence of tidal ebb and flow were observed, as depicted by UAS imagery, and was generally located near the margin of the placement area. Tidal influence was also evident in the form of erosional features and shallow scours within the finer, soft sediment.

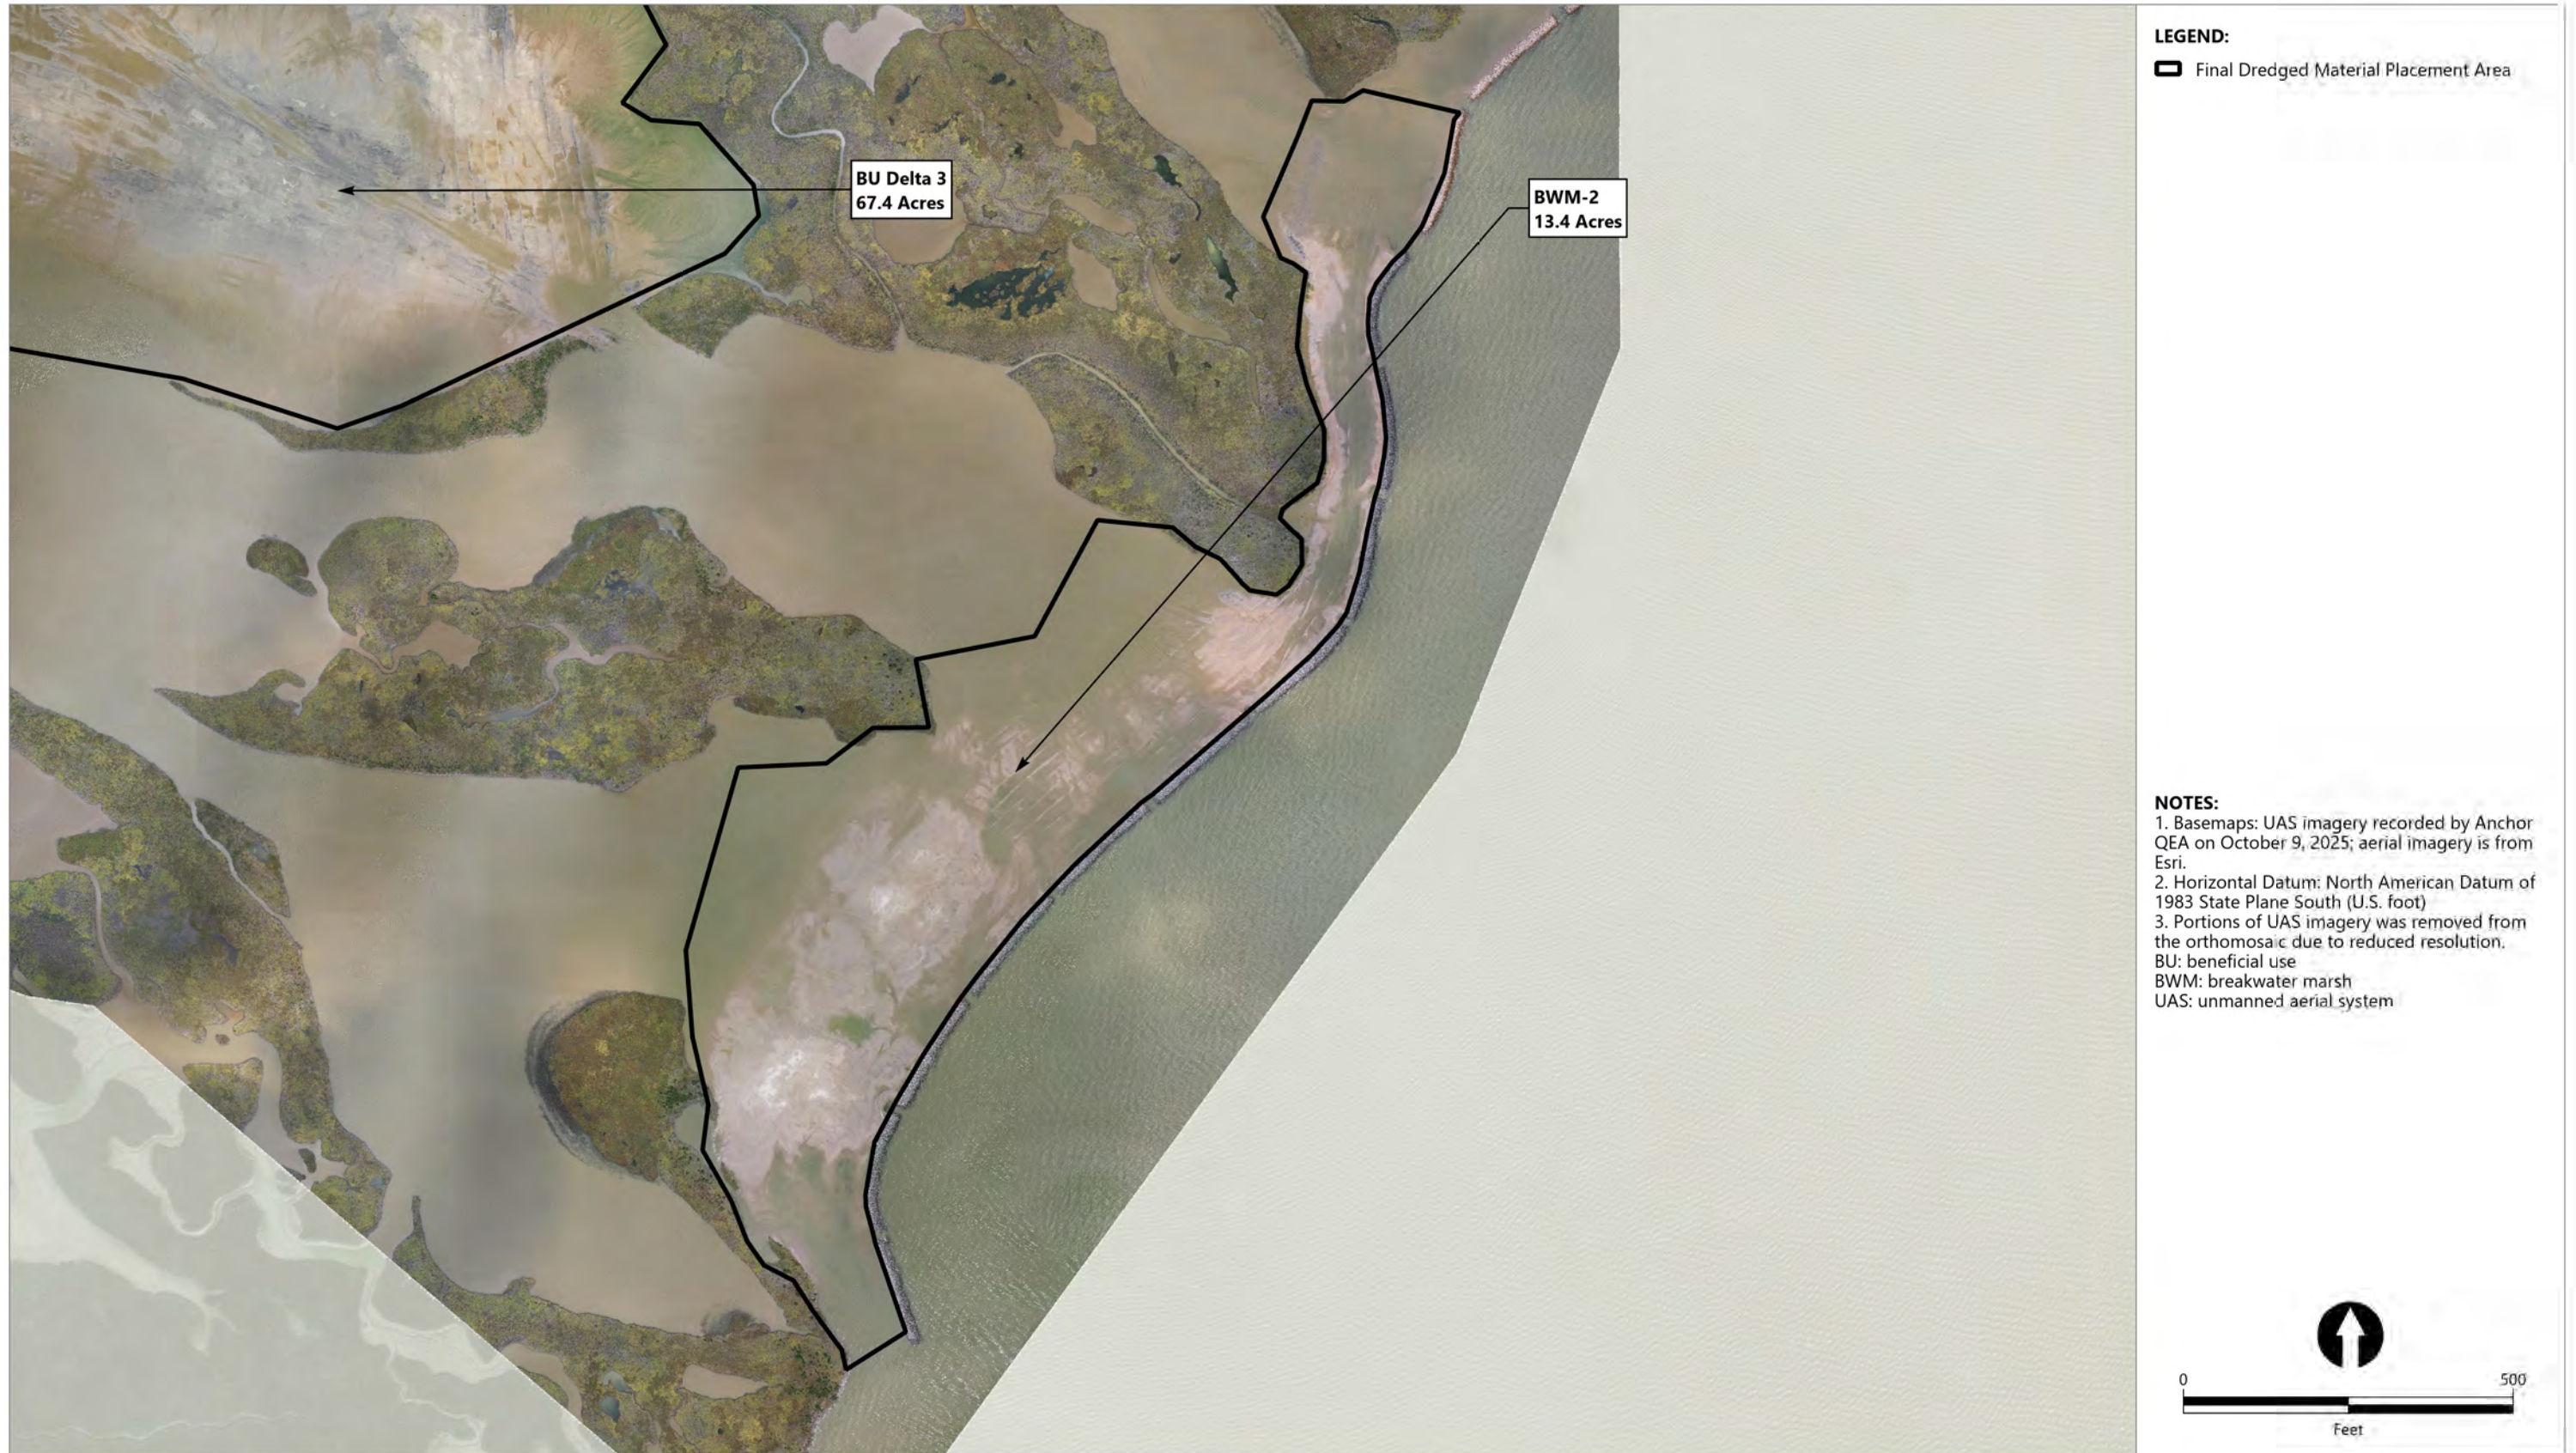
Figure 4.4
UAS Aerial Overview Map (BWM-2)

Topography observed within BWM-2 was relatively flat. Tidal influence was evident throughout the placement area, including significant tidal exchanged between the breakwater gaps. Active tidal flow was observed during both incoming and outgoing daily tides. This tidal exchange appears to have resulted in the development of small scour and erosion features. The most significant tidal exchange observed was present in the northern portion of BWM-2. Water was seen rushing across placed material and flowing between breakwater gaps. Significant evidence of heavy machinery operation was also observed through the placement area and is depicted in UAS imagery. The northwest boundary of BWM-2 exhibited a discernable line of placement material with surrounded undisturbed areas consisting of soft sediment.

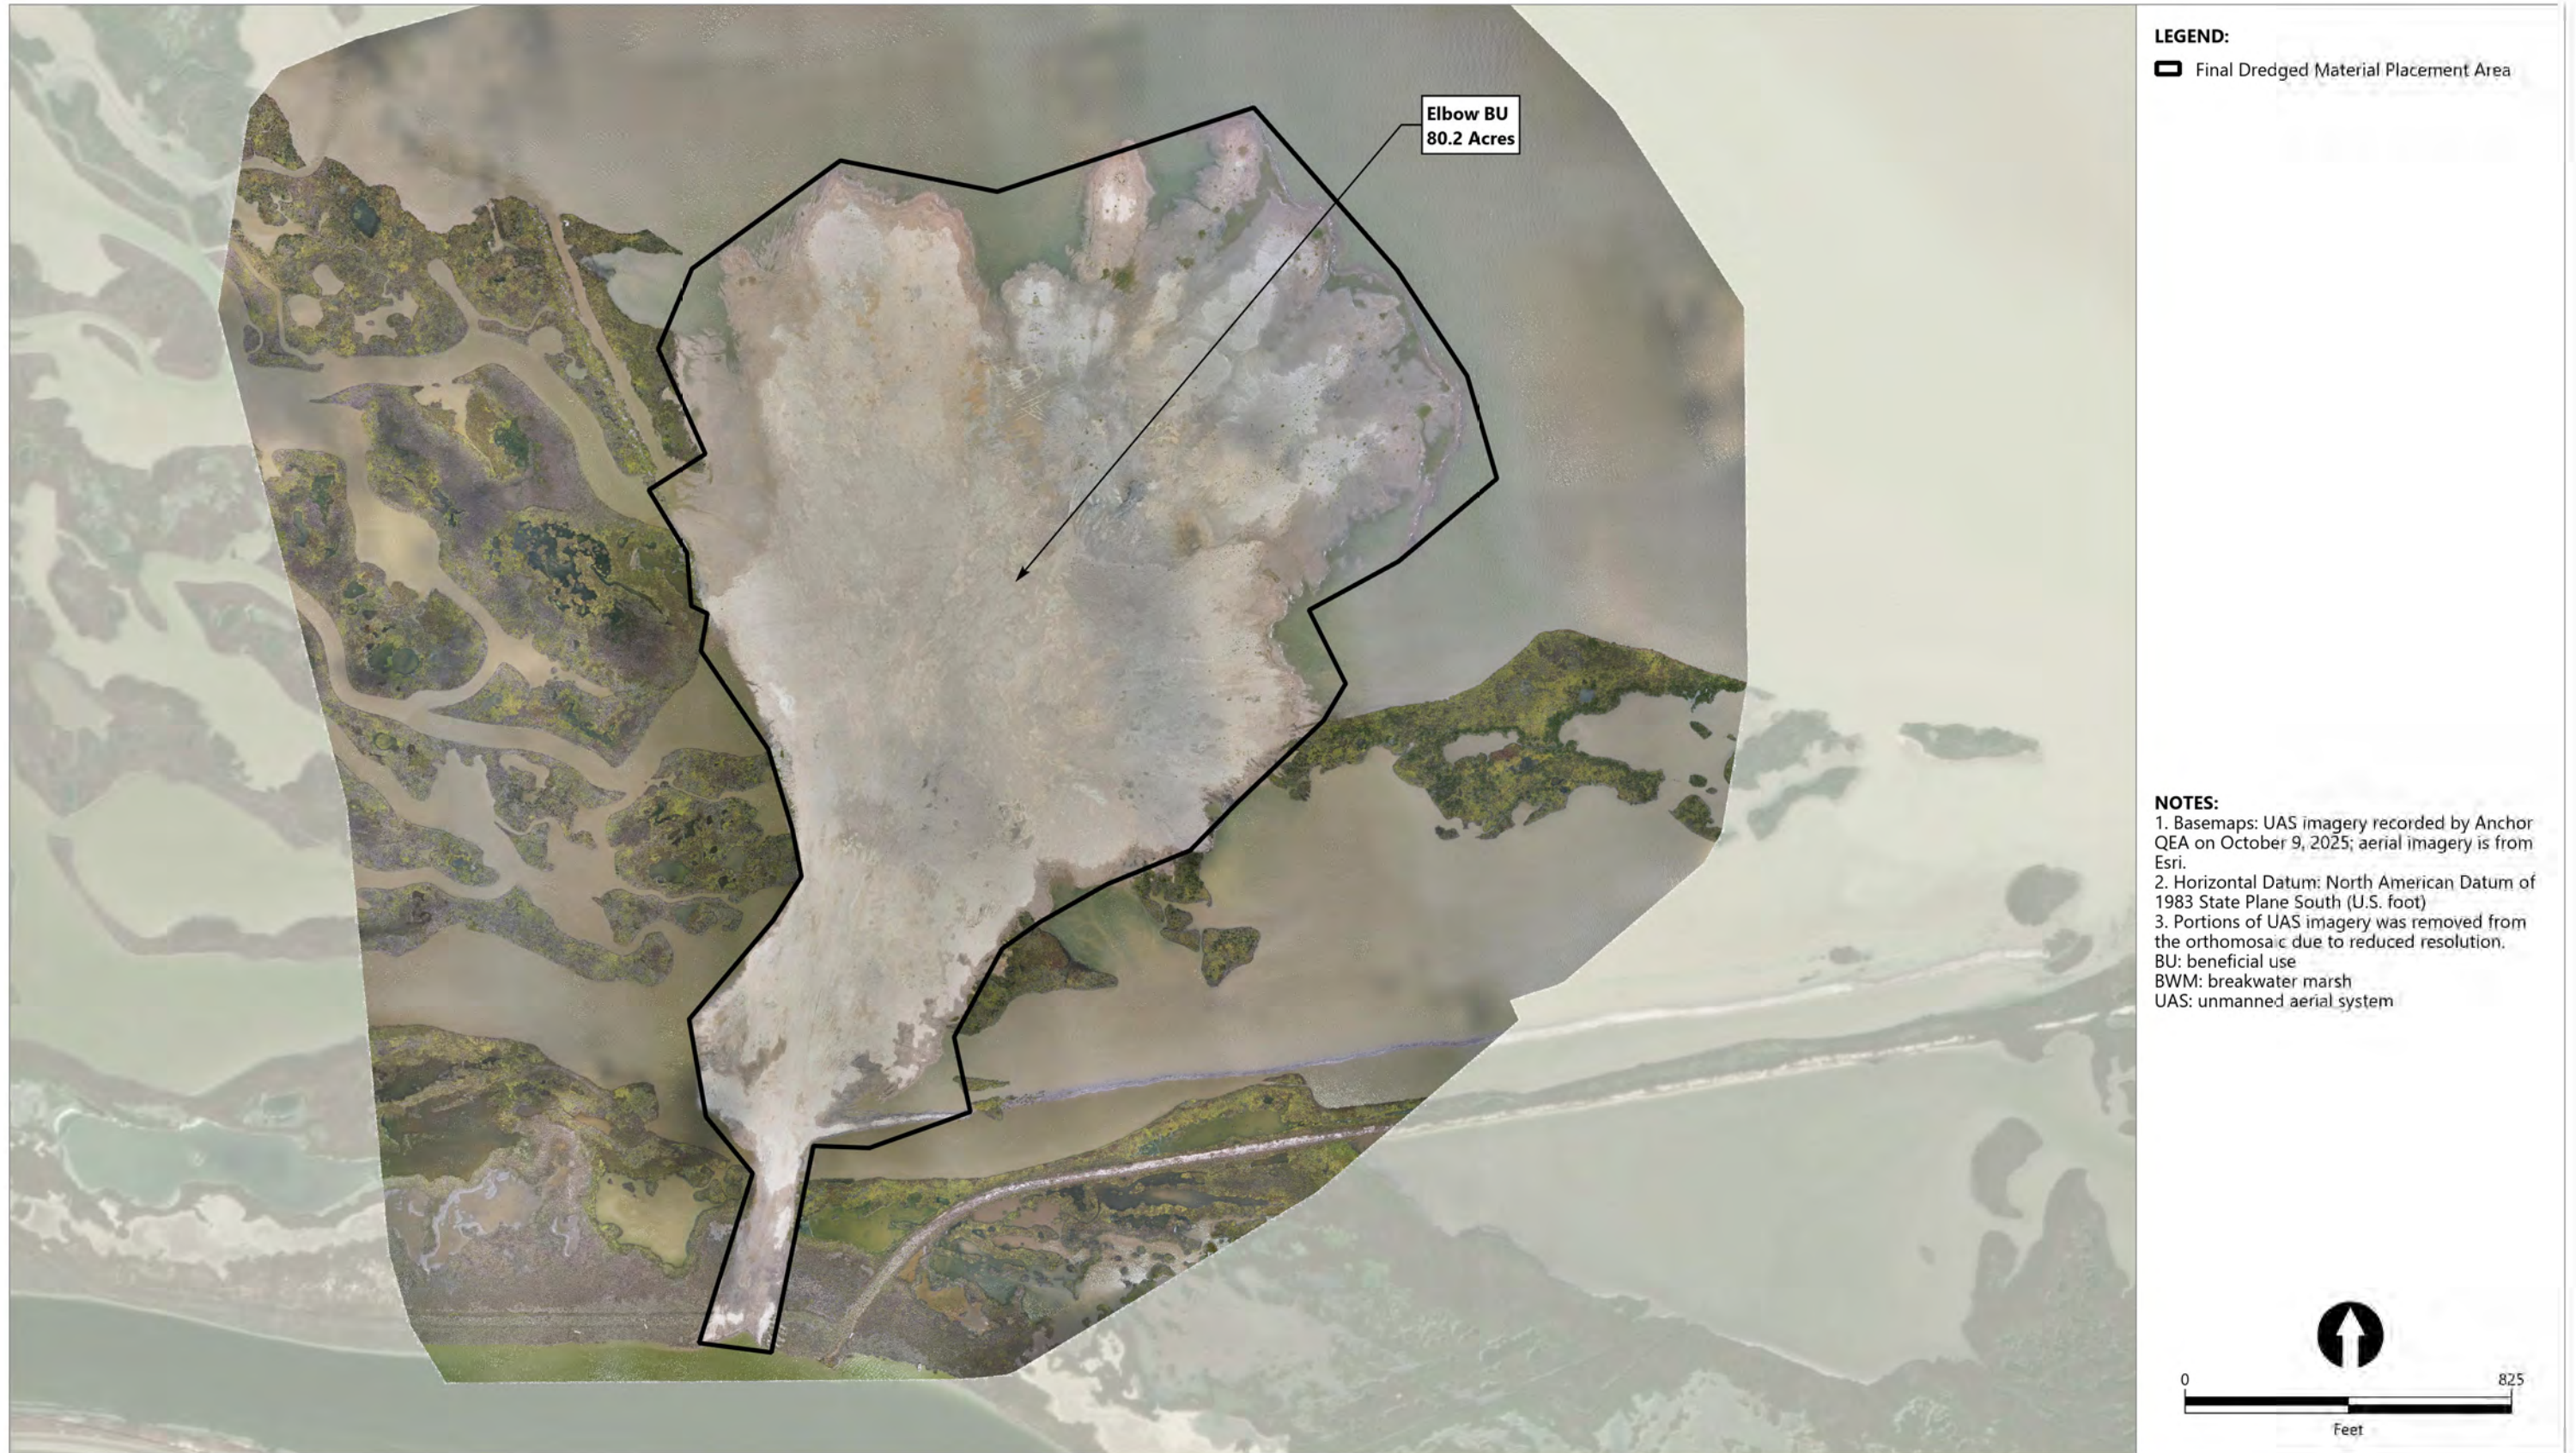
Figure 4.5
UAS Aerial Overview Map (Elbow BU)

Elbow BU is the largest of the placement areas surveyed and contains a higher elevation center with very gentle downward slopes in all directions. Finer surface sediments found throughout appear to have been transported by rain and wind processes. These processes have likely resulted in the exposure of small gravel and shell fragments at the surface. Substrate in the center, higher elevation portion of Elbow BU consisted of hard clay that is relatively compacted. Generally, increasingly sandy clay substrate was observed along the boundary of the placement area. Sediments appear to be slowly migrating or sluffing along the bayward margin of the placement area, creating a shallow shelf. This shelf is along the northern and eastern boundary of the placement area and contains finer material than what was observed within the center of the placement area. In comparison to adjacent marsh habitats, material placed within Elbow BU appears to be at a similar or slightly elevated grade. However, a discernable bluff, approximately 2 to 3 feet in height, was observed along the open-water boundary situated along the southern margin of the placement area. The overall elevation of Elbow BU appears to be situated slightly higher than normal tide levels for the region. Several pits or holes were also observed along the Nueces Bay shoreline. The origin of these features could not be determined. However, it is possible that they formed as a result of substrate variation or erosional energy associated with wind and wave action. Within the Elbow BU, heavy machinery tracks were also evident and observed along the bayward margin of the placement area.

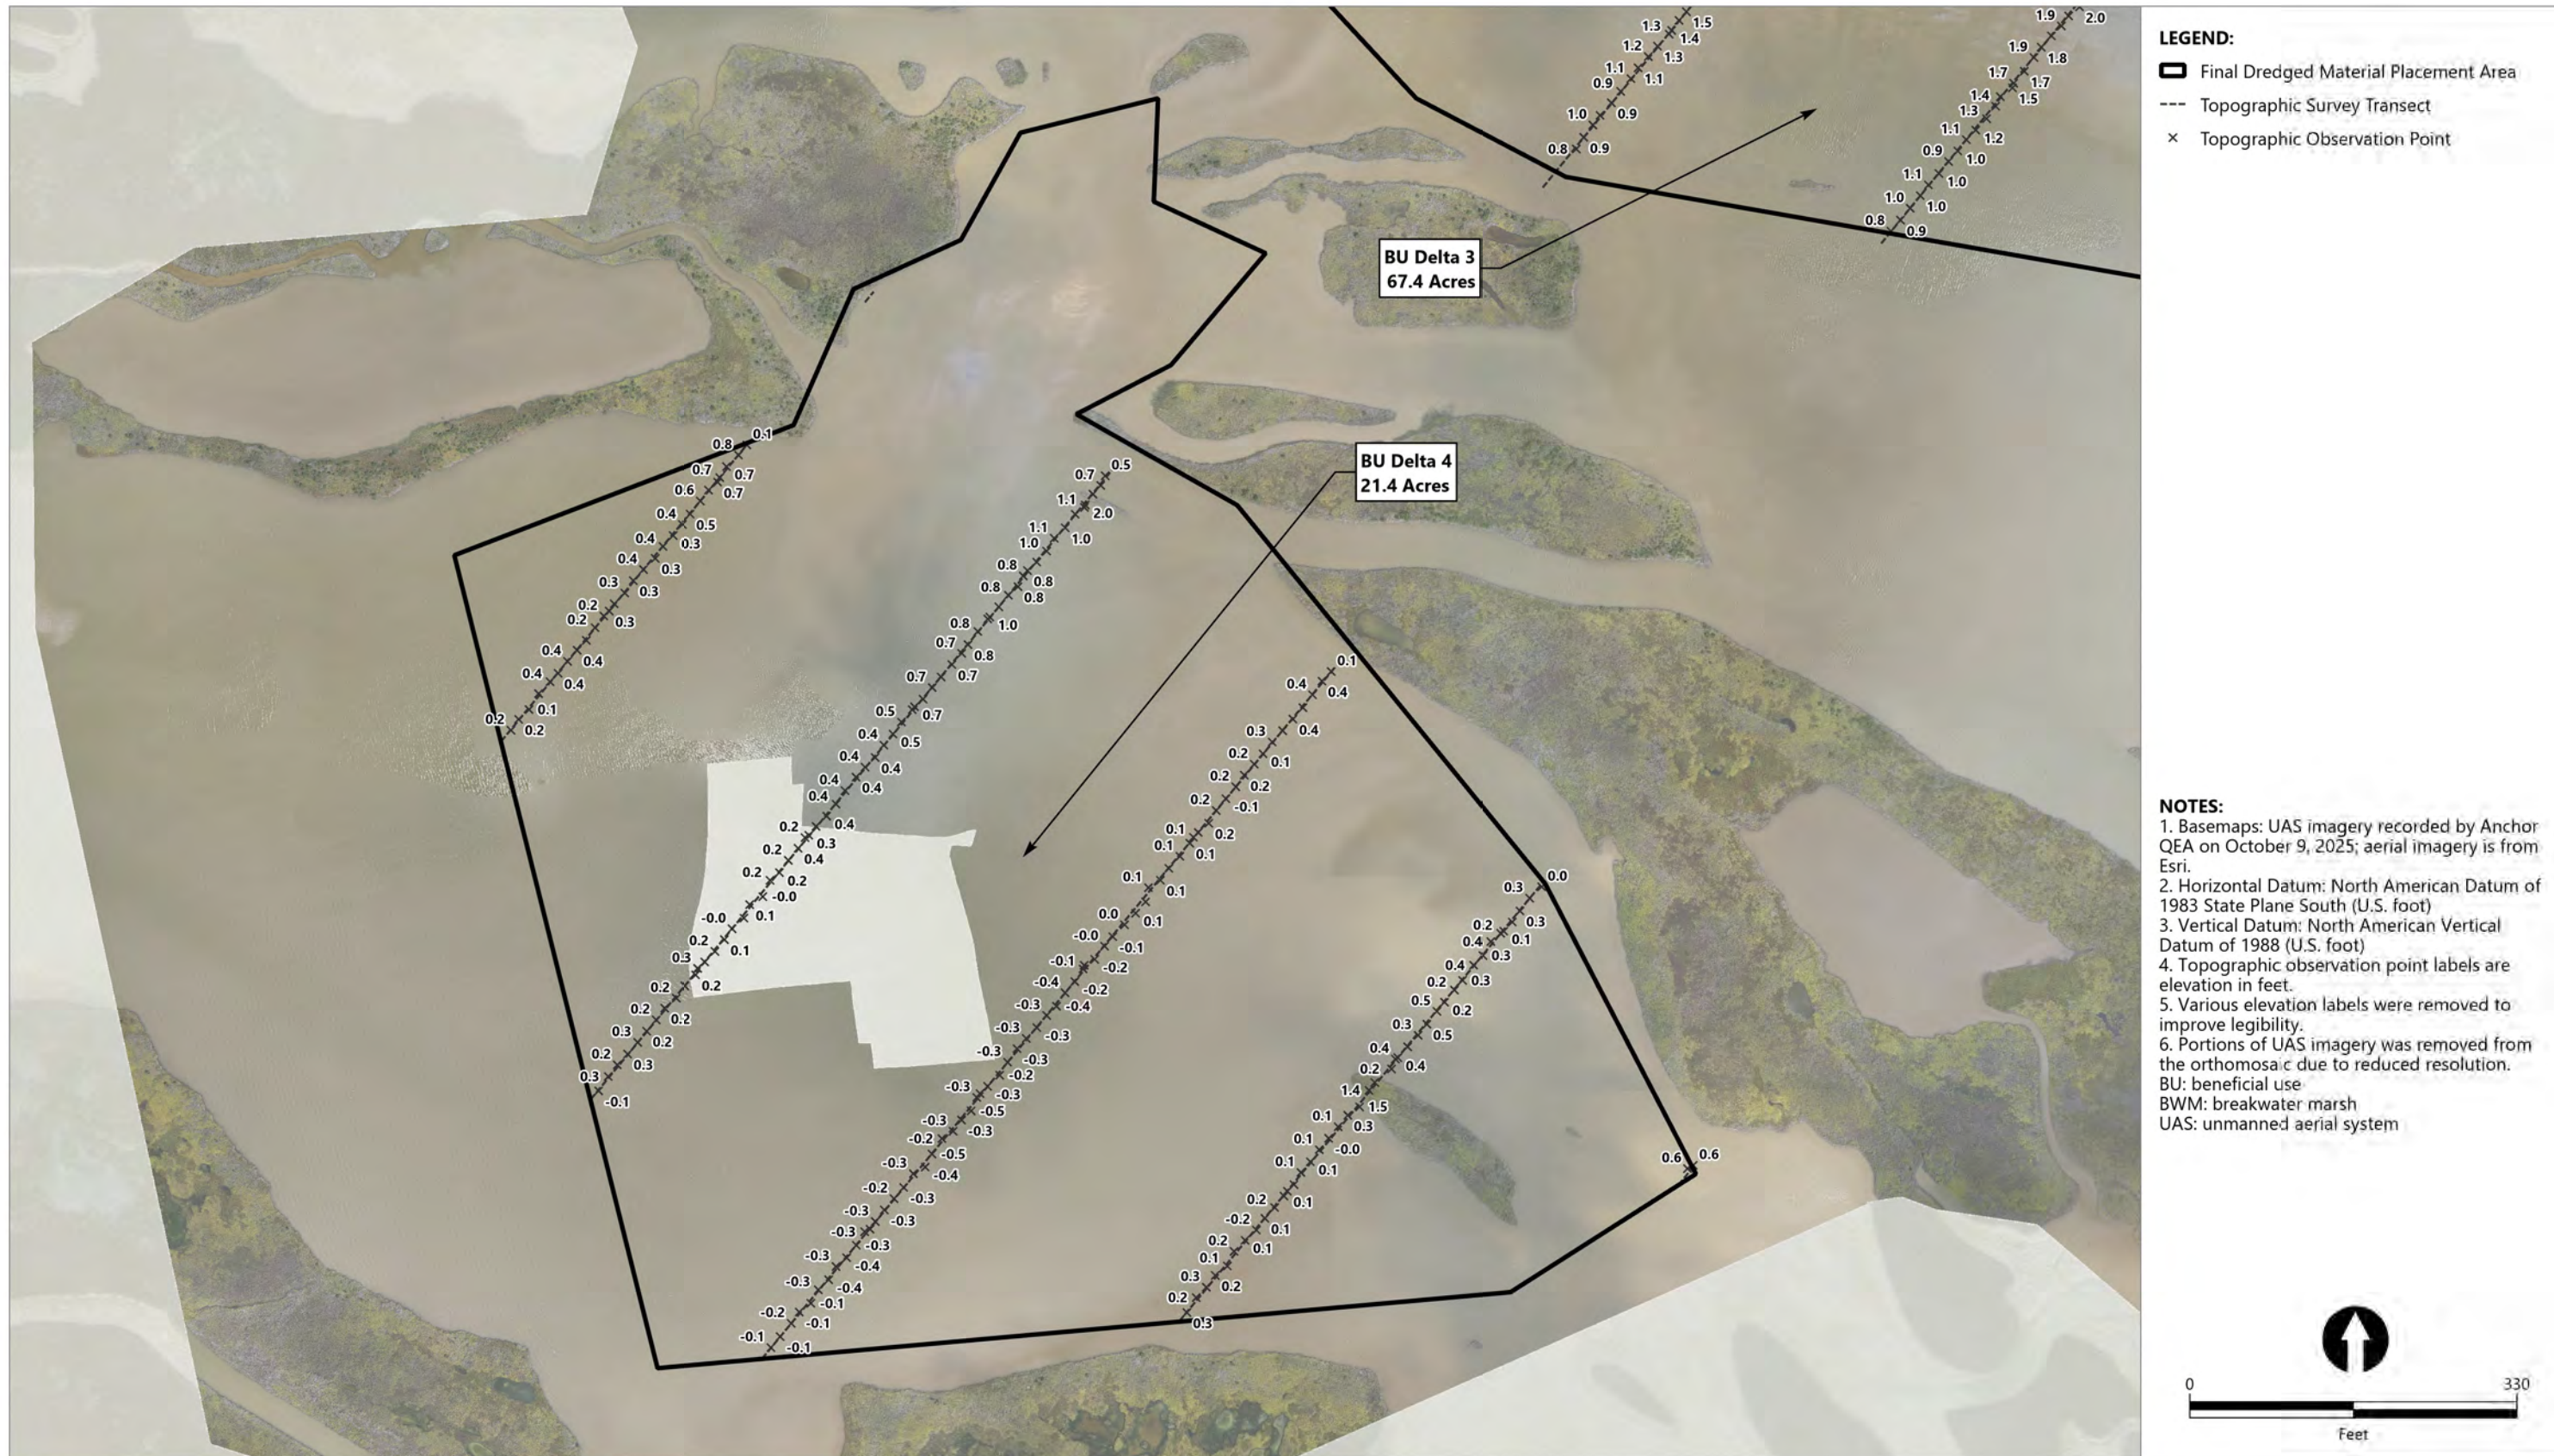
Figure 5.3
Topographic Survey Results Map (BU Delta 4)

Topography observed at BU Delta 4 was relatively flat with a slightly elevated area in the northern portion of the placement area. This higher elevation area was generally surrounded by featureless, unvegetated bay bottom. Survey observations suggest placement activities within BU Delta 4 was limited to the northern portion of the placement area, leaving the southern majority of the area likely undisturbed. However, these areas were not omitted from the monitoring survey, as it is possible that finer sediments were carried into these areas. Where placement activities were evident within BU Delta 4, substrates consisted primarily of sand material with less prevalent occurrences of soft sediments. Where compacted sand material was absent, the area was surrounded by featureless, submerged bay bottom consisting of deep soft sediments.
