Monitoring Success of Dredged Material Placement in the Nueces Delta

Final Report

Publication CBBEP – 199
Project Number – 2404
February 2026

2025 Post-Construction Monitoring Report

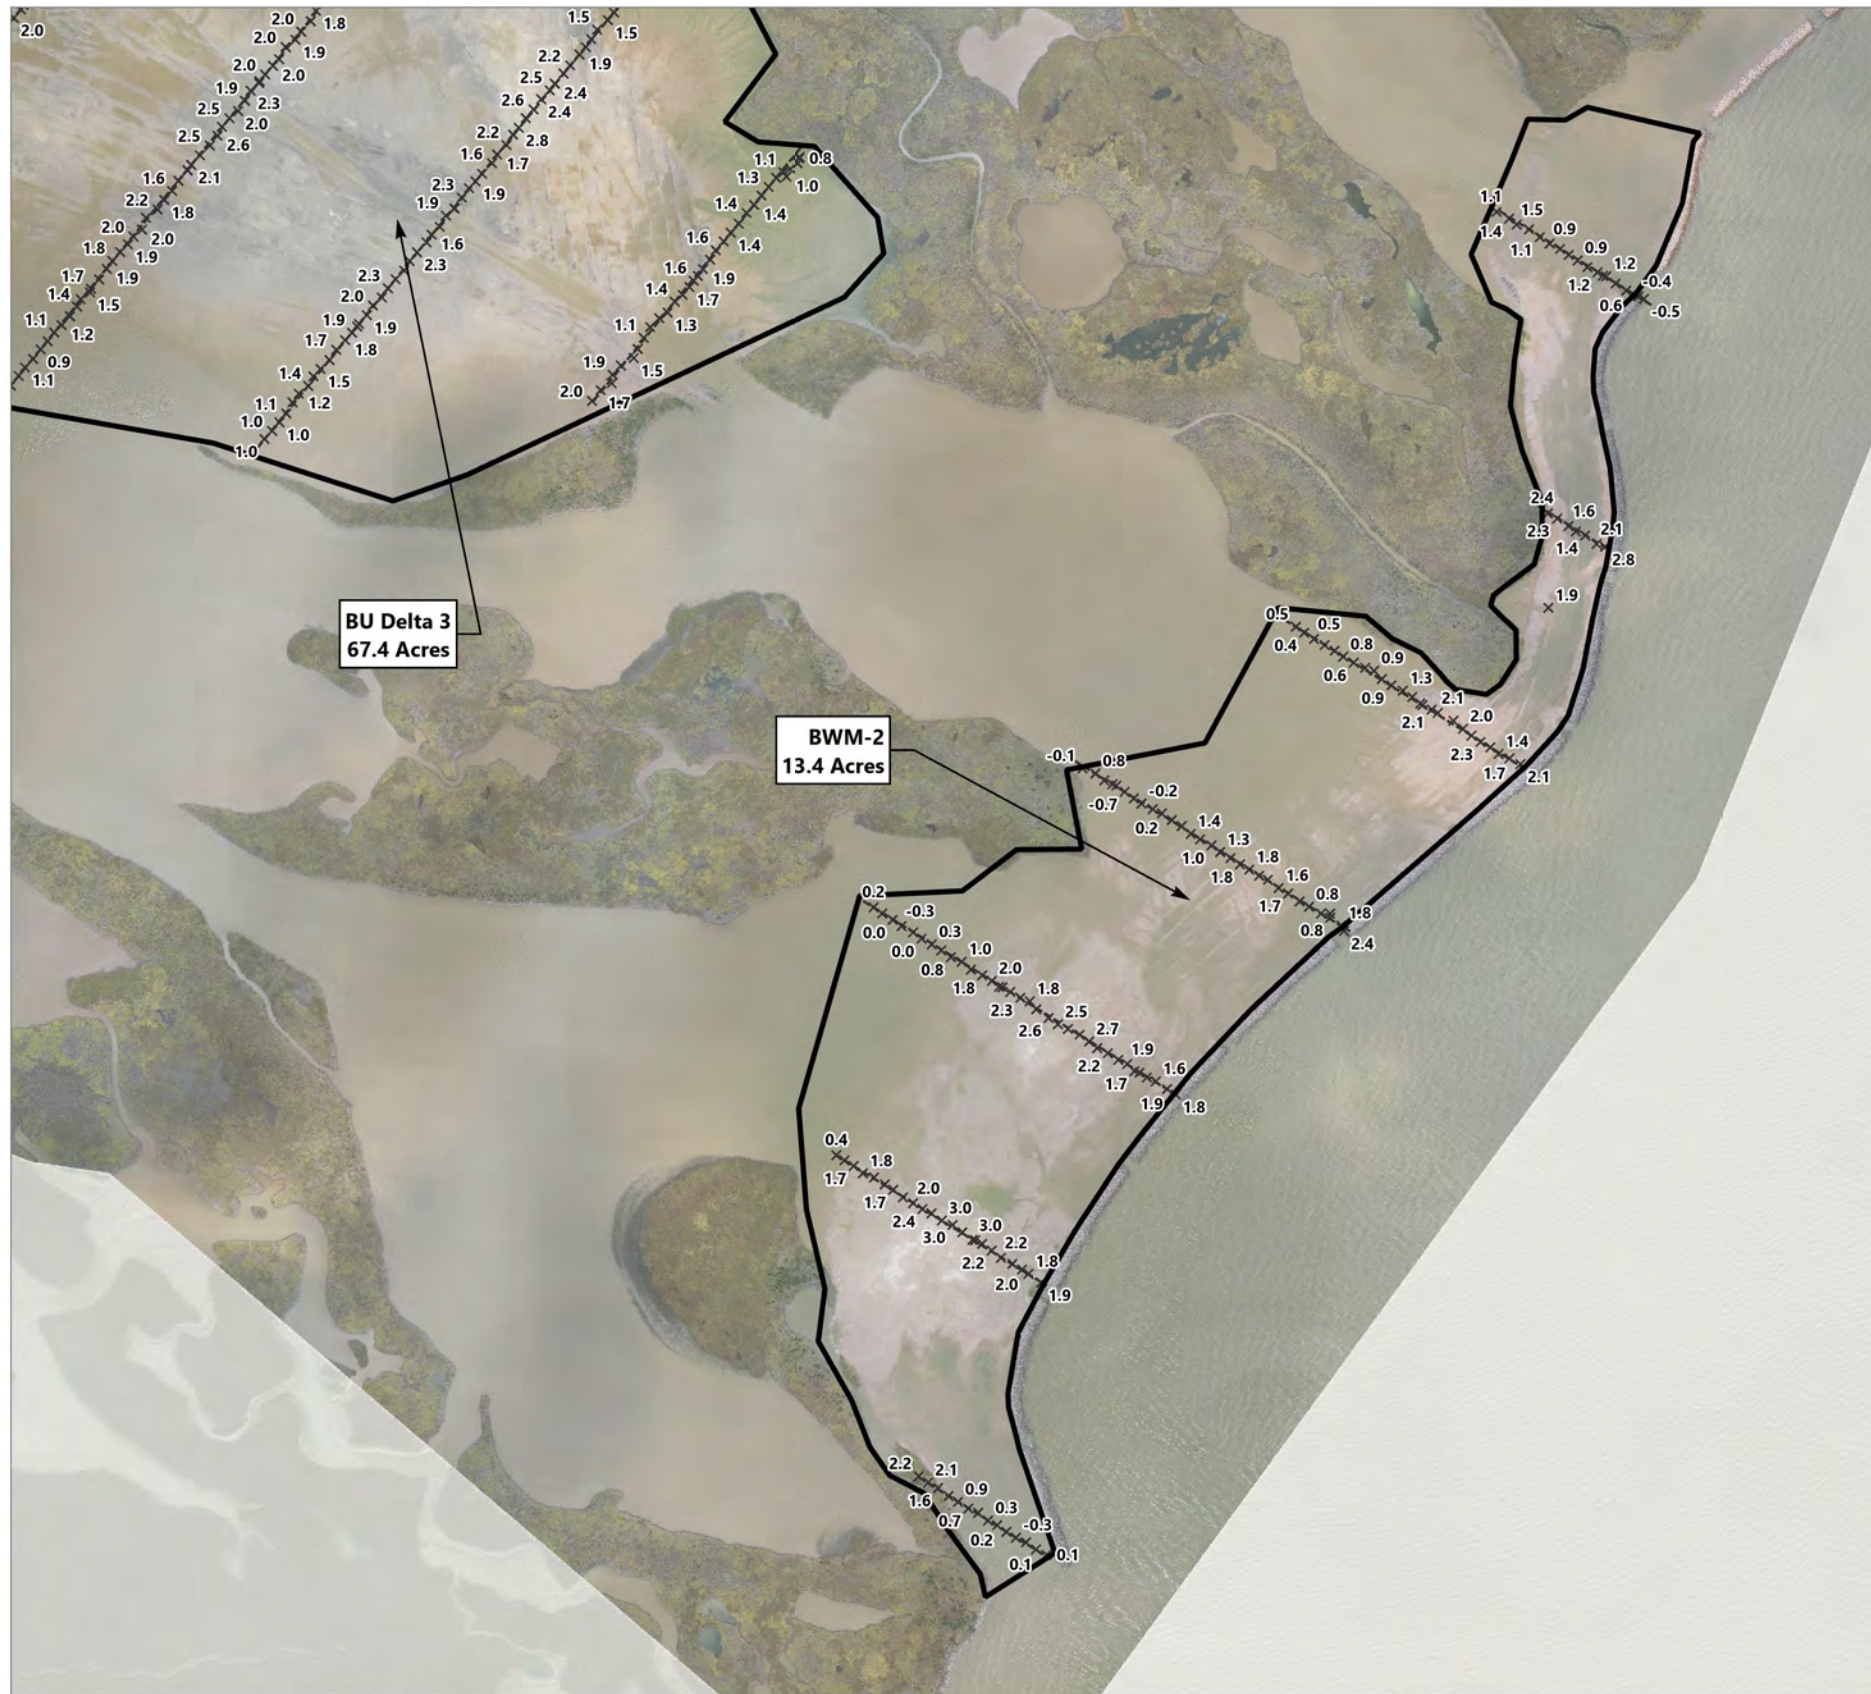
Figure 5.4
Topographic Survey Results Map (BWM-2)

Topography observed within BWM-2 was relatively flat. Tidal influence was evident throughout the placement area, including significant tidal exchanged between the breakwater gaps. Active tidal flow was observed during both incoming and outgoing daily tides. This tidal exchange appears to have resulted in the development of small scour and erosion features. The most significant tidal exchange observed was present in the northern portion of BWM-2. Water was seen rushing across placed material and flowing between breakwater gaps. Significant evidence of heavy machinery operation was also observed through the placement area and is depicted in UAS imagery. The northwest boundary of BWM-2 exhibited a discernable line of placement material with surrounded undisturbed areas consisting of soft sediment.

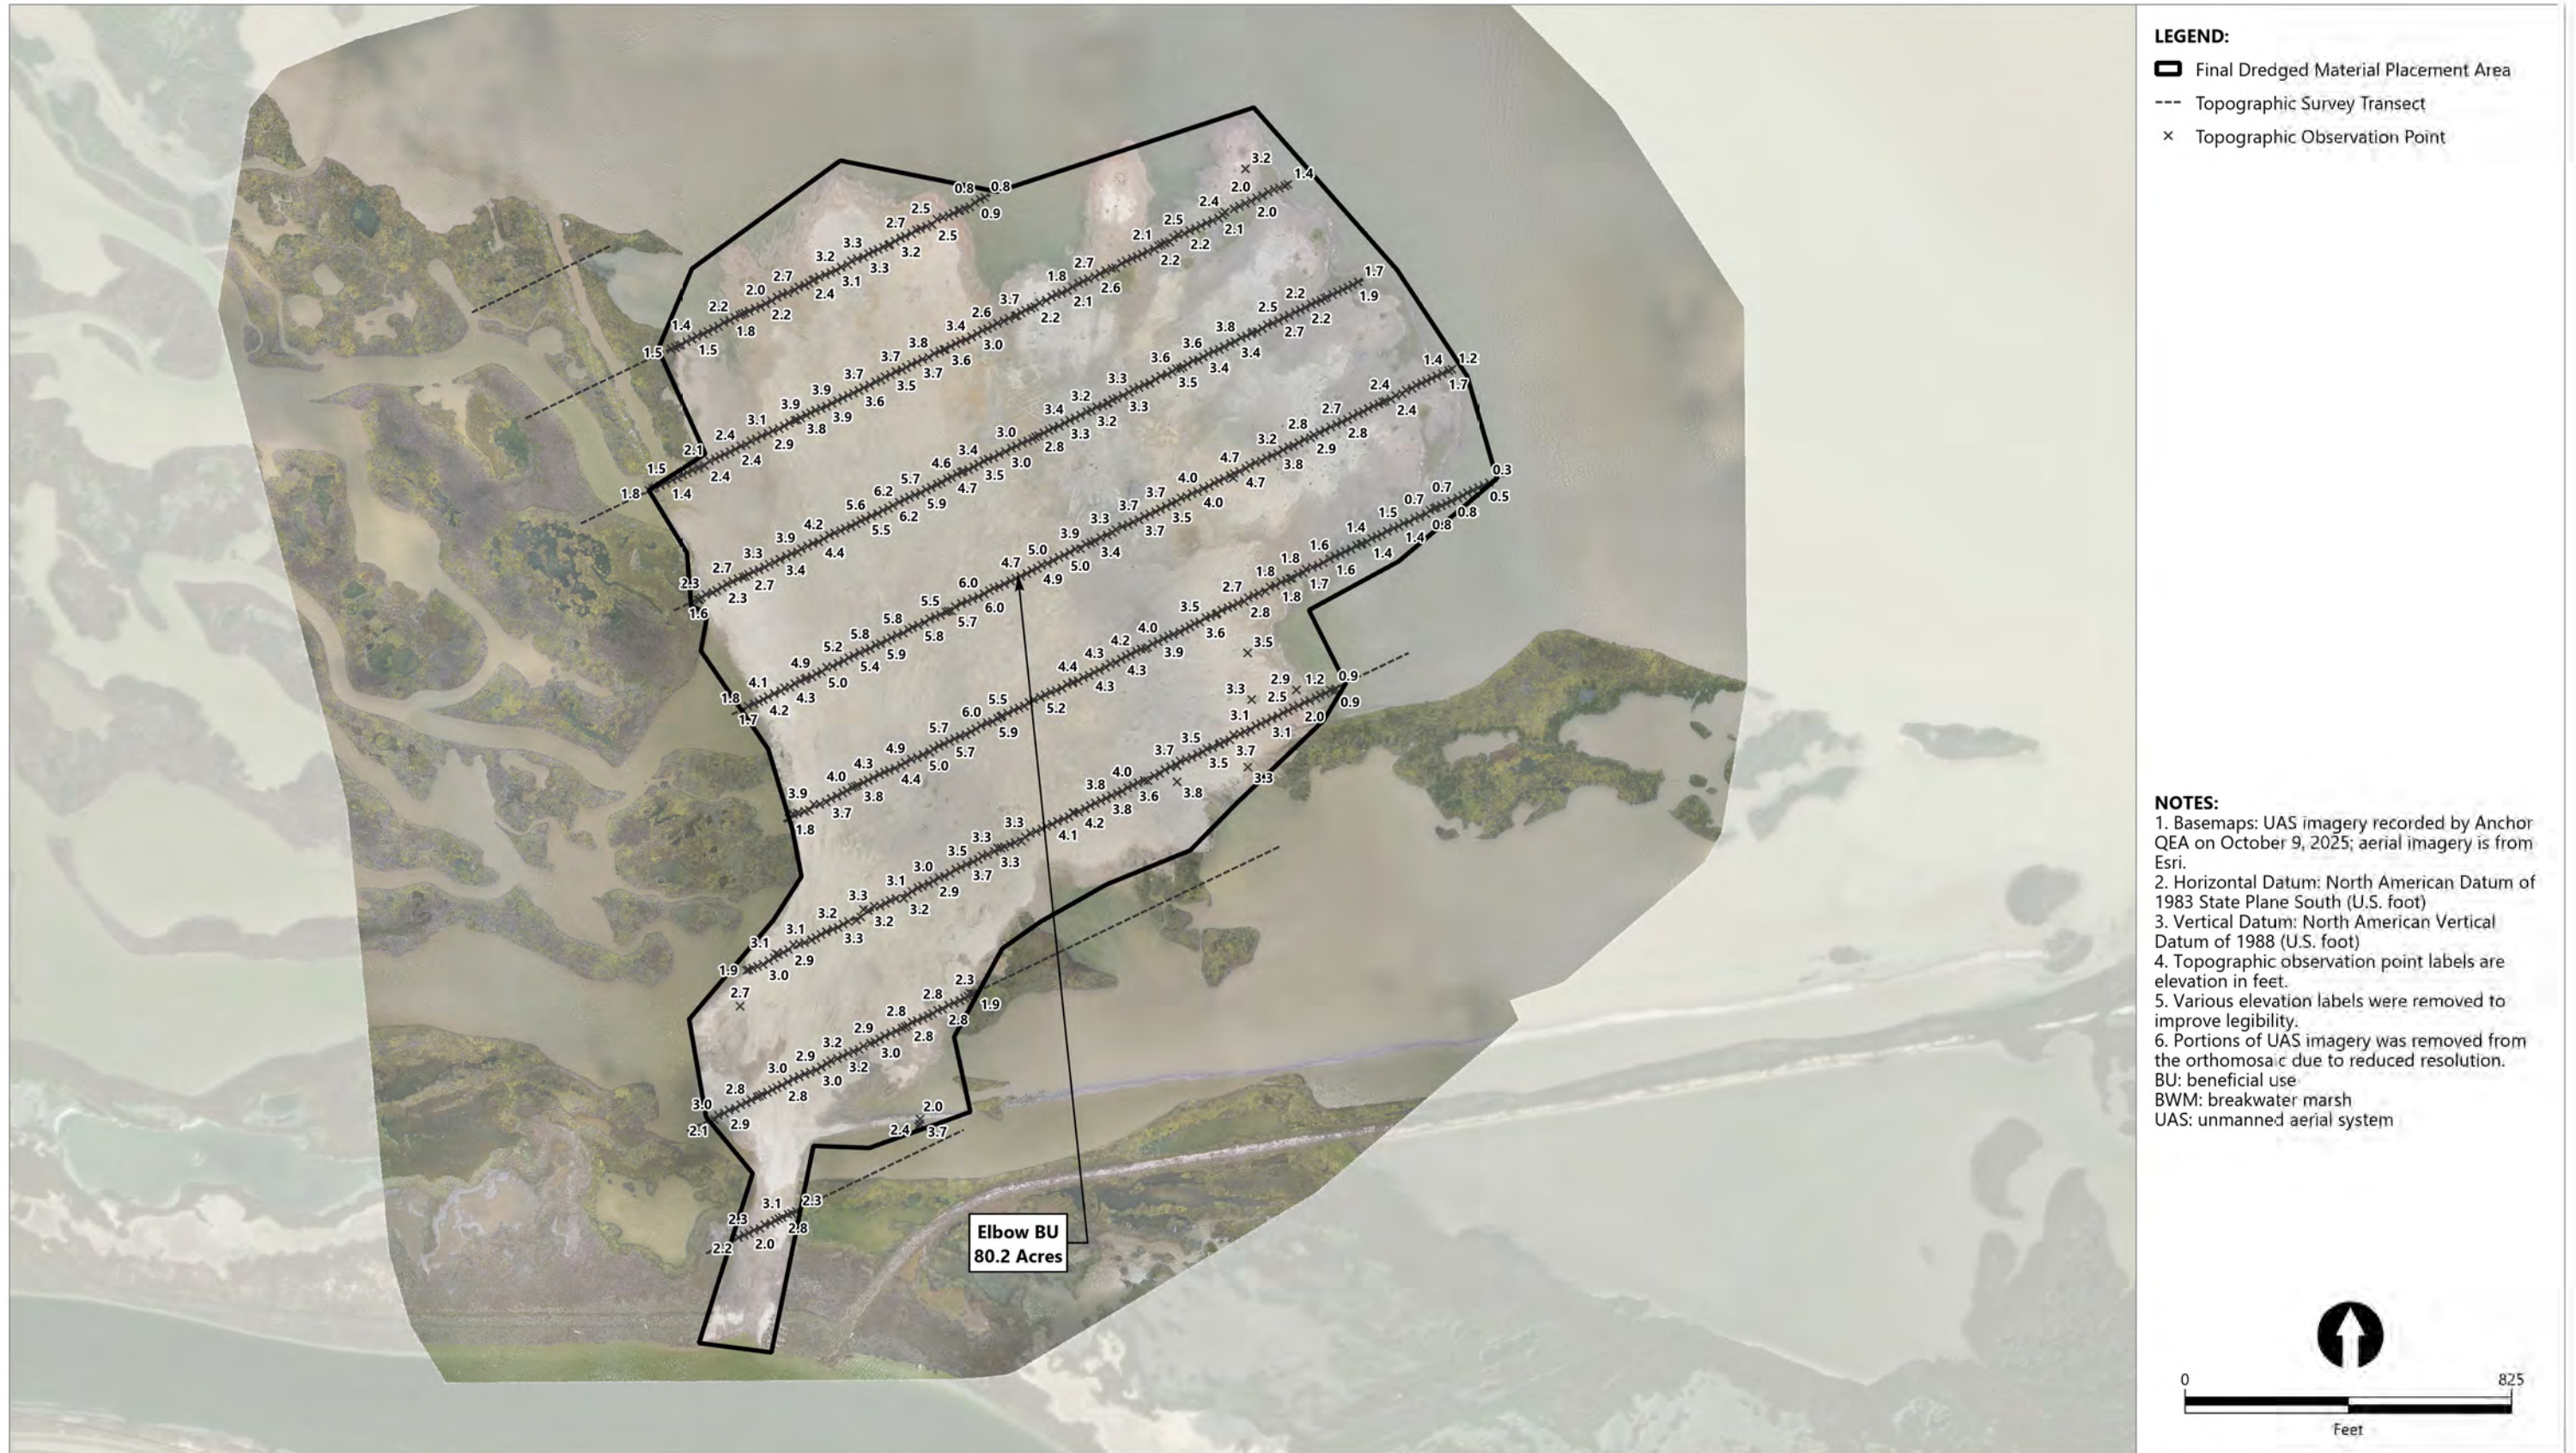
Figure 5.5
Topographic Survey Results Map (Elbow BU)

Elbow BU is the largest of the placement areas surveyed and contains a higher elevation center with very gentle downward slopes in all directions. Finer surface sediments found throughout appear to have been transported by rain and wind processes. These processes have likely resulted in the exposure of small gravel and shell fragments at the surface. Substrate in the center, higher elevation portion of Elbow BU consisted of hard clay that is relatively compacted. Generally, increasingly sandy clay substrate was observed along the boundary of the placement area. Sediments appear to be slowly migrating or sluffing along the bayward margin of the placement area, creating a shallow shelf. This shelf is along the northern and eastern boundary of the placement area and contains finer material than what was observed within the center of the placement area. In comparison to adjacent marsh habitats, material placed within Elbow BU appears to be at a similar or slightly elevated grade. However, a discernable bluff, approximately 2 to 3 feet in height, was observed along the open-water boundary situated along the southern margin of the placement area. The overall elevation of Elbow BU appears to be situated slightly higher than normal tide levels for the region. Several pits or holes were also observed along the Nueces Bay shoreline. The origin of these features could not be determined. However, it is possible that they formed as a result of substrate variation or erosional energy associated with wind and wave action. Within the Elbow BU, heavy machinery tracks were also evident and observed along the bayward margin of the placement area.

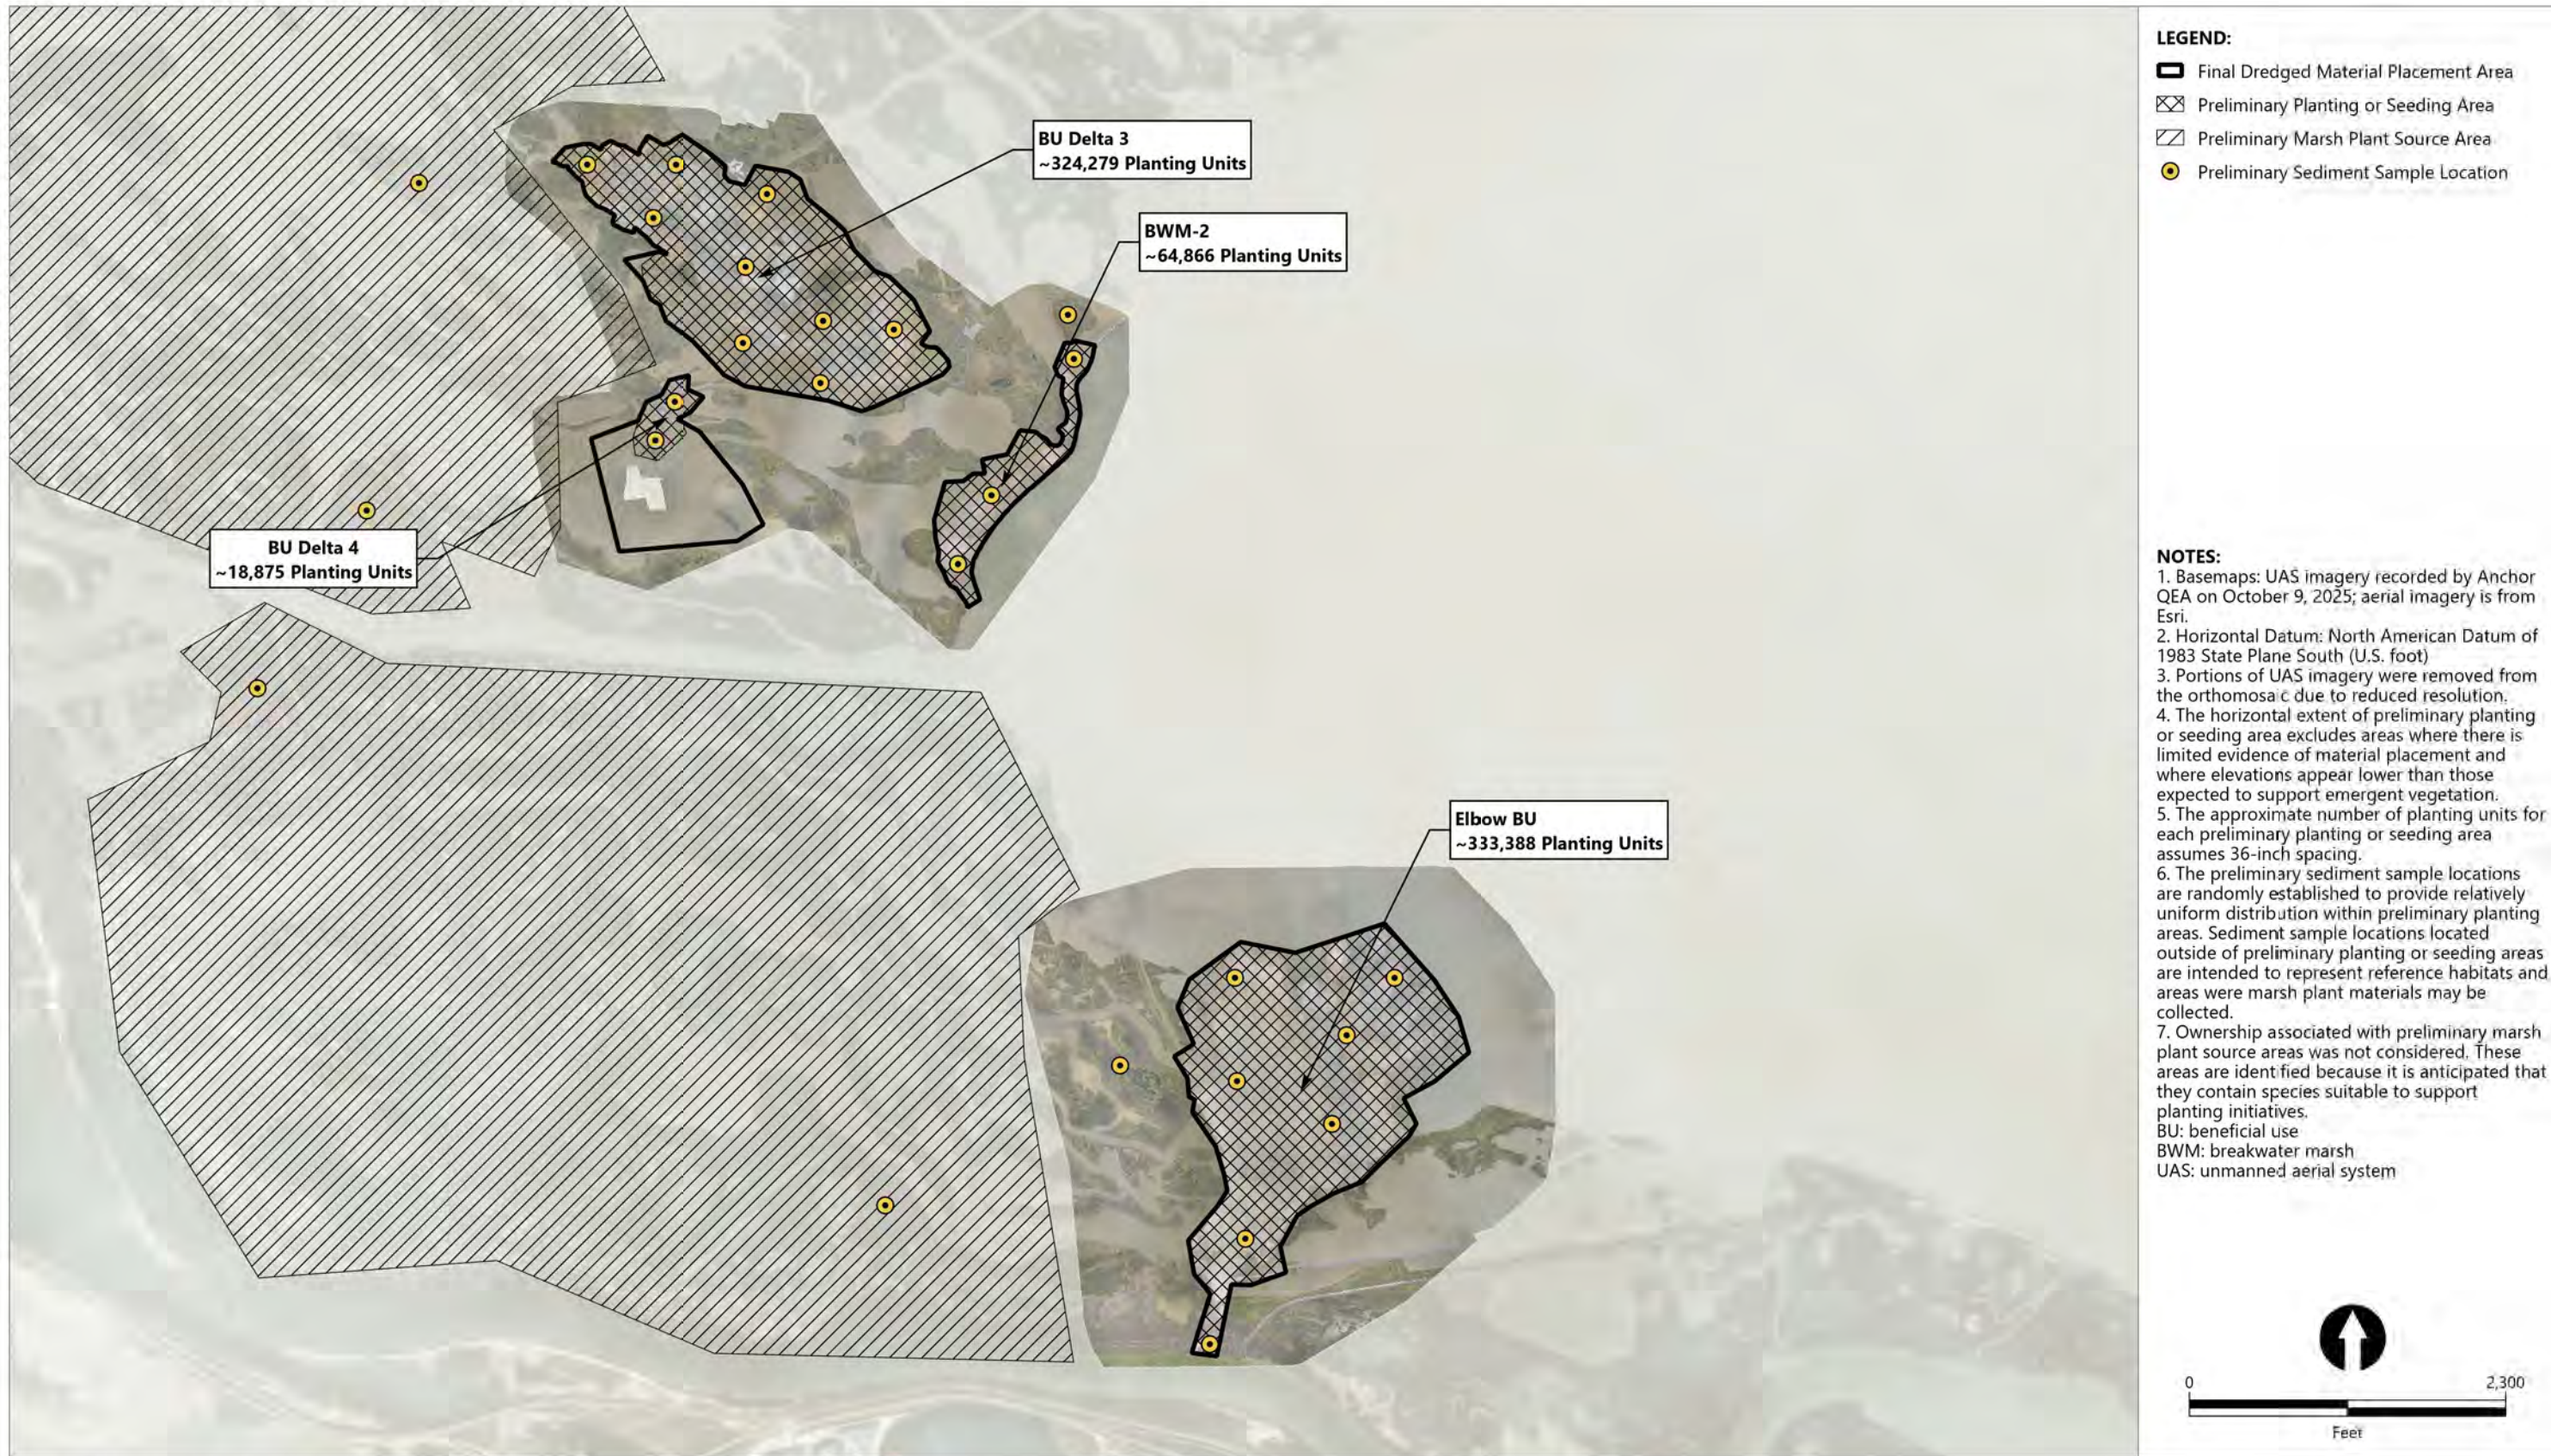
Anchor QEA recommends that dredged material placed be tested to determine if soil characteristics act as an underlying problem. It is recommended that a sampling program that compares material placed within Nueces Delta to in situ material from adjacent, prolific marsh habitats be developed. The sampling program should be developed based on relevant sampling guidelines, but particular emphasis should be included for pH, salinity, organic matter, nitrogen and phosphorus. Testing related to contaminants (i.e., heavy metals) could also be included should future monitoring results suggest evidence of contamination not addressed as part of development and execution of the Corpus Christi Ship Channel Deepening and Widening Project. Baseline recommendations generally call for one sample location per 0.25 to 1 acre. However, given the anticipated homogenous nature and shared origin or material placed during the Project, this sampling density could likely be reduced substantially to minimize costs. Regardless, sampling plan development will likely determine that multiple samples should be collected within each placement area to ensure that different sediment types are adequately characterized. A sampling plan is also expected to include sample locations within numerous reference habitat types. Figure 8 depicts an example of distribution of sediment sample locations.

Results from sediment nutrient testing would be used to determine appropriate soils amendments for Elbow BU and the timing for their implementation. It is recommended that amendments be selected to address speculative nutrient deficiencies identified within Elbow BU as compared to testing results from adjacent marsh habitat. It is anticipated that use of soil amendments would be concurrent with live-root planting (Section 4.1.1.3). However, CBBEP may elect to implement soil amendments as a standalone adaptive management technique to determine if soil amendments are sufficient in triggering more rapid natural recruitment across Elbow BU. While the appropriate soil amendment would be determined based on material sampling results, preliminary options may include organic matter additions such as compost, nutrient fertilizers particularly those including nitrogen and phosphorus, additives to address pH conditions such as lime or gypsum, or silicon additives to promote nutrient uptake in estuarine restoration. Similarly, biochar may also warrant consideration depending on the results of sediment testing and soil amendment selections.
