## **Riparian Evaluation for Baffin Bay Tributaries**

Final Report

Publication CBBEP – 132

August 2019

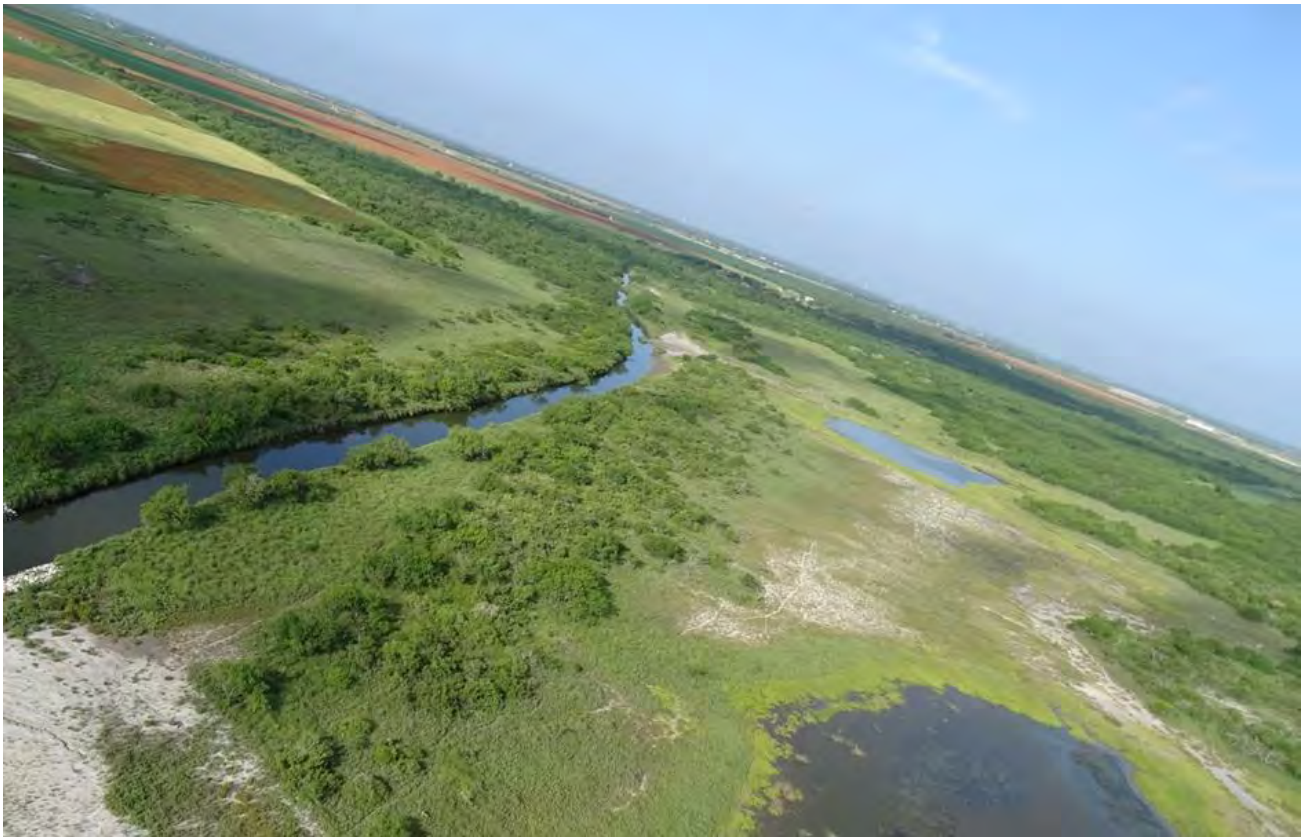
**Figure 6** Image shows wide functional marsh-like riparian area flanking San Fernando Creek near its mouth at Cayo del Grullo. Farming activities are set back from the creek, and the wide floodplain is well vegetated.

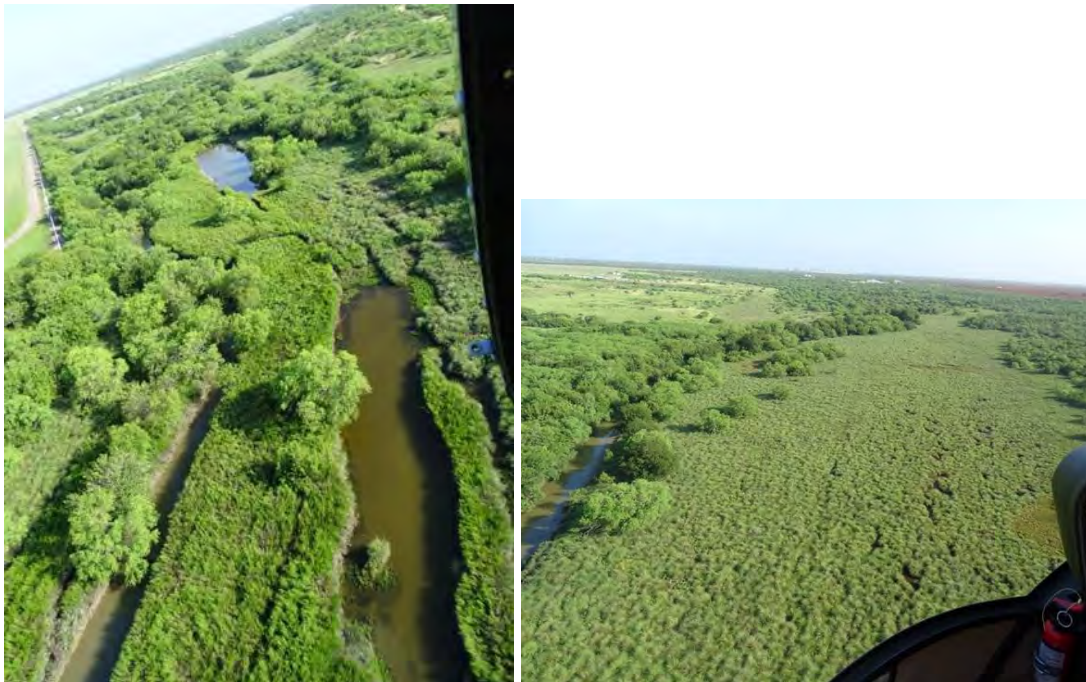
**Figure 7** These images show highly functional riparian areas along San Fernando Creek around the Naval Air Station. Image on the left shows braided channels with banks vegetated in Spiny aster. Image on the right shows a riparian area (river right) more than 1,000 feet wide covered in Cordgrass with pockets of standing water. Retama and Mesquite ring the channels with occasional Willow and Ash trees present.

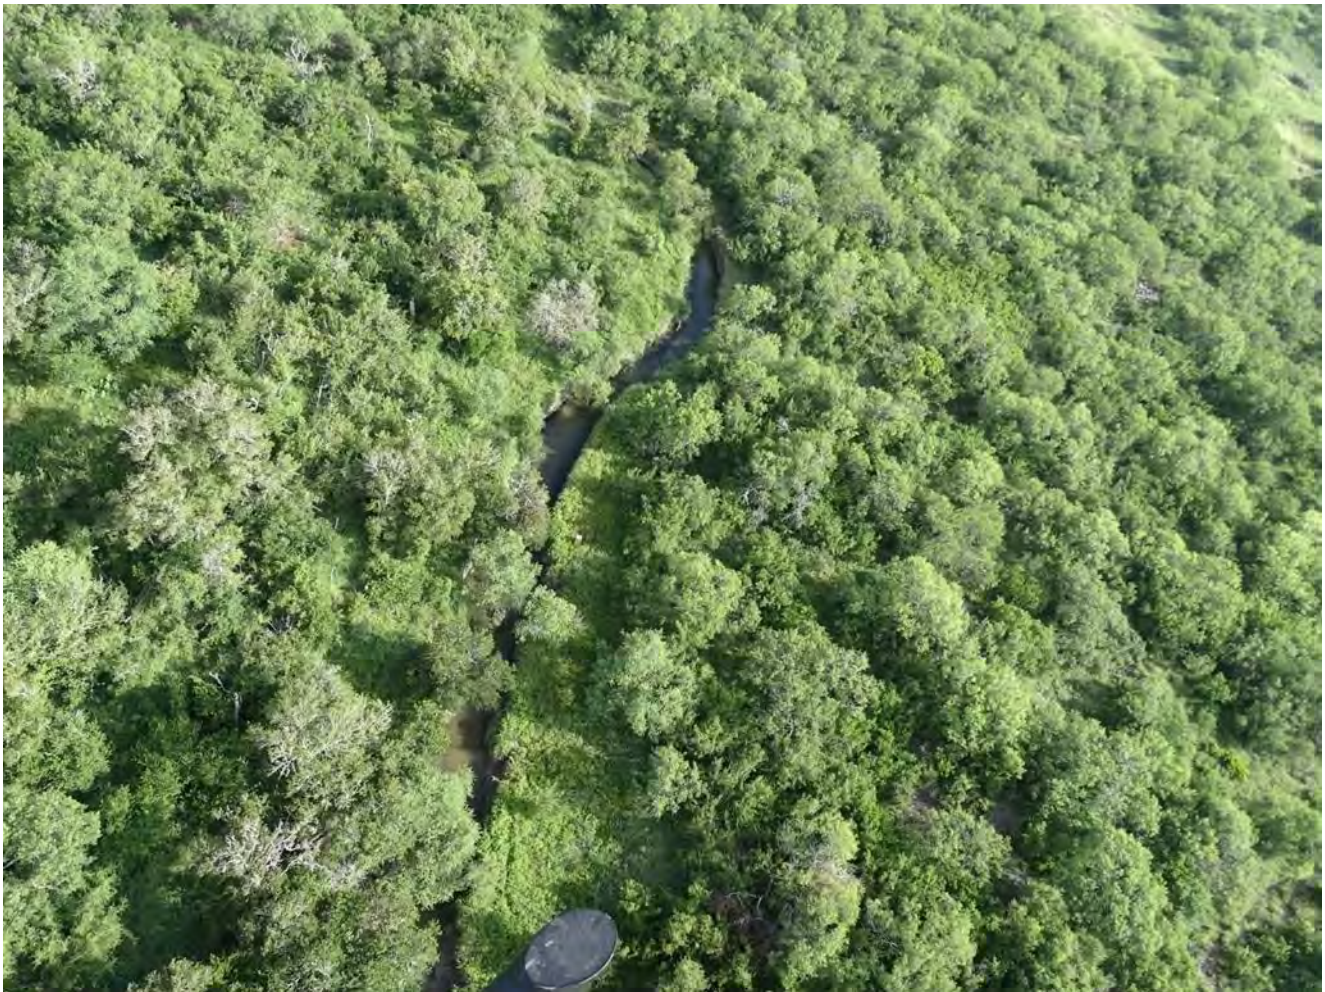
**Figure 8** Near the top of the reach the creek narrows and becomes a heavily wooded meandering stream, retaining a highly functional condition.

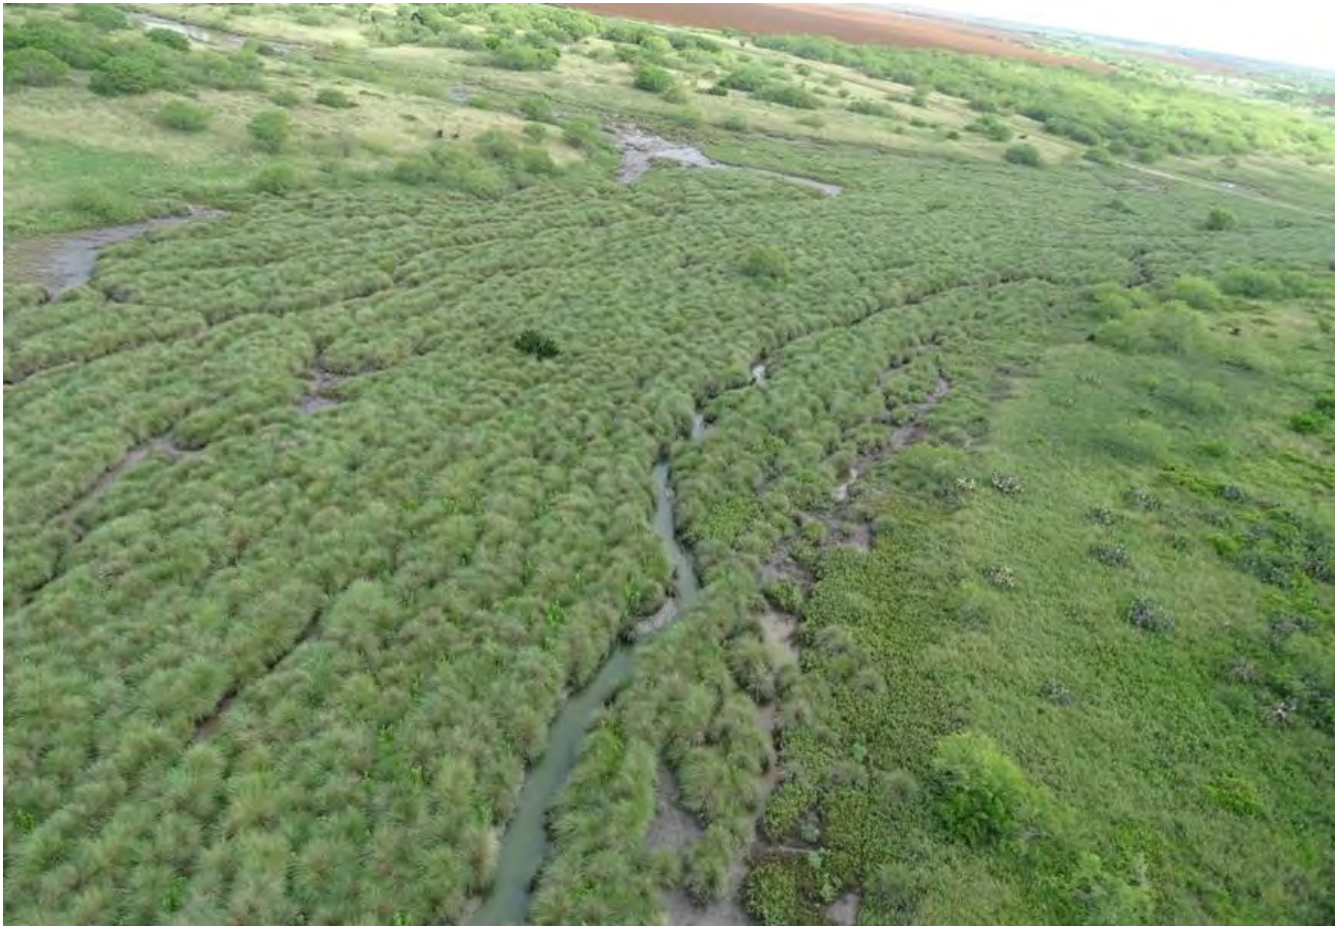
**Figure 11** Carreta Creek's channel is braided and laced with Cordgrass. The overall width of channel and riparian area is estimated at about 1,000 feet in this area.

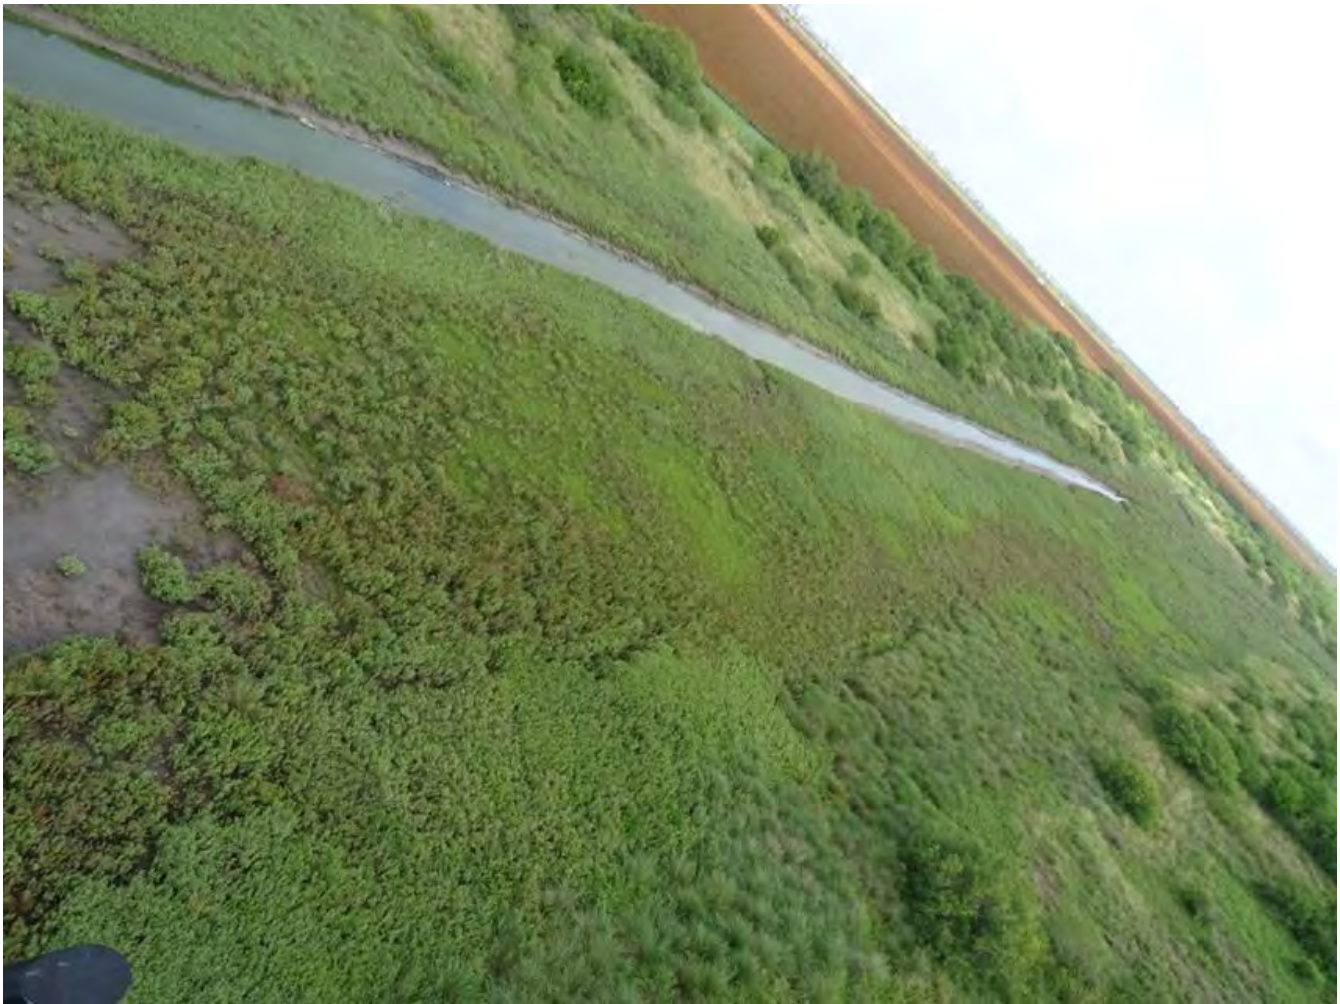
**Figure 12** Further upstream the creek's channel becomes straight and single thread, but the riparian area remains wide and well vegetated.

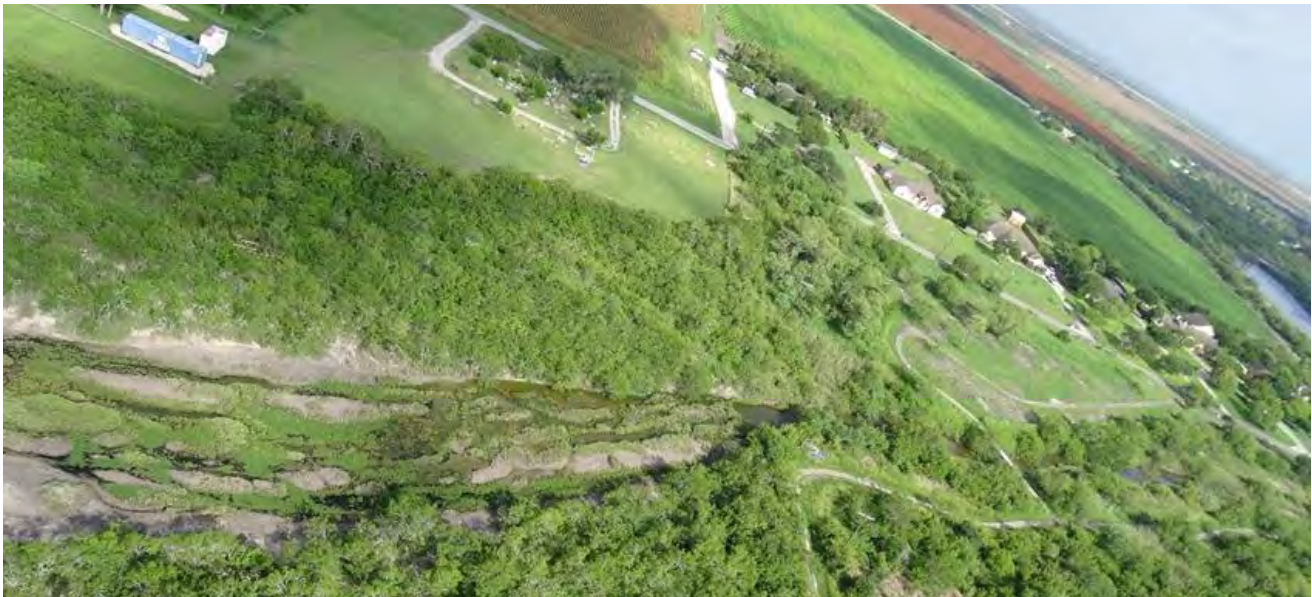
Overall, Carreta Creek is high functioning and similar to the benchmark condition observed on the lower reach of San Fernando Creek. Carreta's creek channel alternates between single thread and braid two or three times over its length that could be indicative of a past sediment transport issue. However, given the extensive vegetation present, it appears that the channel condition is becoming balanced and normal. None of the hindrances typically associated with increased sediment delivery were observed.

**Figure 14** The creek's riparian area remains remarkably functional and well vegetated as it runs through the town of Bishop. The channel braiding could be indicative of excessive sediment runoff in the past, but the creek seems to be managing its sediment now — most braids have well-vegetated perimeters

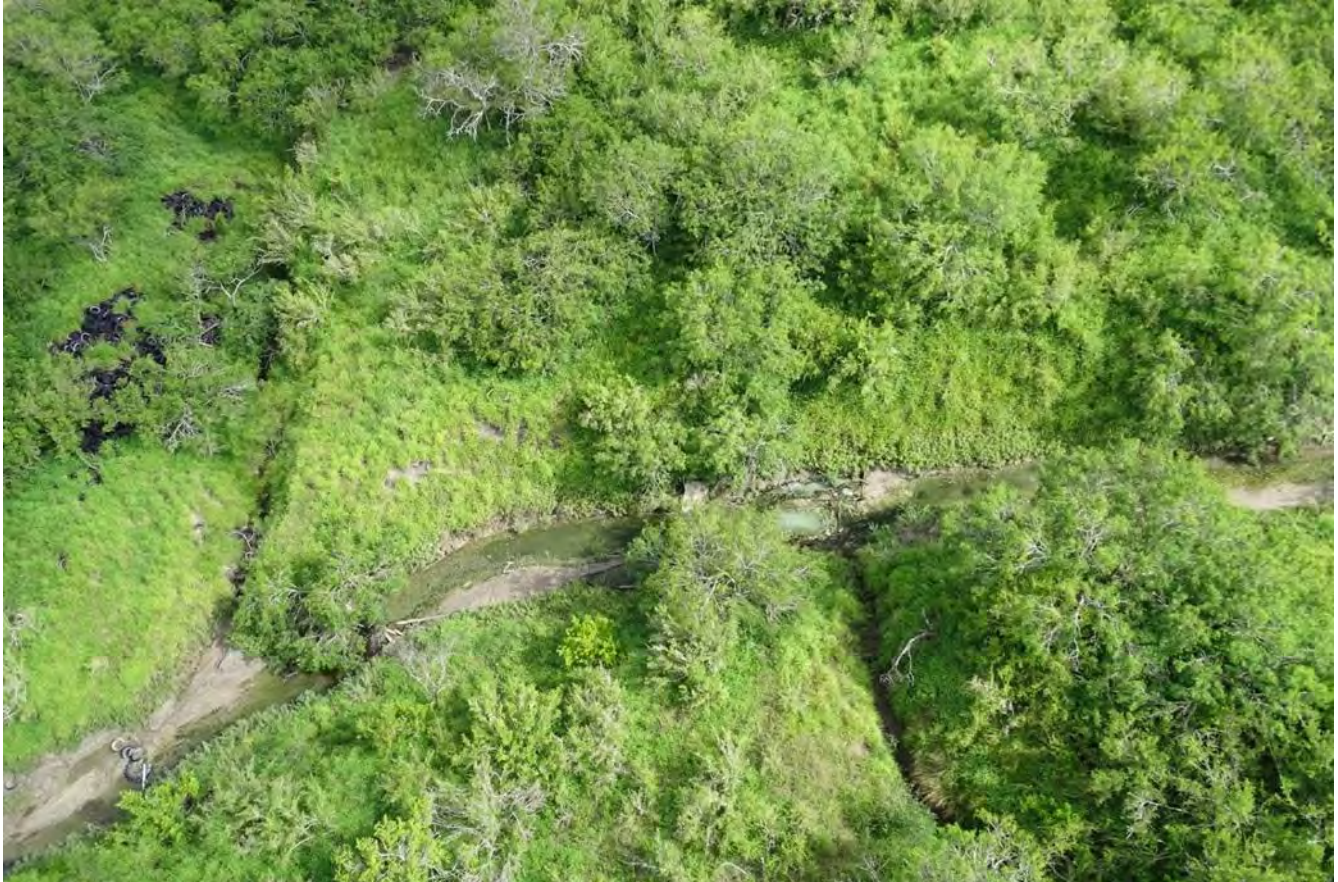
**Figure 17** Pictured here are one of several large tire and debris dumps located on the creek. Banks are vegetated here, but not with riparian plants that can provide functional attributes.

- 1) Work with landowners and engage community leaders to address the dumping and learn about riparian function.
- 2) Encourage a cessation or setback of mowing in the riparian area where acceptable for accommodating drainage.

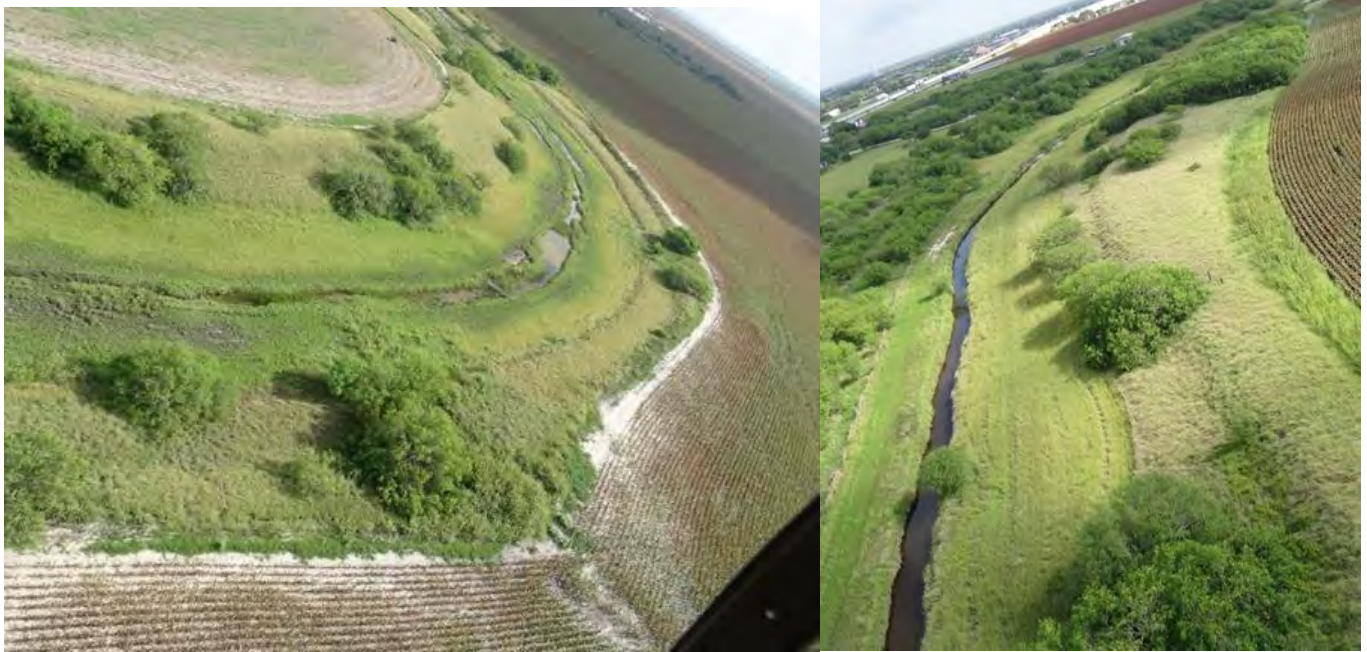
**Figure 18** Farming too close, channelizing and mowing riparian areas to enhance field drainage serves to hinder riparian function along a creek. Pictured here, the creek is well vegetated primarily with non-riparian grasses. One exception in the image on the left are the obligate plants growing within the channel that appear to be trapping some fresh sediment and creating tiny meanders to process it.

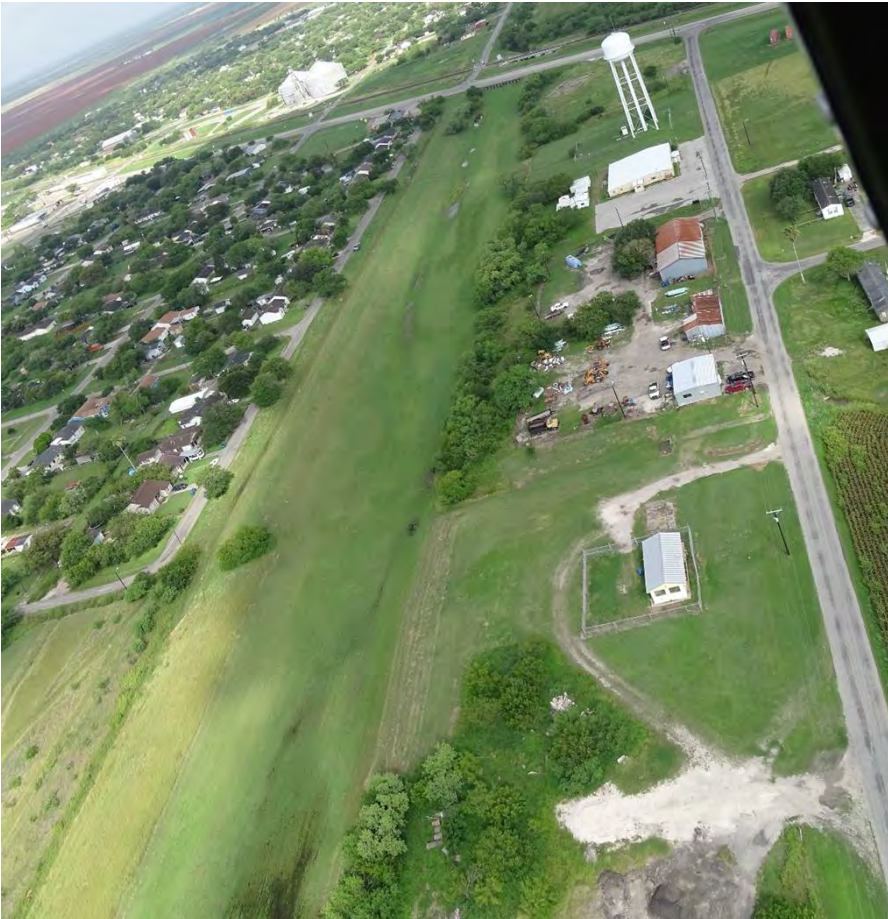
**Figure 19** As the creek runs through Bishop it become a wide, grassy drain way primarily vegetated with non-riparian grasses that are mowed to enhance drainage.

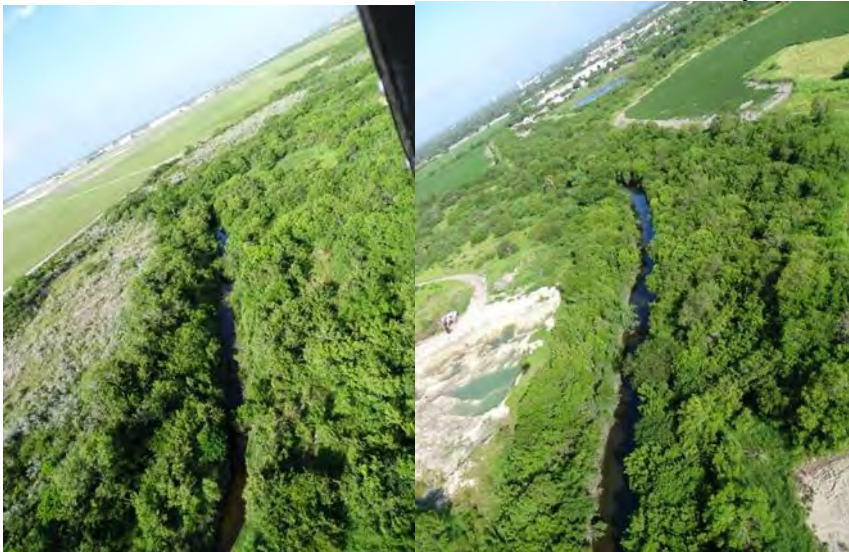
**Figure 22** Tranquitas Creek below U.S. 77 is a highly functional wooded creek. Farming and mining activities are mostly set back from the banks and do not appear to be hindering riparian function.

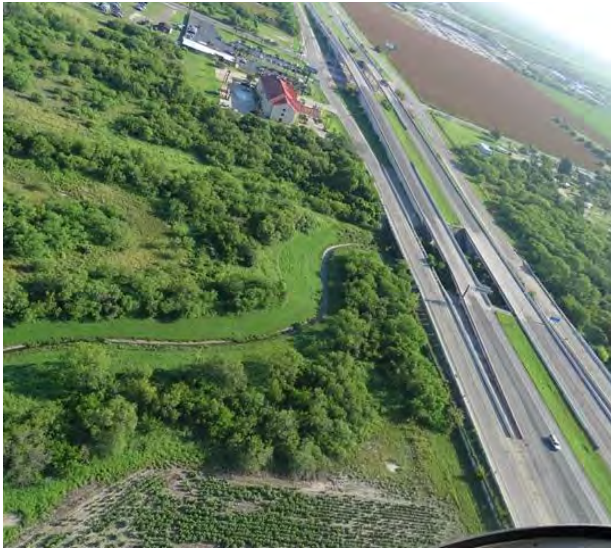
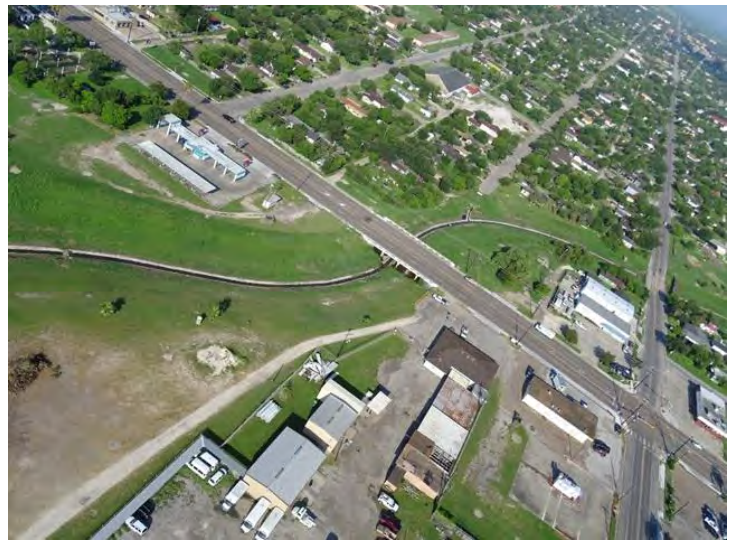
**Figure 23** As the creek enters Kingsville, passing under U.S. 77, it becomes a manicured and manipulated floodway with hardened cement bed.

- 1) Engage Kingsville community leaders and stakeholders to recognize the potential value of a healthy functional (wooded) stream running through their town. A functional stream can also preform floodway/drainage services while offering recreation and aesthetic value to residents and visitors.
- 2) Work with landowners to reward the current stewardship; protect and document the highly functional riparian condition along Tranquitas Creek below U.S. Hwy 77. Without creating new hindrances, find ways to utilize the high functioning portion of the creek to inform stakeholders of the potential for recovery of a wooded stream amenity within Kingsville.

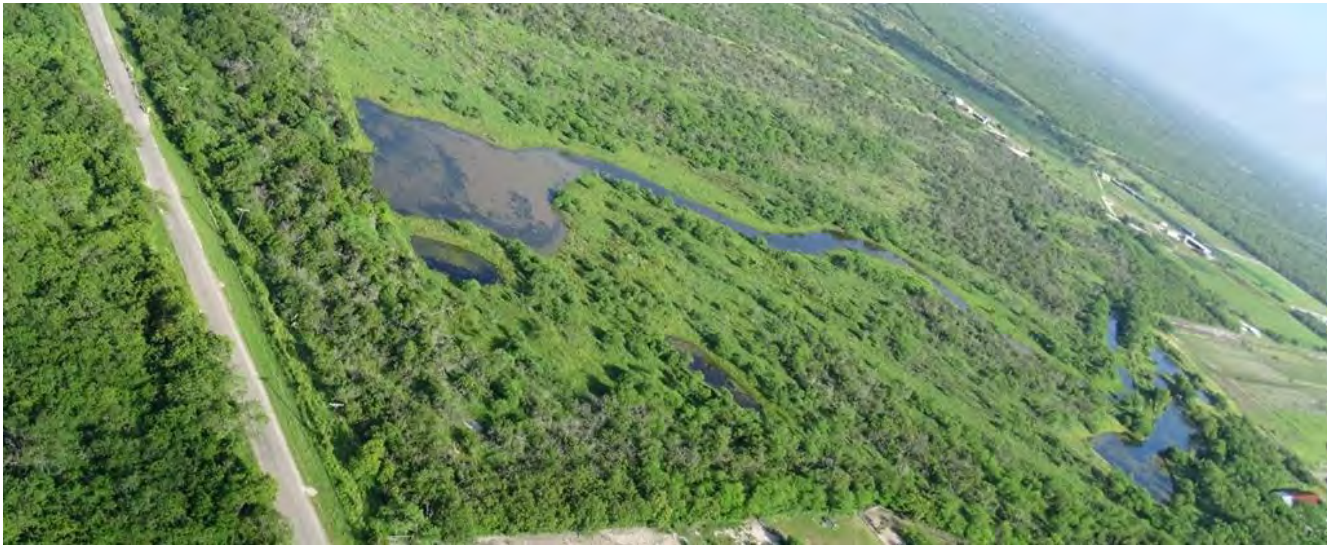
**Figure 24** As the creek leaves Kingsville it once again becomes highly functional ending at Tranquitas Lake above FM 1355.

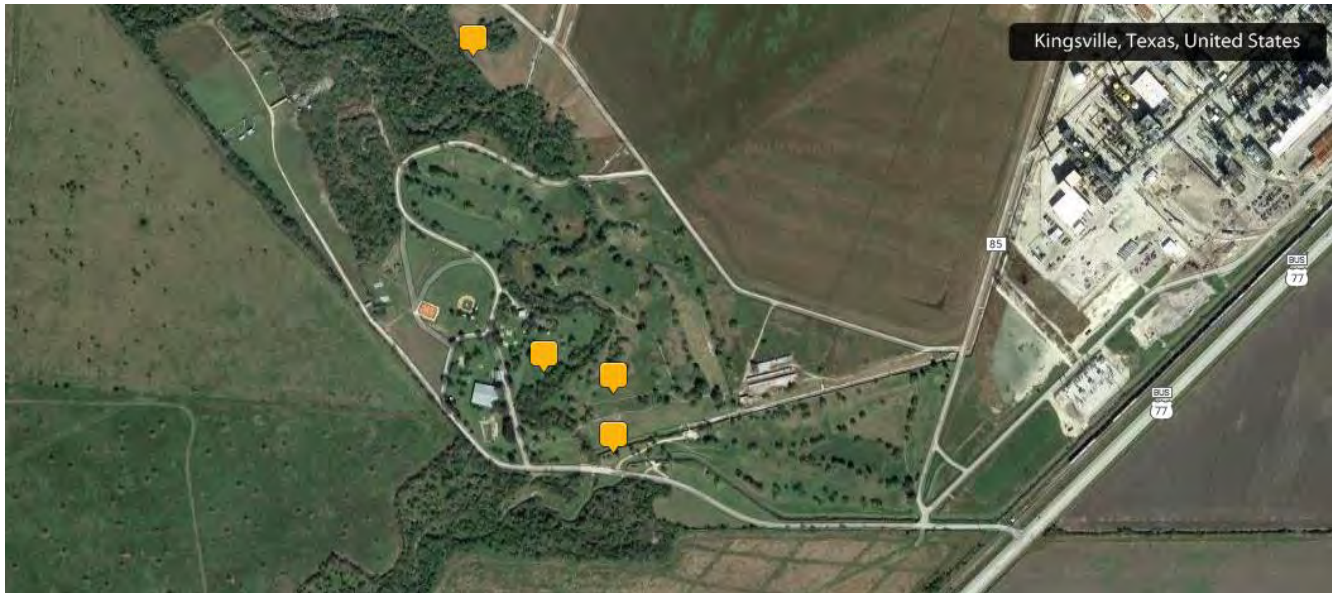
**Figure 28** GoogleEarth™ image of the park/plant area along Upper Reach of San Fernando Creek where the creek banks are manicured and channel/floodplain appear altered.

Work with landowners to address the identified hindrances within the park/plant area which could include setting mowing/manicuring away from the creek bank to allow riparian plant recovery.

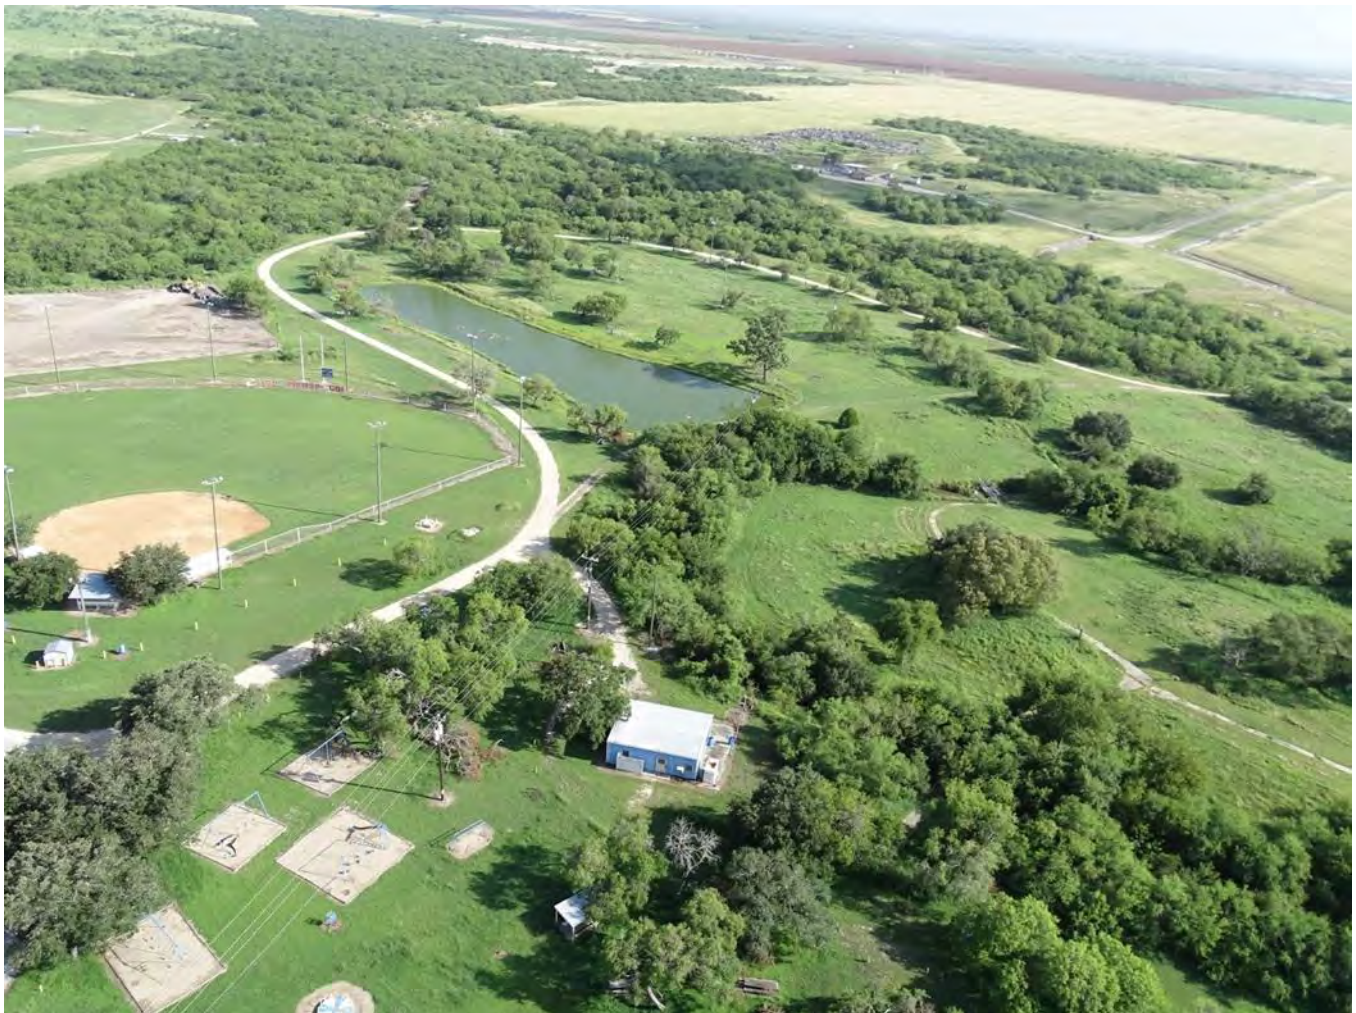
**Figure 29** Community park with manicured grounds and off-channel pond.

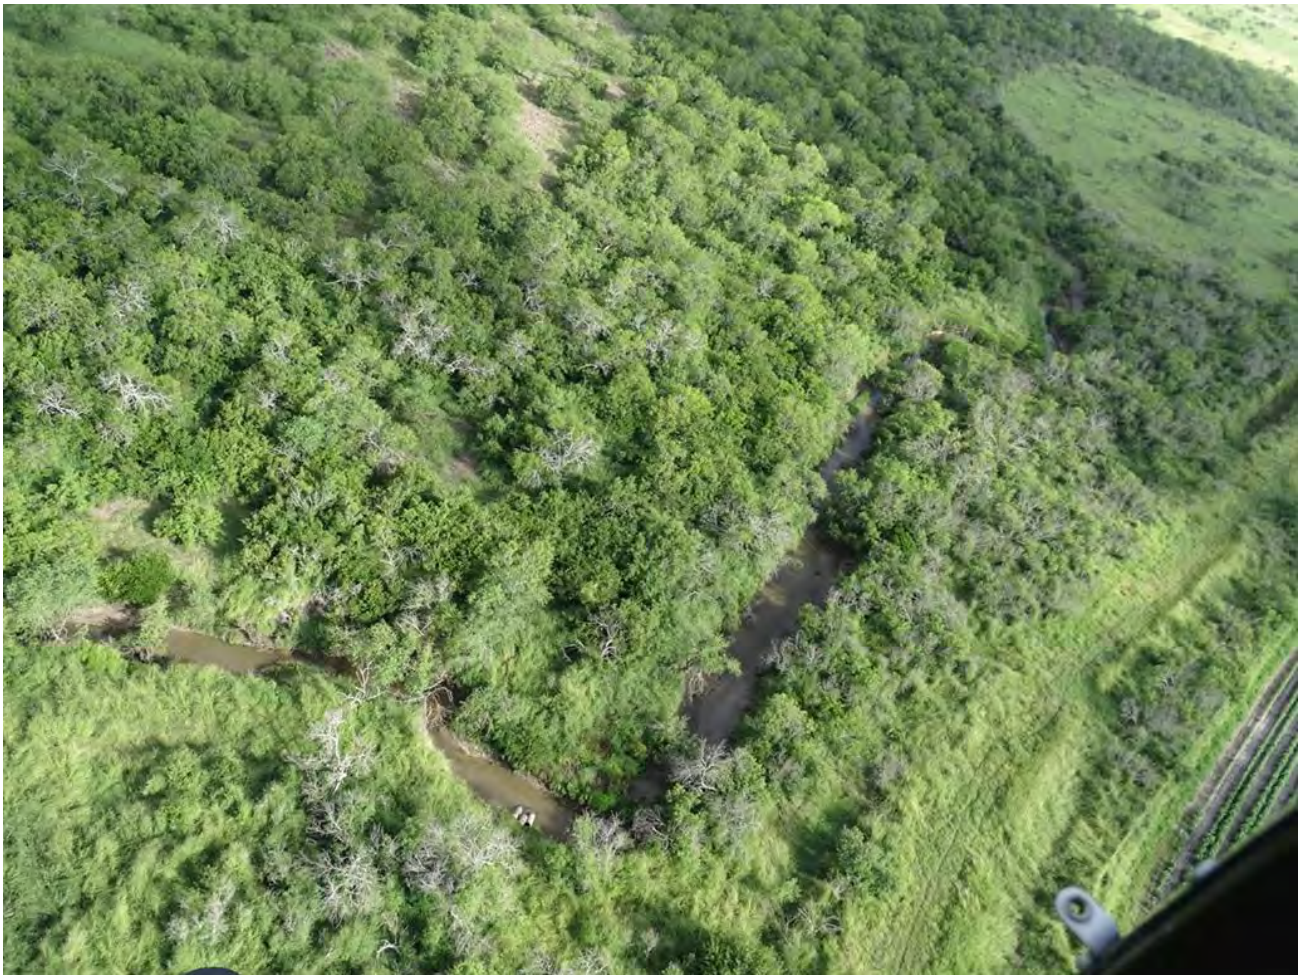
**Figure 30** Heavily wooded meandering channel of the upper reach of San Fernando Creek.

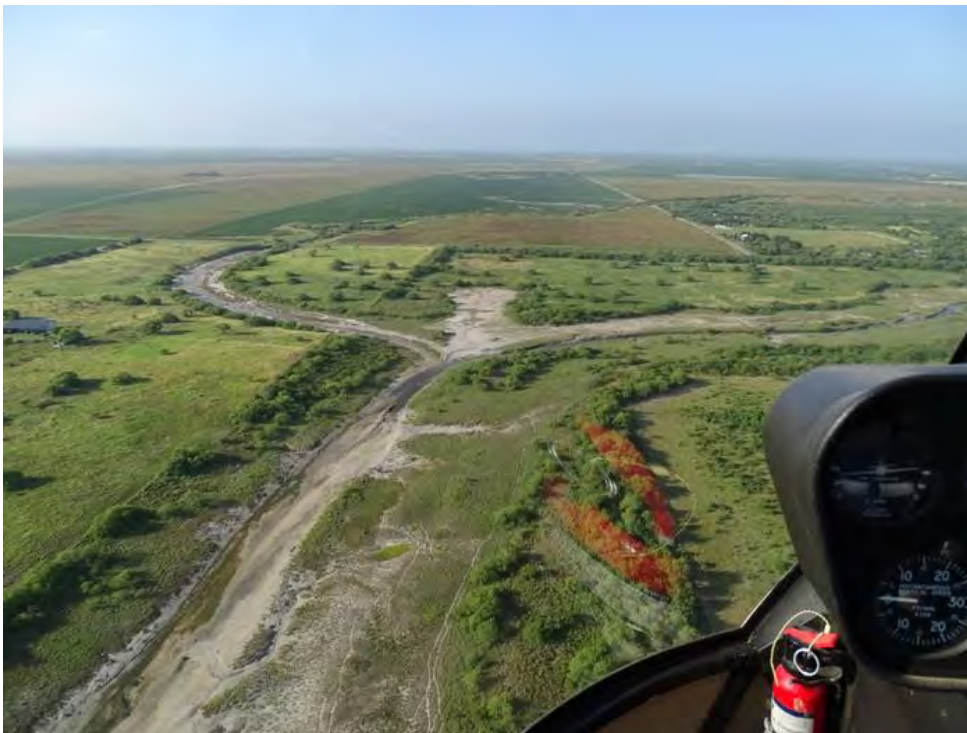
**Figure 36** Confluence of Janboncillos (right) and the tributary (left).

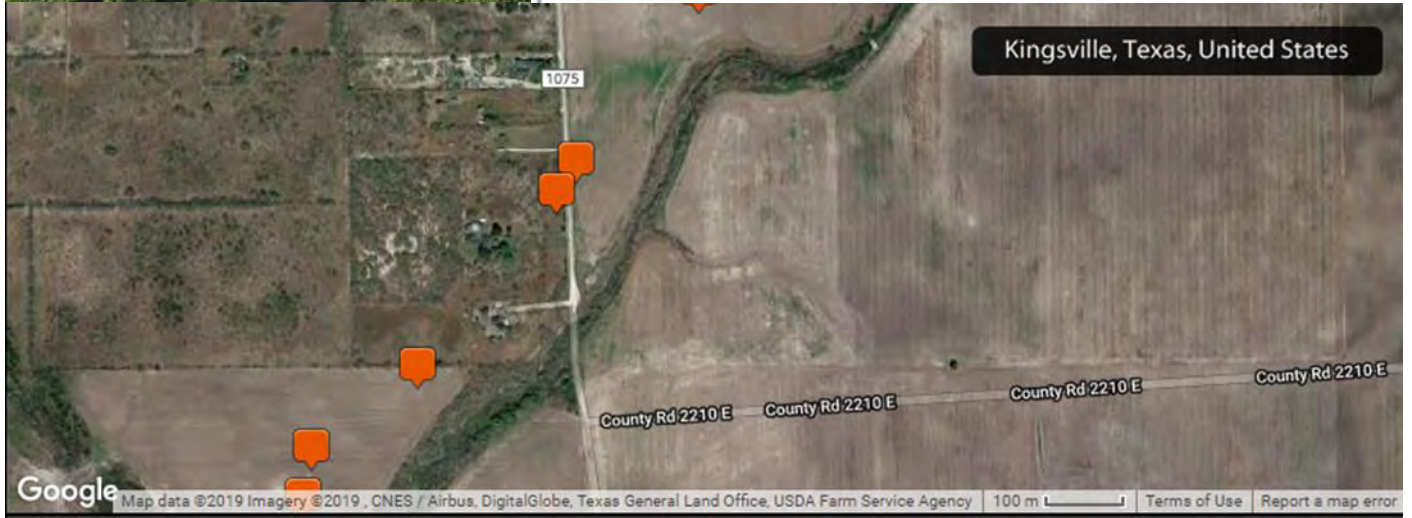
**Figure 38** Looking east at the confluence of a small drain way and Jaboncillos Creek tributary. This image illustrates the hindrance of farming to close to a drain way and the opportunity for enhanced function with a setback of disturbance. This image is an aerial photo point choice.

- 1) Work with landowners to address identified hindrances.
- 2) Remove, repair or replace the poorly designed crossing.

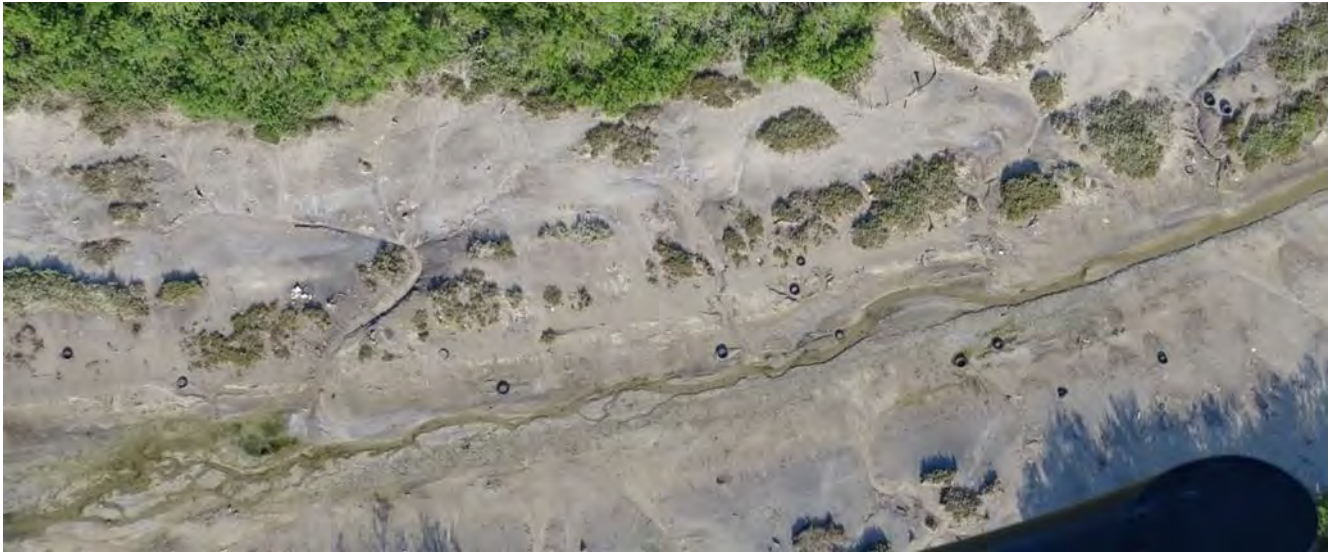
**Figure 39** Image shows discarded tires dotting the channel of Jaboncillos creek. Tires can be seen in large numbers, floating, strewn and in dump piles along many Baffin Bay tributaries.

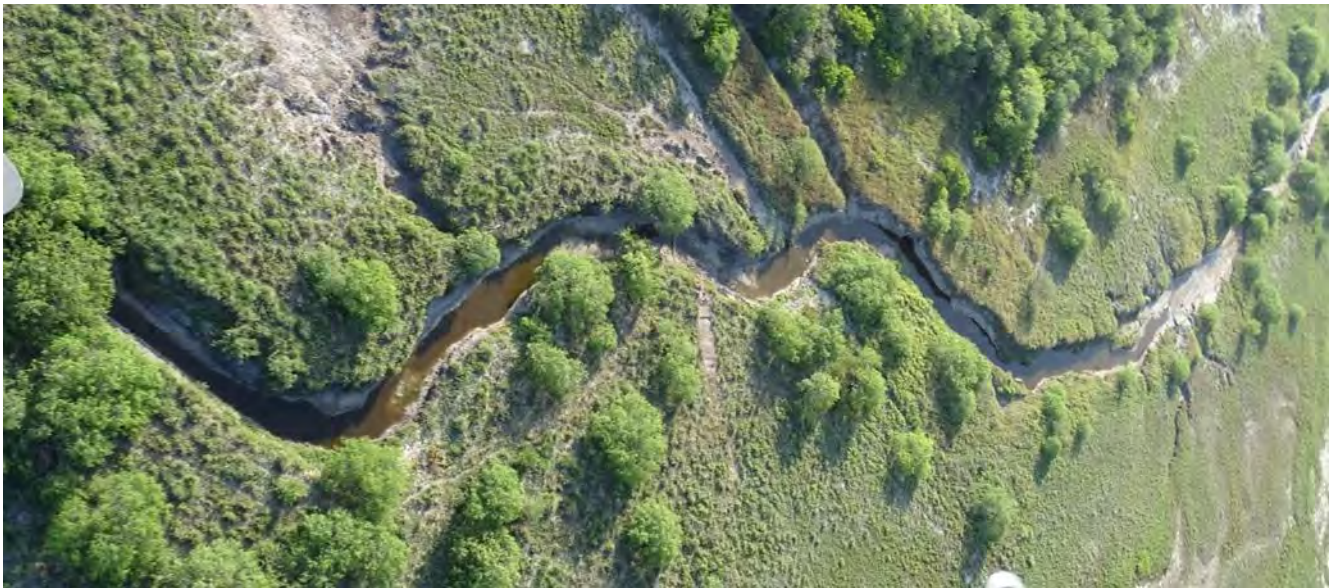
**Figure 40** Image shows channel slightly incised and grazing concentrations in the creek area that appears to be hindering vegetation recovery.

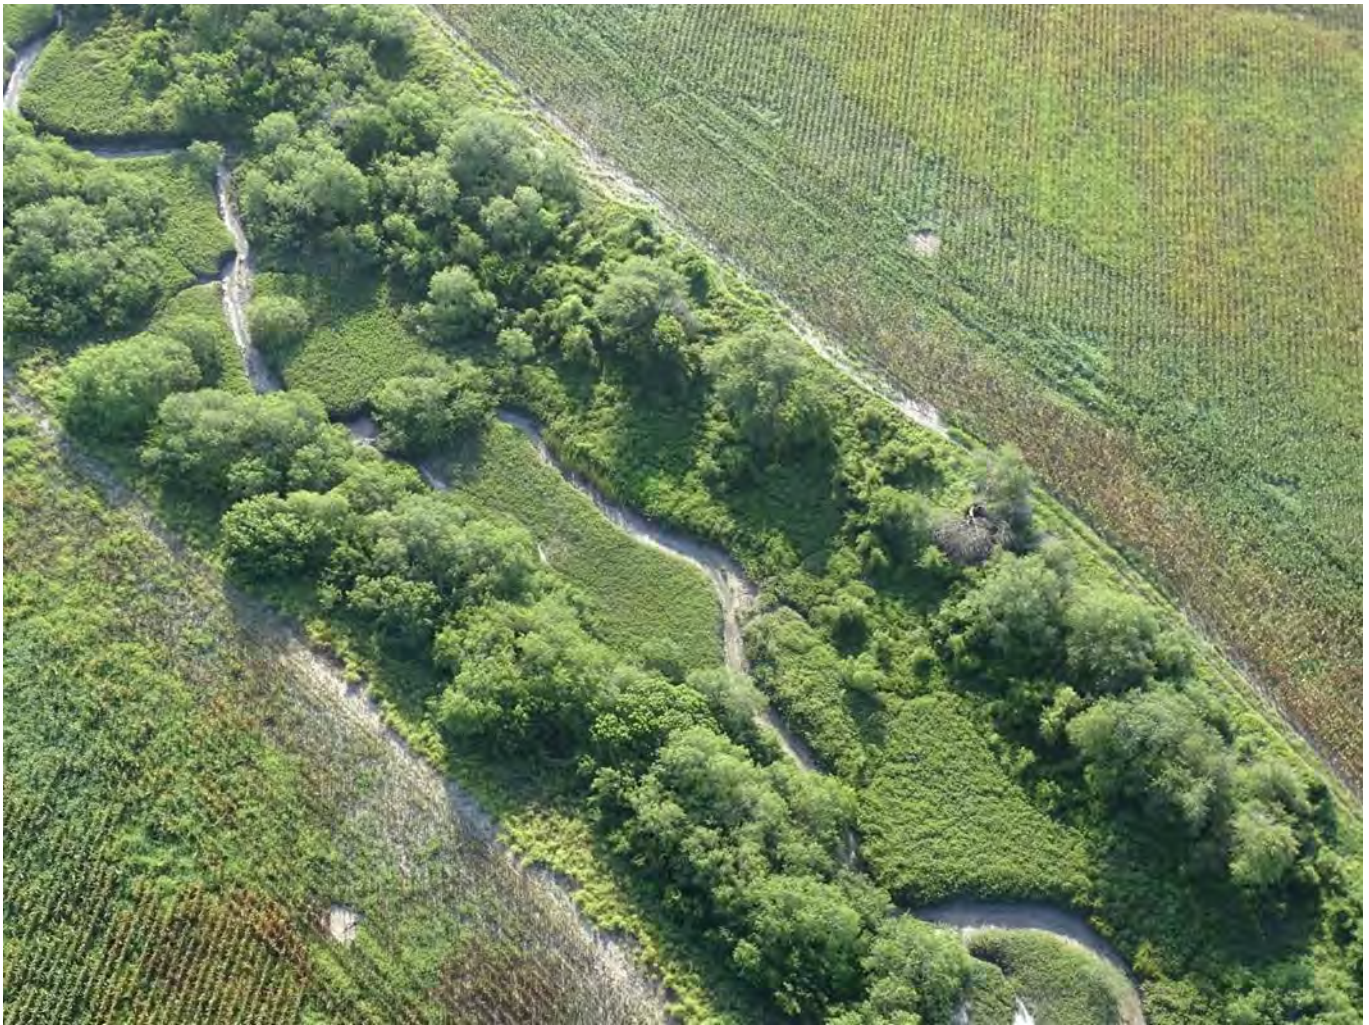
**Figure 41** Image shows an exceptionally well-buffered segment of the tributary.

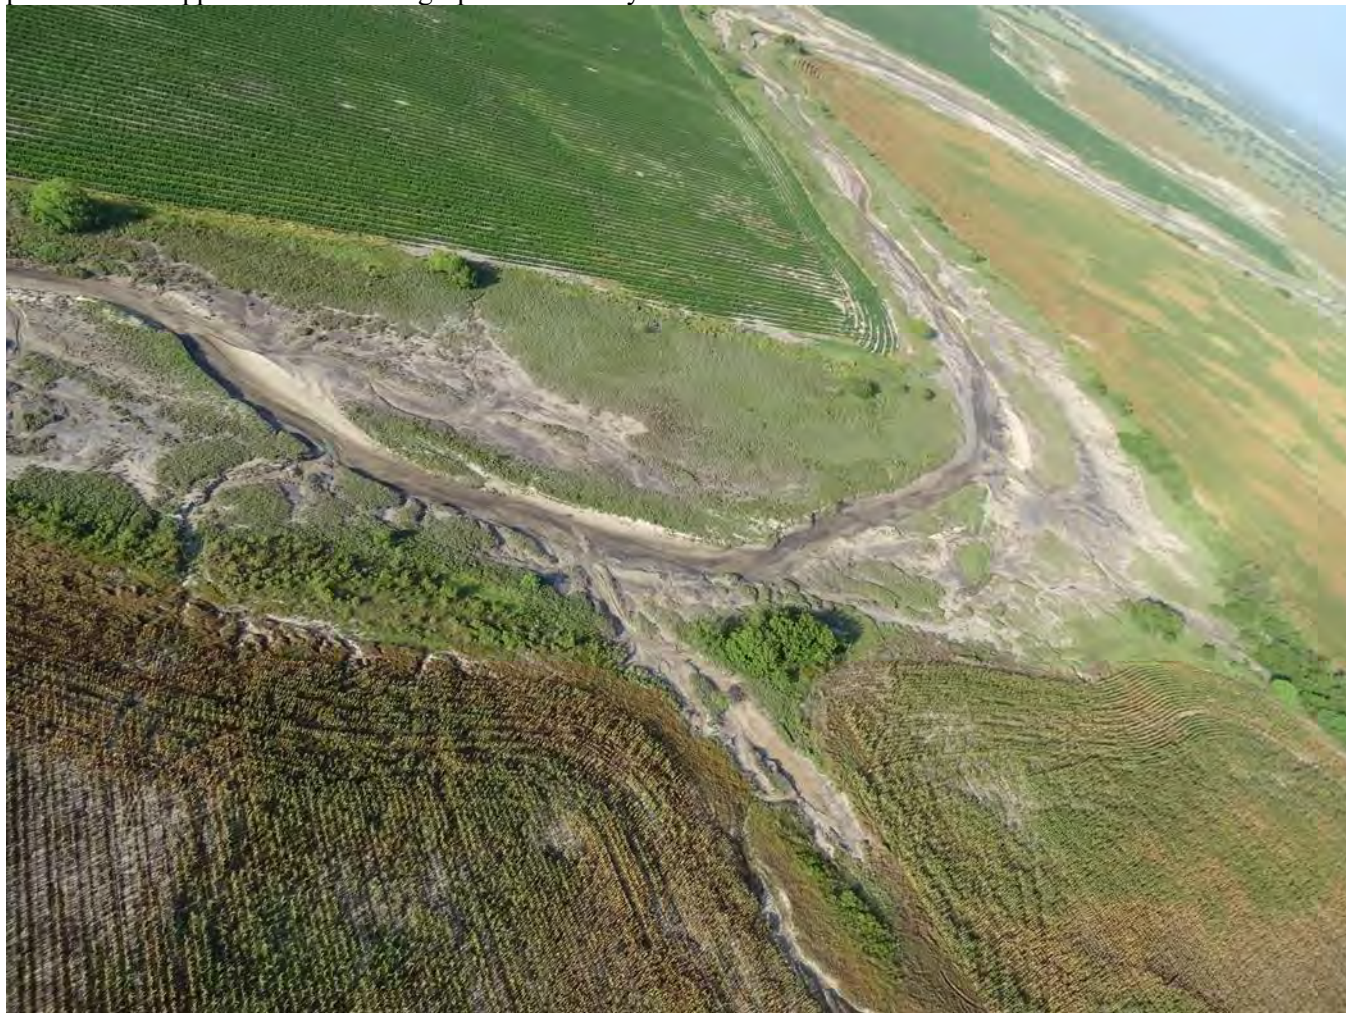
**Figure 44** Image illustrates the riparian condition along most of Radicha Creek and its tributaries.

Work with landowners to address identified hindrances and improve water quality.
