## **Riparian Evaluation for Baffin Bay Tributaries**

Final Report

Publication CBBEP – 132

August 2019

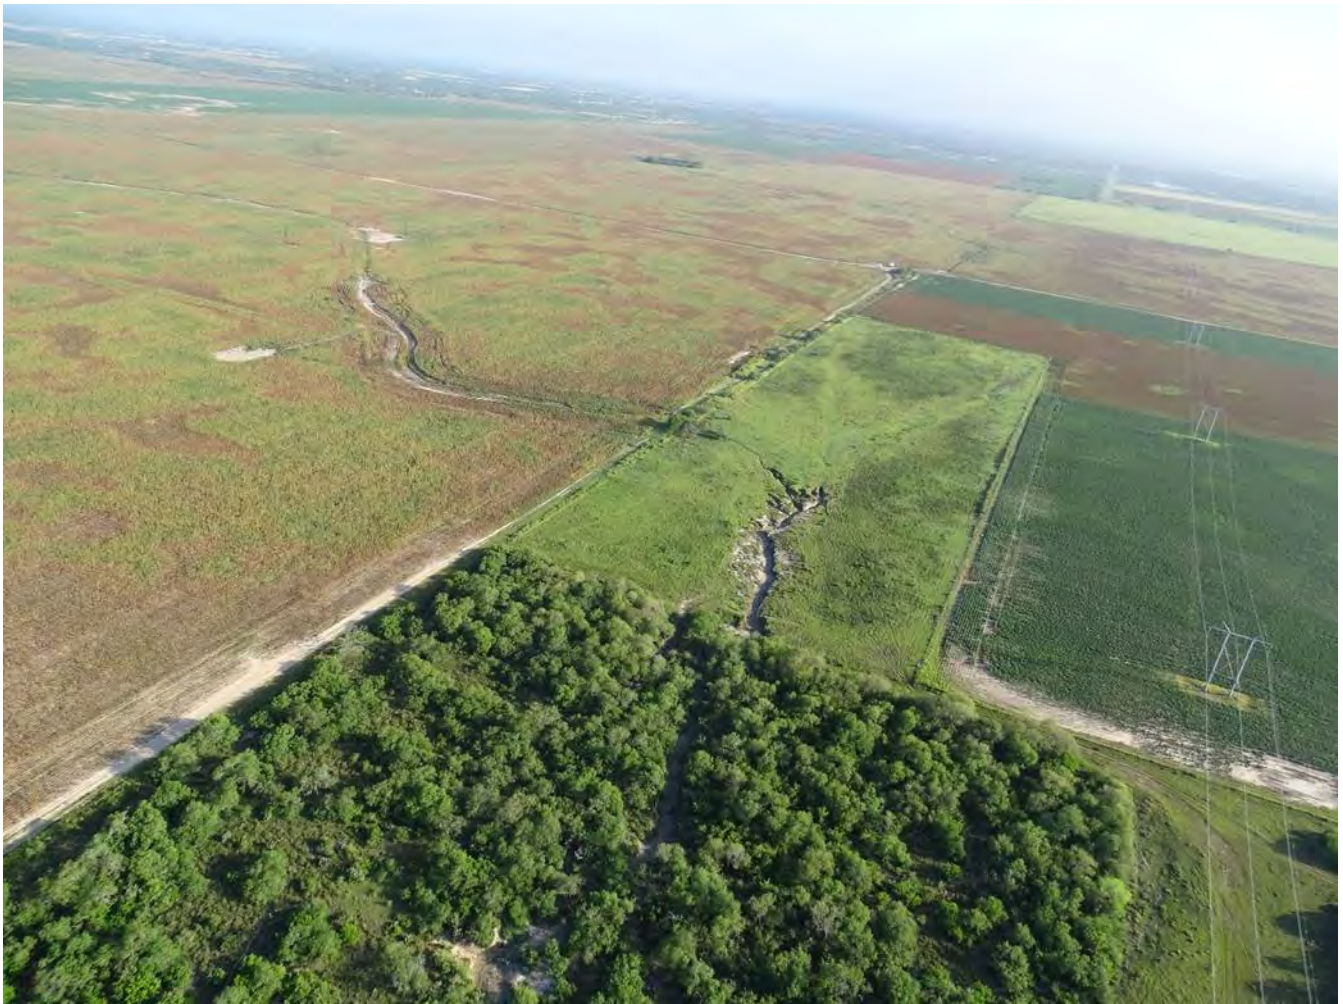
**Figure 45** Image illustrates the riparian condition along most of Radicha Creek and its tributaries in contrast with the heavily wooded tract in the foreground.

Work with landowners to address identified hindrances and improve water quality.

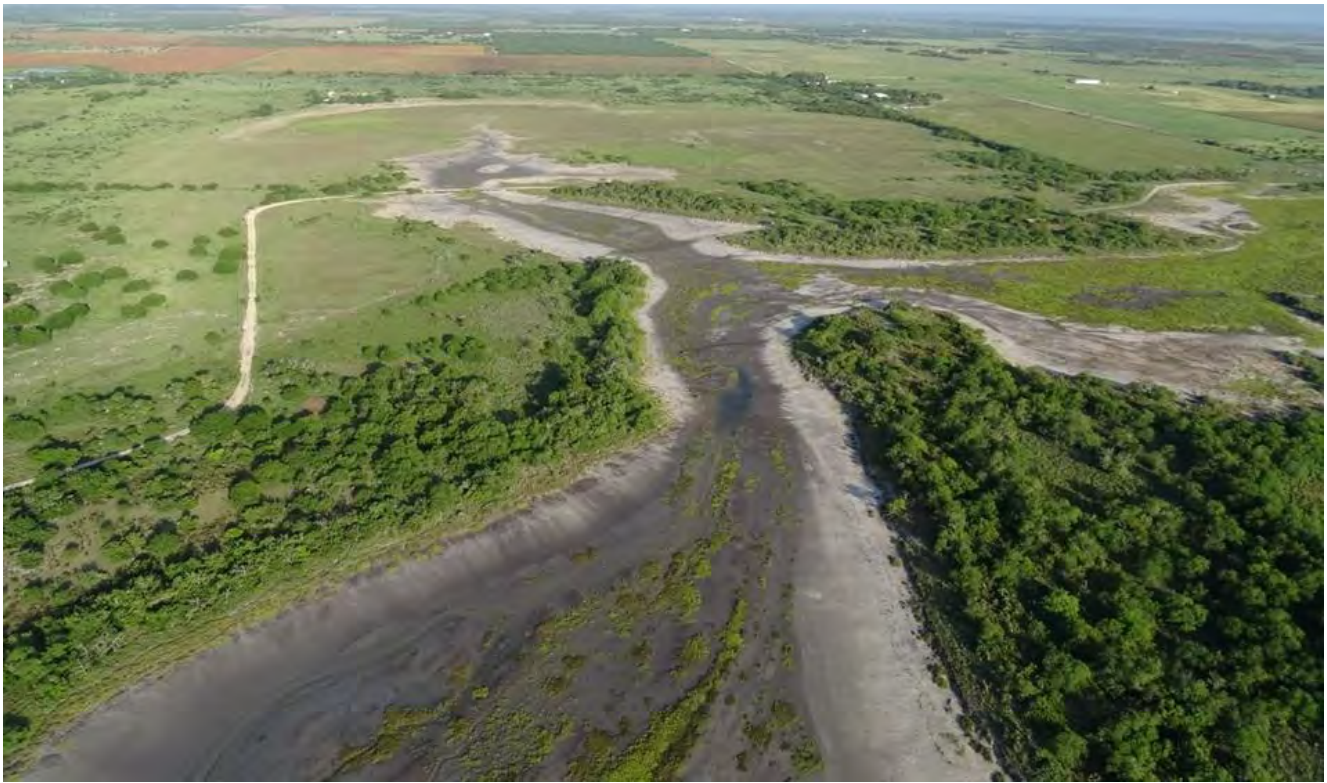
**Figure 50** Looking upstream from the mouth of Vattman Creek. The creek veers to the right in this image.

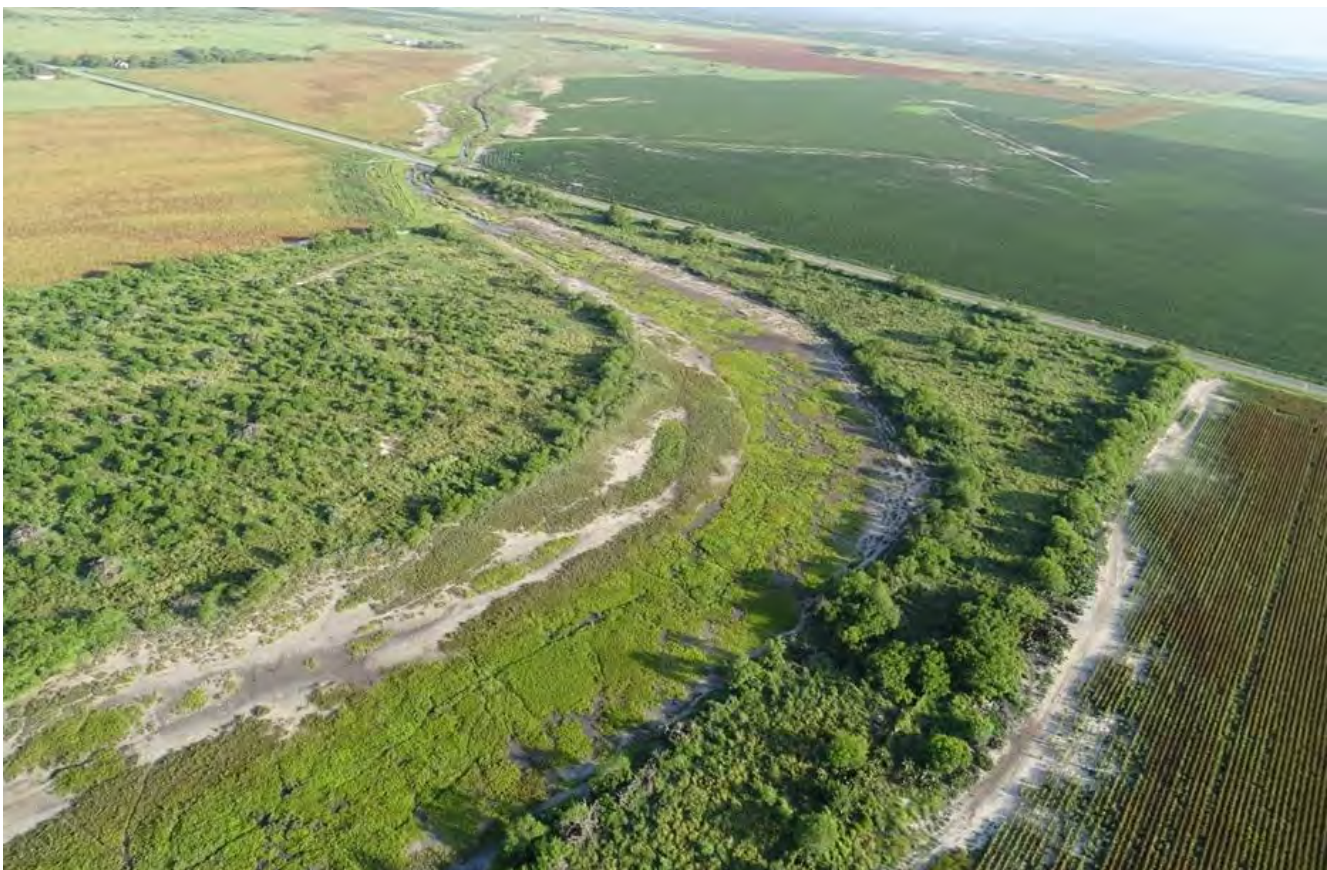
**Figure 51** Looking upstream at the FM 628 crossing of Vattman Creek, the riparian areas is functional and well vegetated below and immediately above this location.

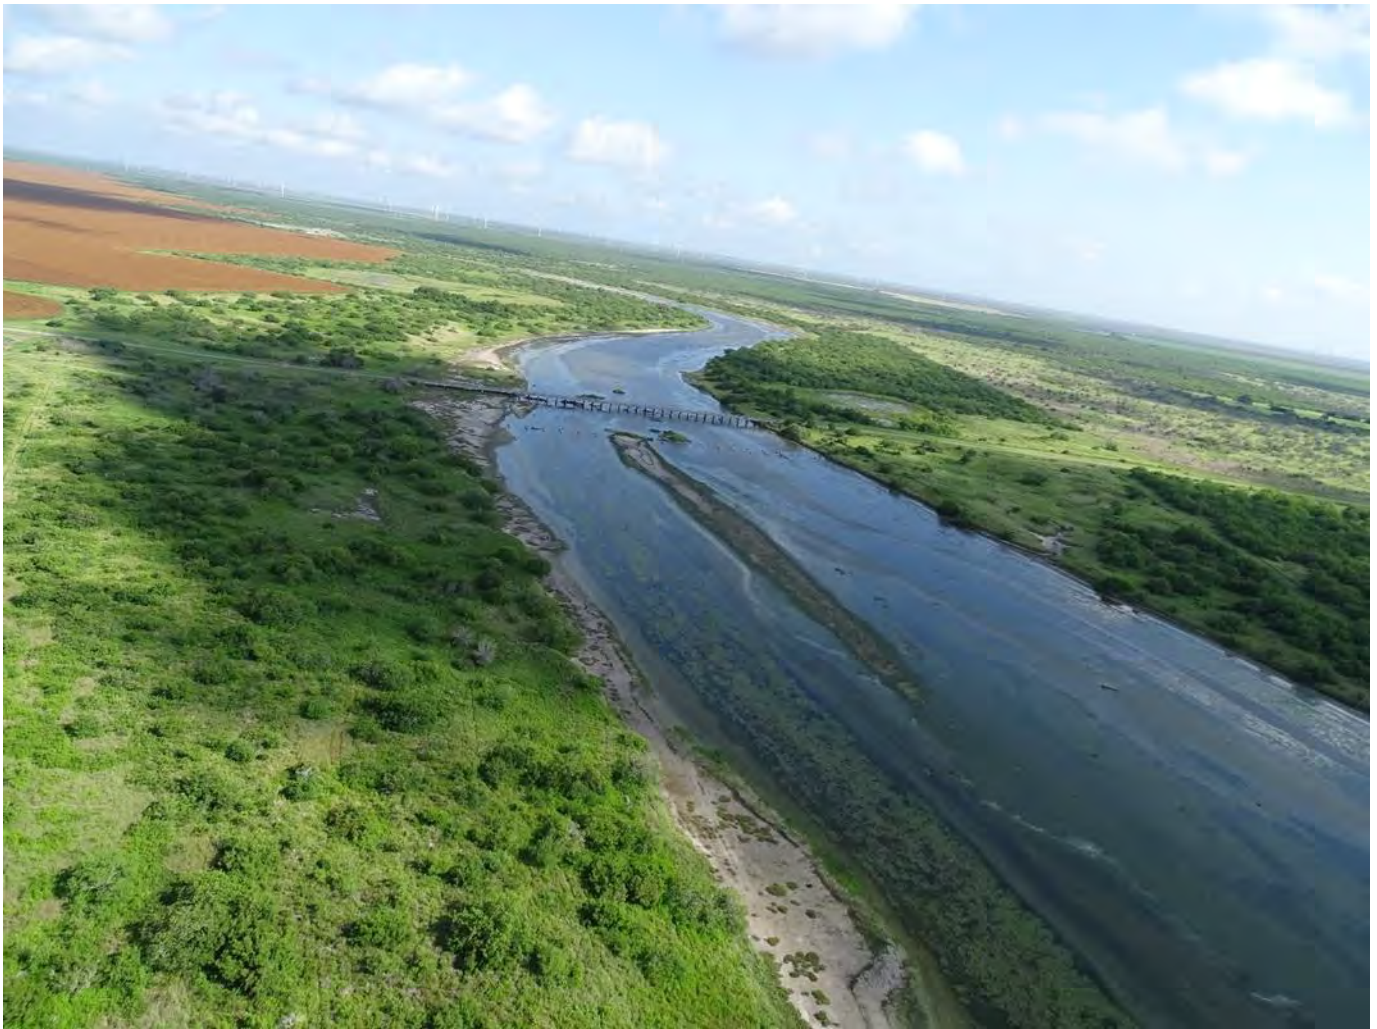
**Figure 56** Image shows wide functional riparian area flanking Petronila Creek at the Laureles Ranch Road bridge. Farming activities are set back from the creek, and the wide floodplain is well vegetated.

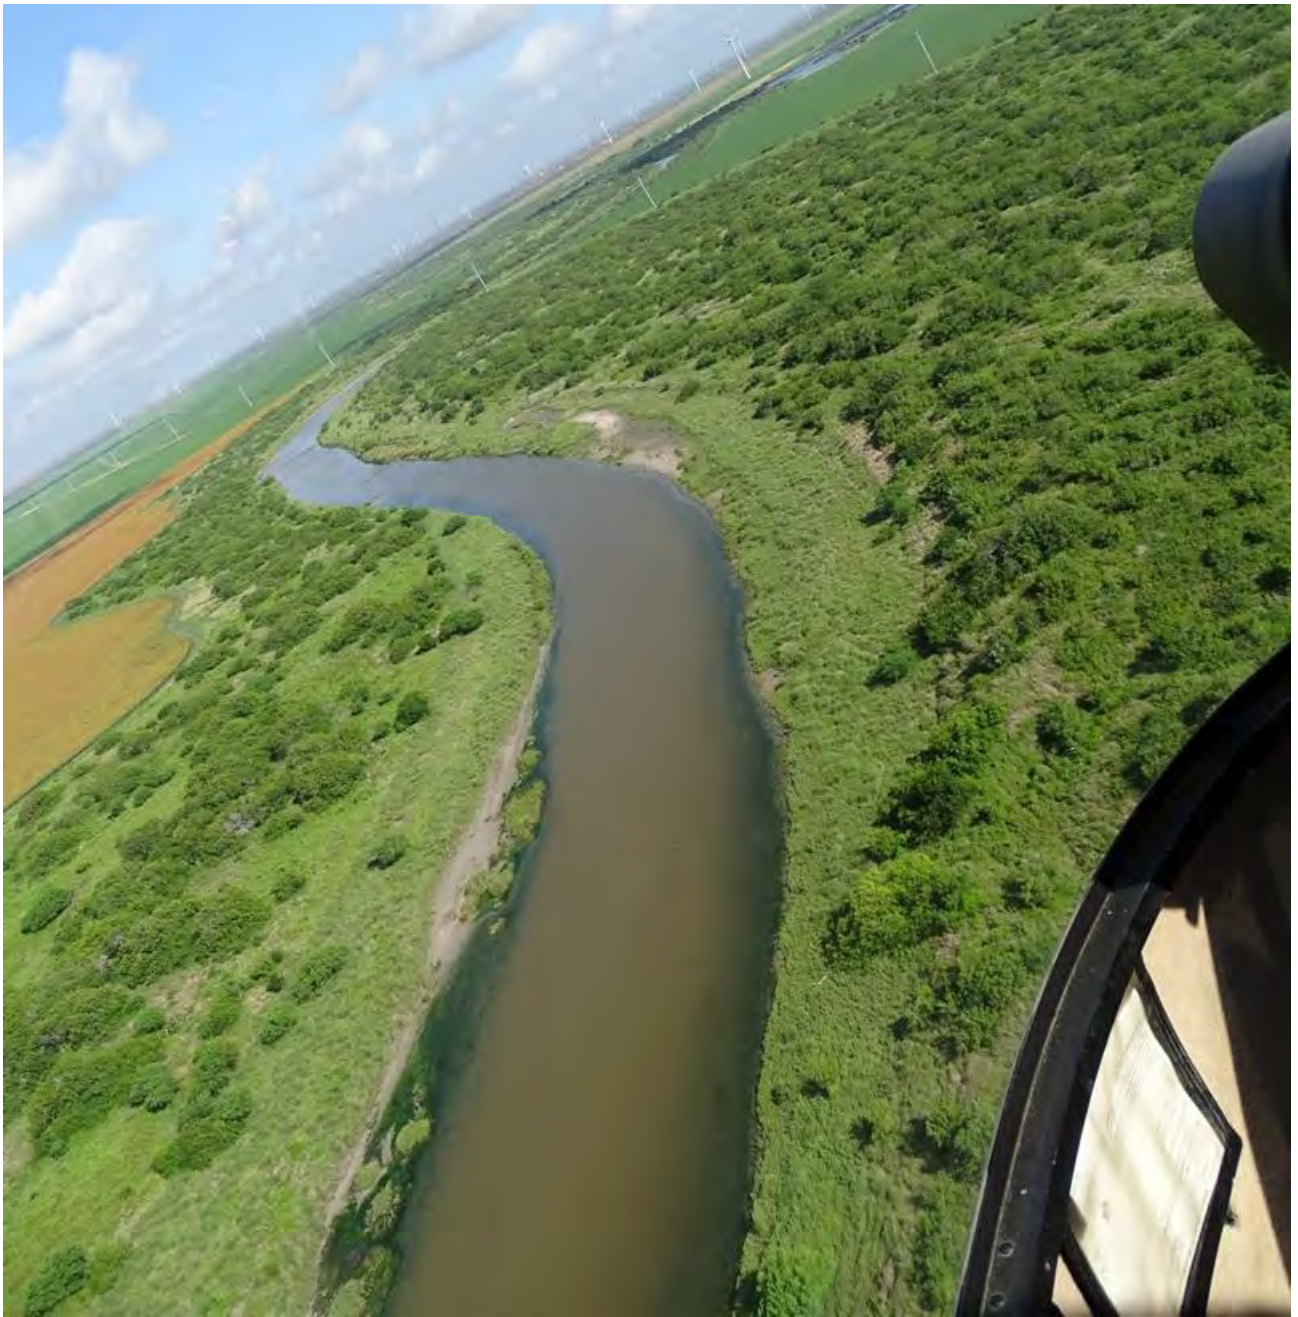
**Figure 57** Images show highly functional riparian areas along the Lower/Chapman Ranch Reach of Petronila Creek near the top of the reach. Banks are well vegetated in what appears to be Cordgrass with Retama and Mesquite. A fringe of algae is visible along the channel edge. At this point, the riparian area is narrower than the downstream areas of the reach.

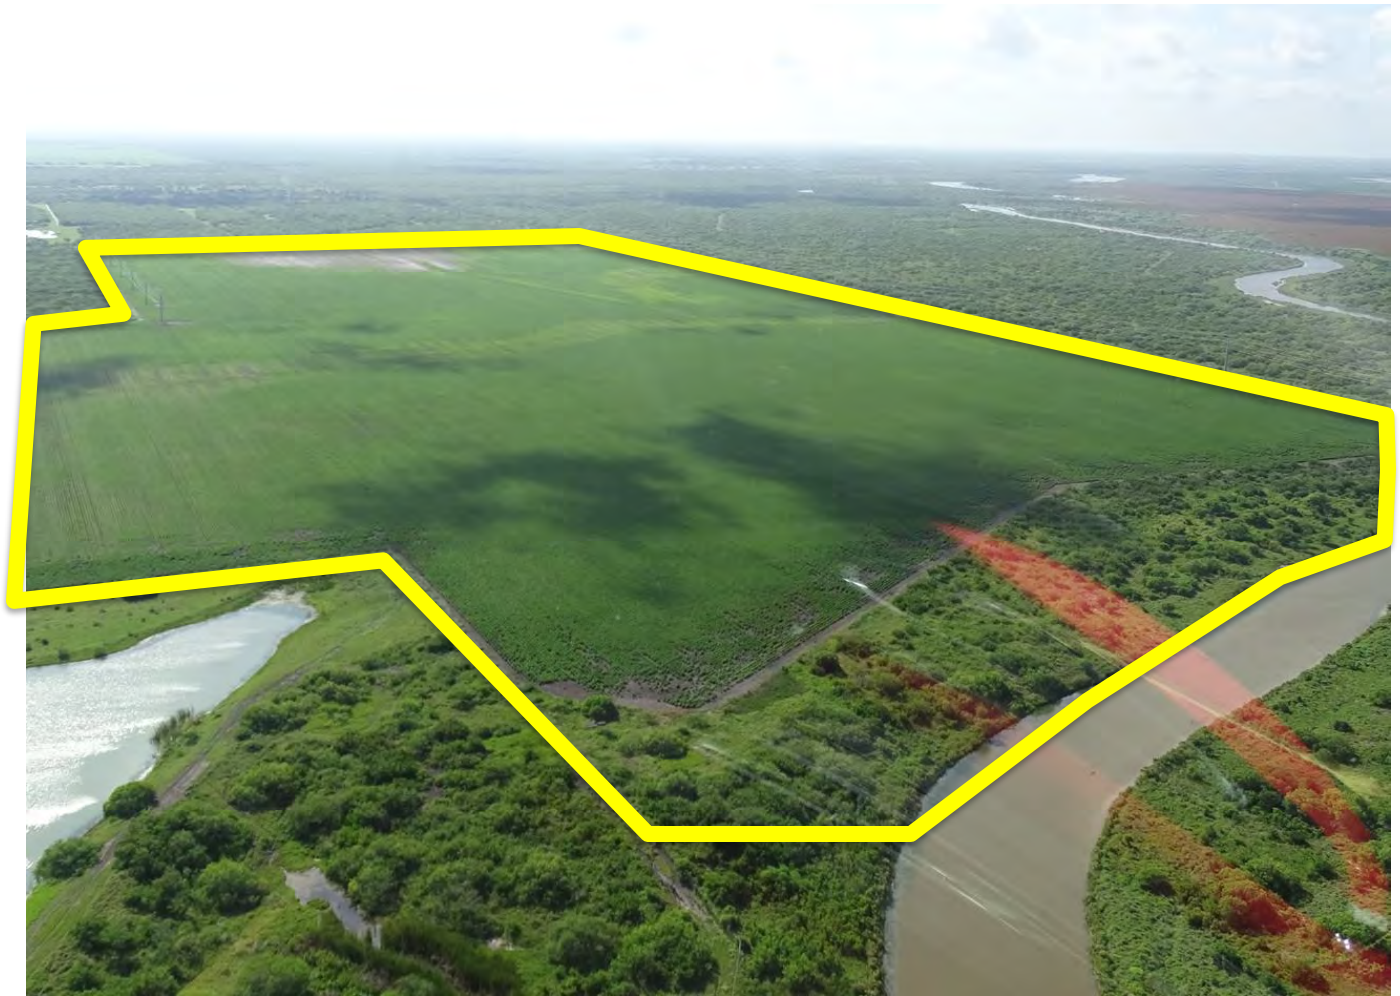
**Figure 58** Pictured here is part of a 200+/- acre farm where an installed wetland is being contemplated to improve water quality in Petronila Creek before it reaches the bay.

- 1) Work with landowners to reward the current stewardship; protect and document the functional riparian condition along the lower reach of Petronila Creek.
- 2) Work with willing landowners to convert farmland to functional wetlands for the purpose of improving water quality in the creek before it reaches the bay.

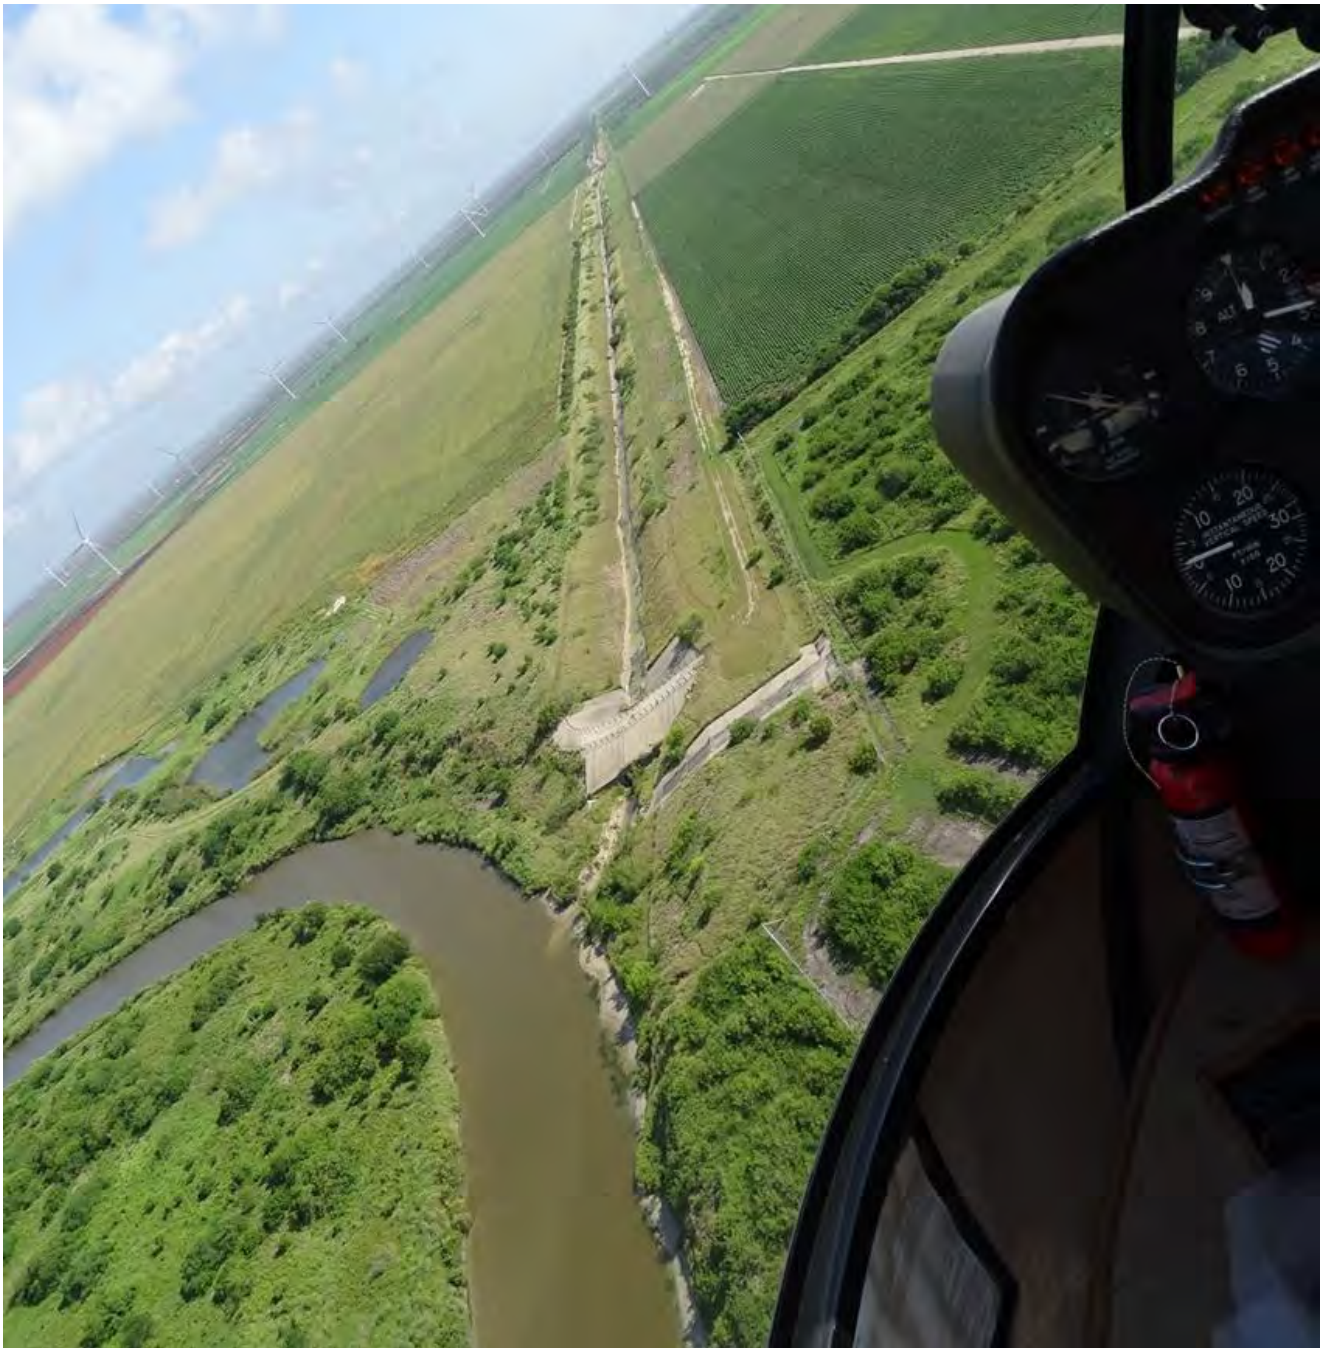
**Figure 59** Near the top of the reach, the creek and its riparian area narrow and become meandering. This image shows the confluence of the Landfill Ditch stormwater drain to Petronila Creek.

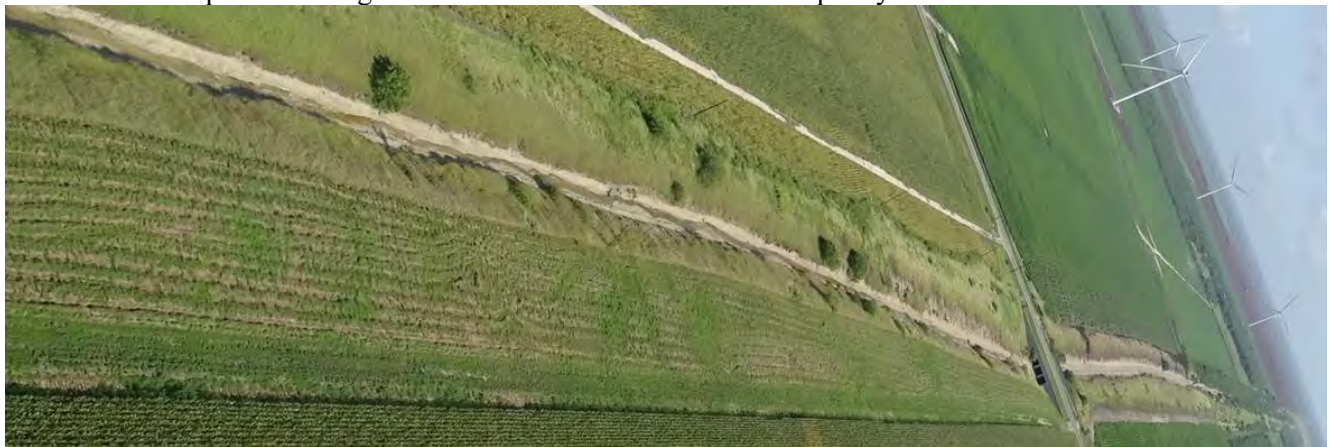
**Figure 62** This image shows the Landfill Ditch stormwater drain to the Lower Reach of Petronila Creek incised and its banks either bare or kept mowed. There appears to be a setback, perhaps an easement that restricts row crops to within 80-150 feet of the channel edge.

- 1) Work with landowners the landfill operators to allow vegetation to grow along the entire length of the ditch with the landfill border as a benchmark.
- 2) Plant riparian vegetation where needed.
- 3) Allow or encourage the ditch to meander, possible by expanding its floodplain, lowering its banks and even incorporating what appear to be portions of natural channel.
- 4) Where appropriate and acceptable, work with willing landowners to convert farmland to functional wetlands for the purpose of improving water quality in the creek before it reaches the bay.

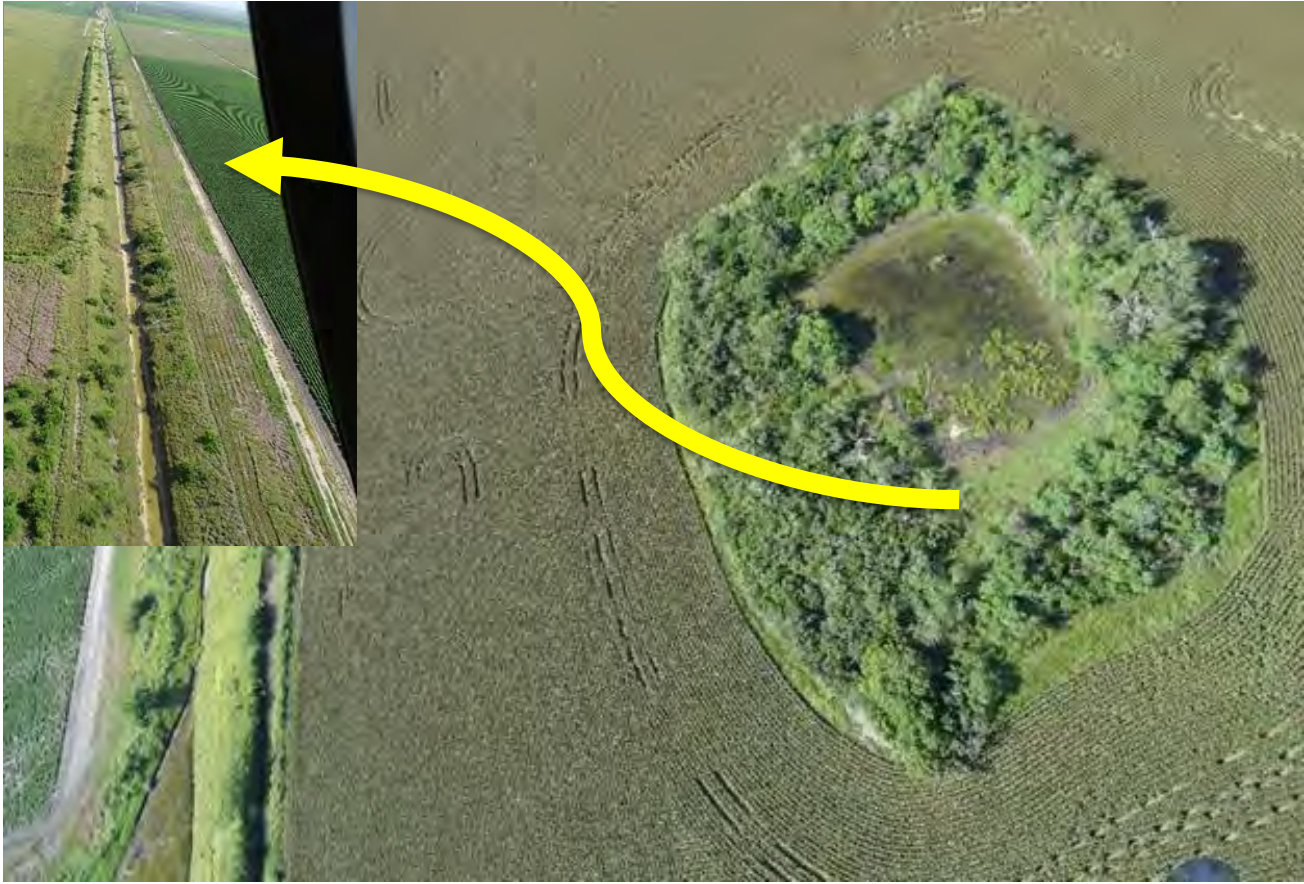
**Figure 63** The Landfill Ditch stormwater drain to the Lower Reach of Petronila Creek is overly straight for a natural drain. In this image we identified a water hole that may be a remnant of the old meandering channel of a natural drain before channelization. This feature could be included in a re-meander project to enhance riparian function for the benefit of water quality.

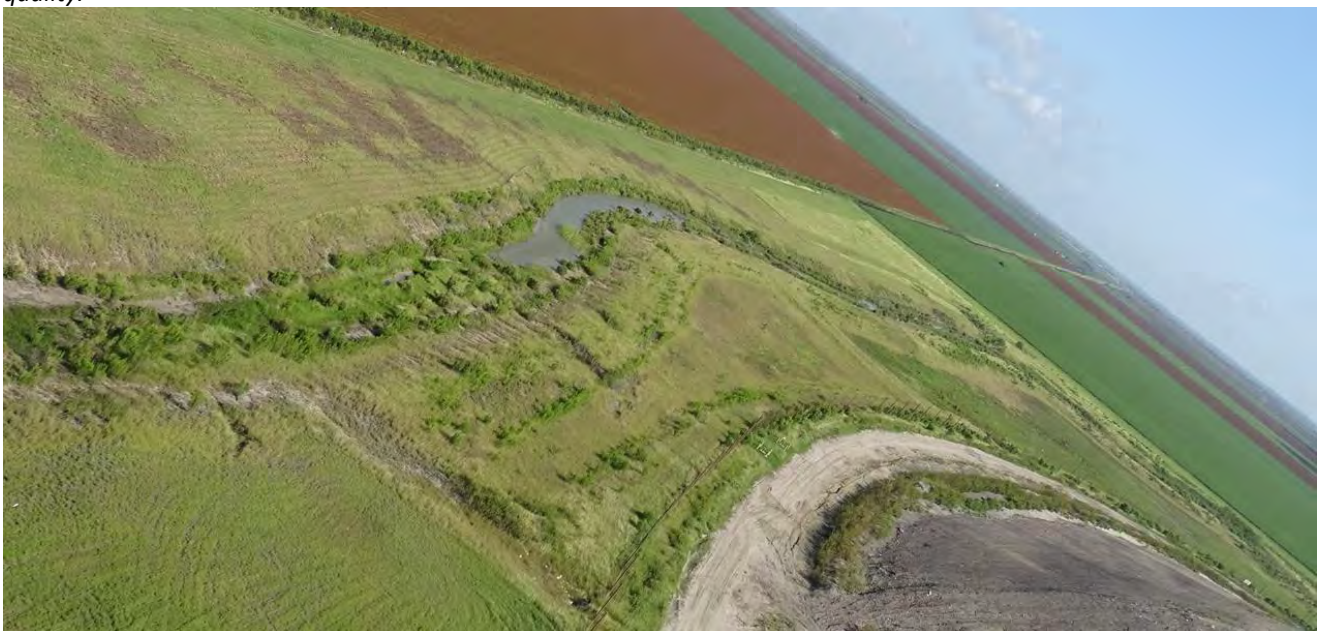
**Figure 64** Near the landfill the drain becomes more functional, vegetated with obligates and slightly meandering.

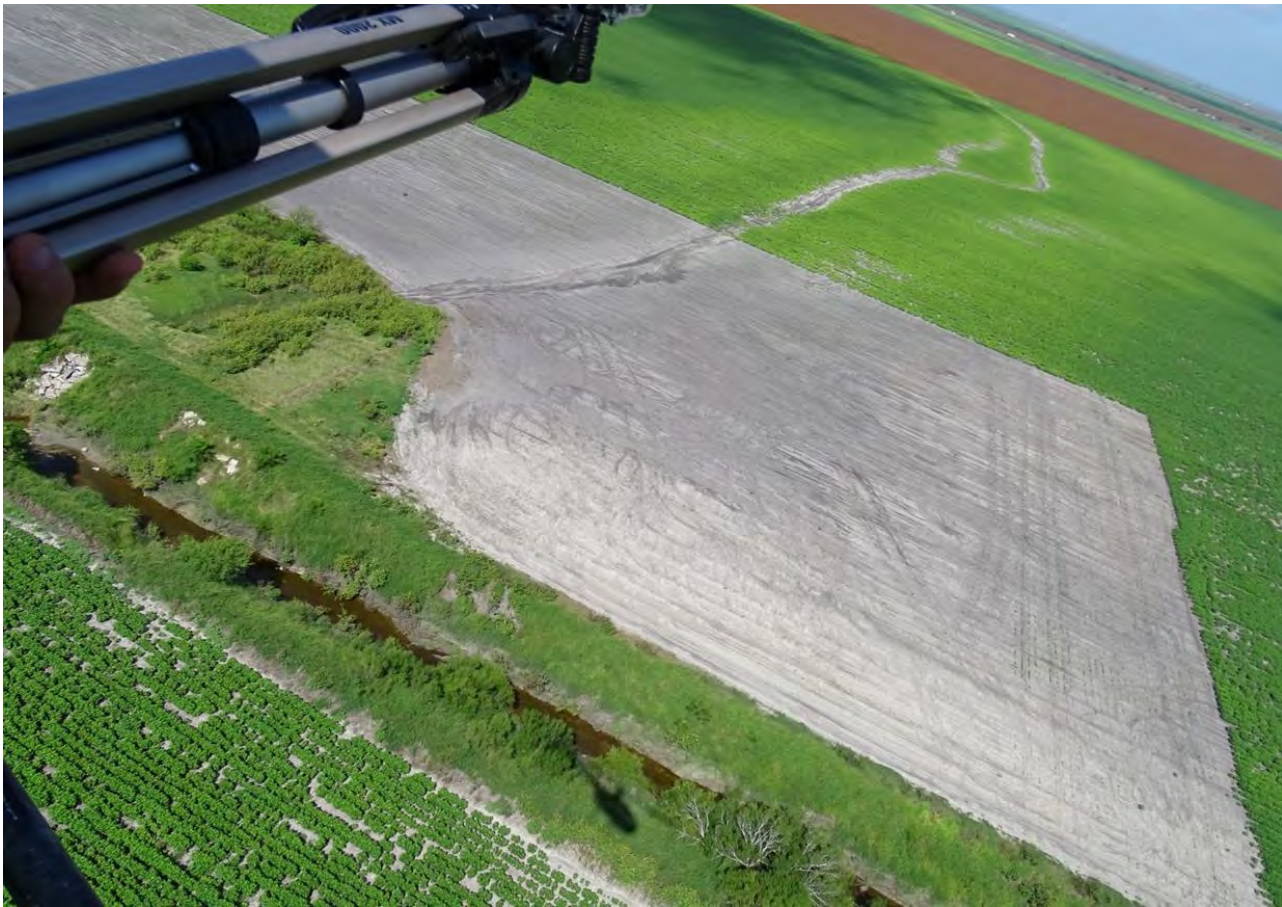
**Figure 69** This image shows gullies forming where runoff drains from adjacent farmland into the ditch. Allowing the drain to develop energy dissipating vegetation could slow the runoff and help slow the gully formation.

8. **Water storage.** OBL sedges were observed at the water's edge only, and not on the banks or floodplains.
9. **Bank and channel erosion.** Erosion can be observed with gullies being formed where drains enter the creek. Deposition is apparent in the channel. Deposition and erosion do not appear to be balanced. Channel is not capable of managing flow and sediment.

- 1) Work with landowners the landfill operators to allow vegetation to grow along the entire length of the ditch with the landfill border as a benchmark.
- 2) Plant riparian vegetation where needed.
- 3) Allow or encourage the ditch to meander, possible by expanding its floodplain, lowering its banks and even incorporating what appears to be portions of natural channel.
- 4) Where appropriate and acceptable, work with willing landowners to convert farmland to functional wetlands for the purpose of improving water quality in the creek before it reaches the bay.

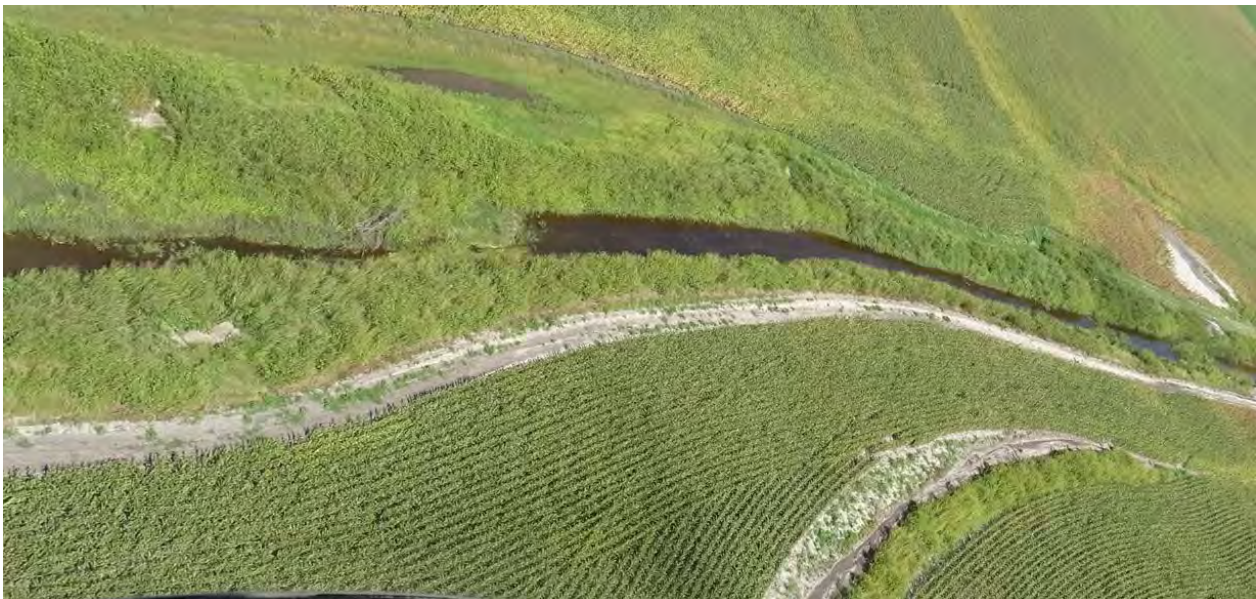
**Figure 70** In this image the banks of Lost Creek Ditch appear well vegetated, but only a portion of the vegetation is believed to be native riparian plants, like Spiny aster. Herbaceous buffers for creeks draining farmland were often planted in Guinea grass, a strong colonizer of disturbed soils. It is a non-native, weak-rooted, ground-covering plant that does not advance riparian function.

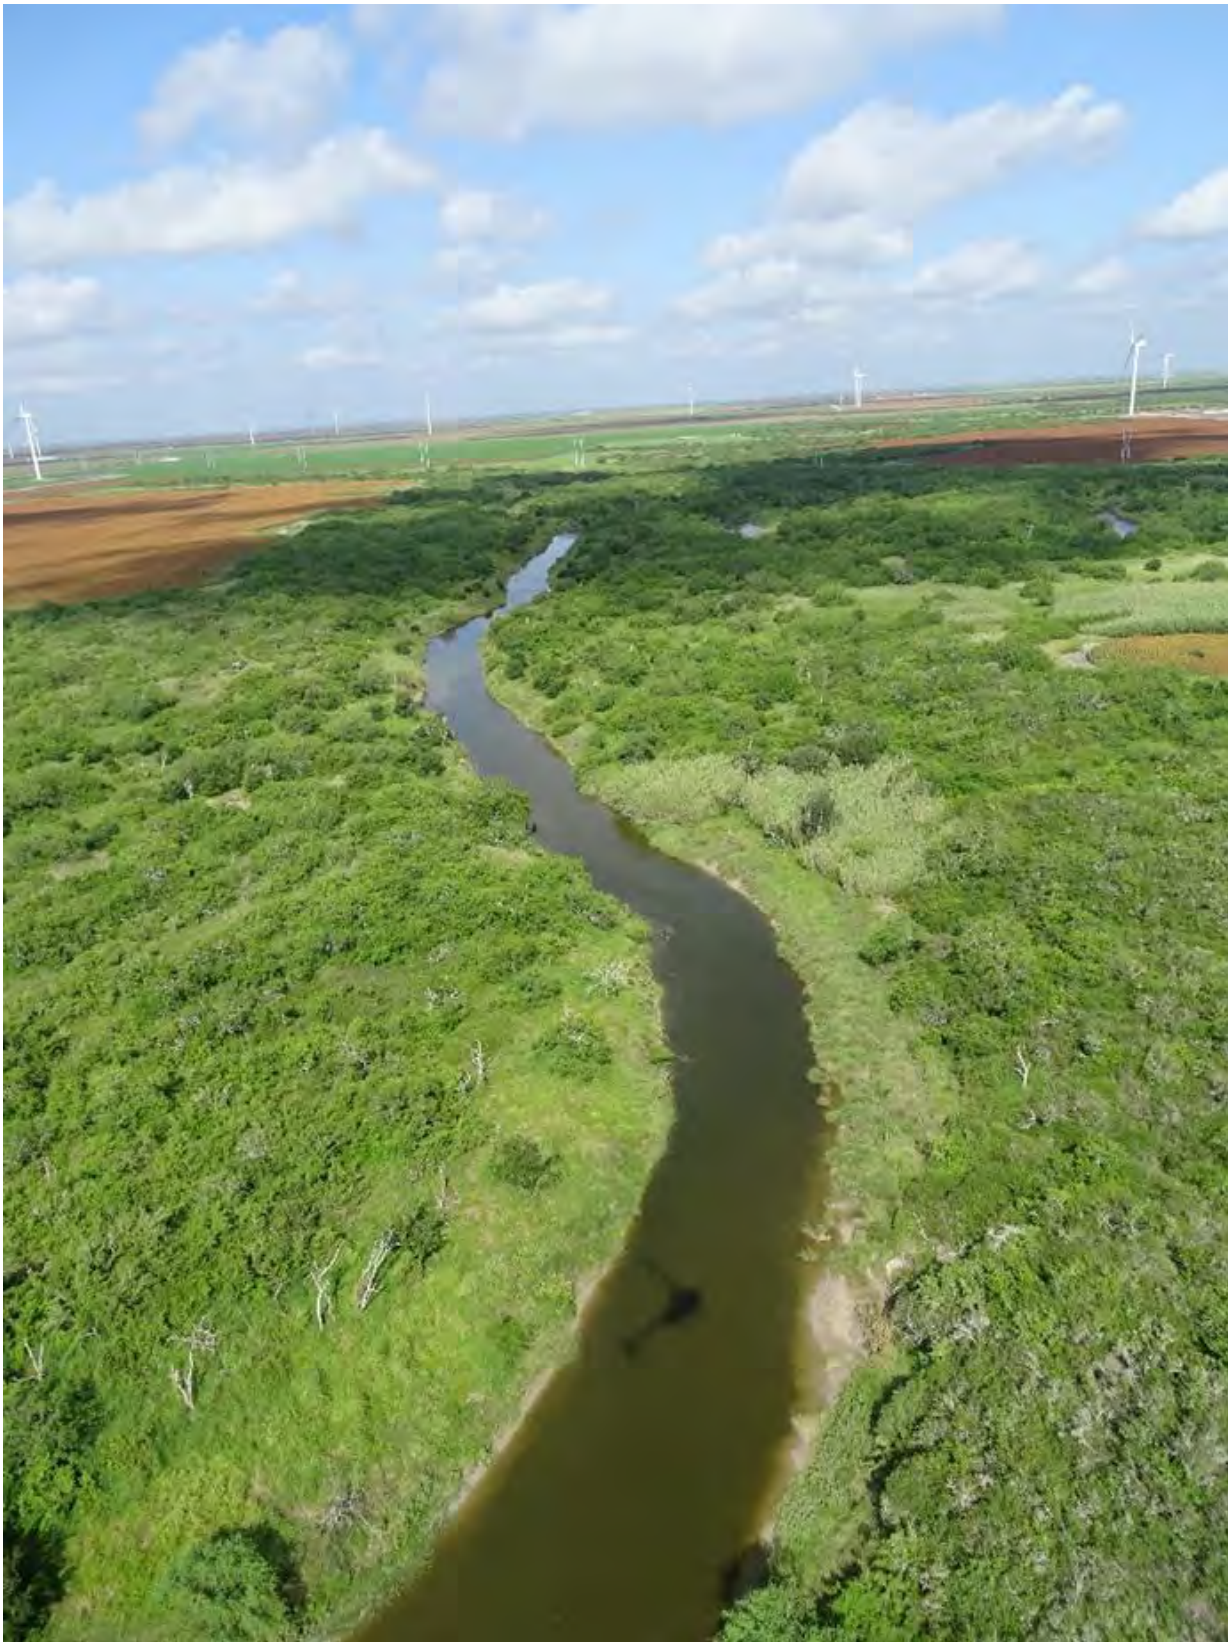
**Figure 73** Pictured here is the Lubby/Driscoll Reach of Petronila Creek with its well-vegetated banks and floodplain. Visible in this image is a healthy stand of what appears to be Cordgrass on the right bank and an abundance of large trees: Oak, Ash, Mesquite, Retama and others. Guinea grass and *Arundo donax* were also observed.

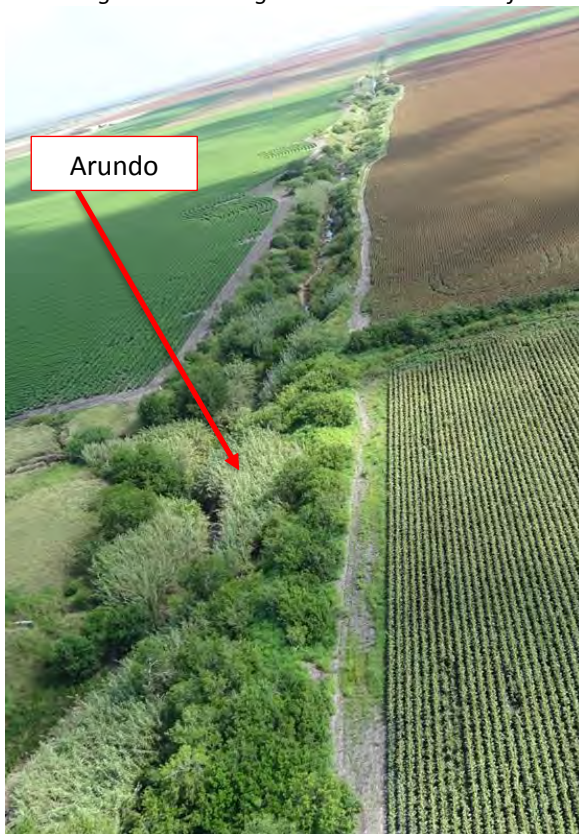
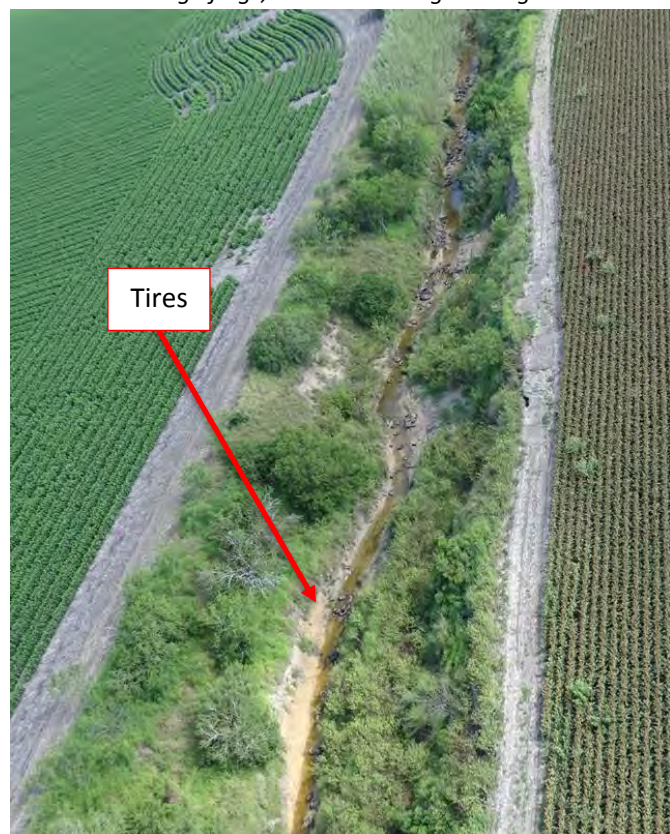
**Figure 77** This image shows the small drain entering Petronila is littered with large quantity of dumped tires and covered with the highly invasive plant, *Arundo donax*.

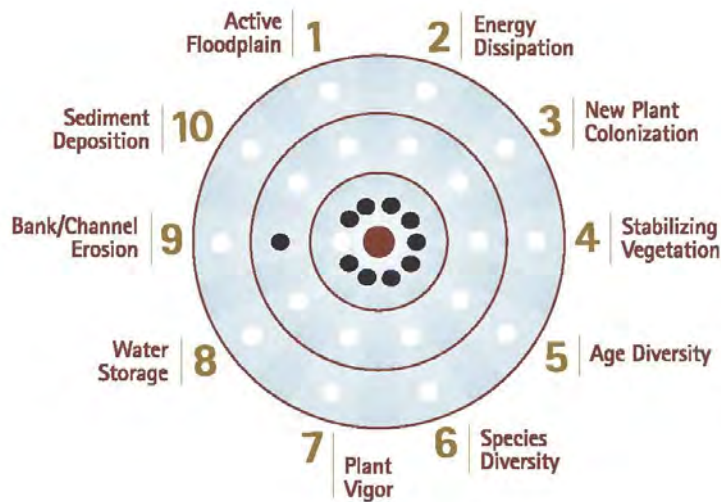
**Figure 78** Bull's-Eye evaluation target for Gertrude Lubby Lake/Driscoll Reach of Petronila Creek.

- 3)1) \_\_\_\_\_ Work with landowners to ensure proper setback for wind towers and furrow agriculture, and maintain a strong vegetated buffer between the farms and the creek bank.
- 4)2) \_\_\_\_\_ Engage the town of Driscoll in ways to evaluate the pond and seep and their possible relationship with the creek. Off-channel wetlands or other tertiary treatment options have been demonstrated to protect water quality in receiving waters.

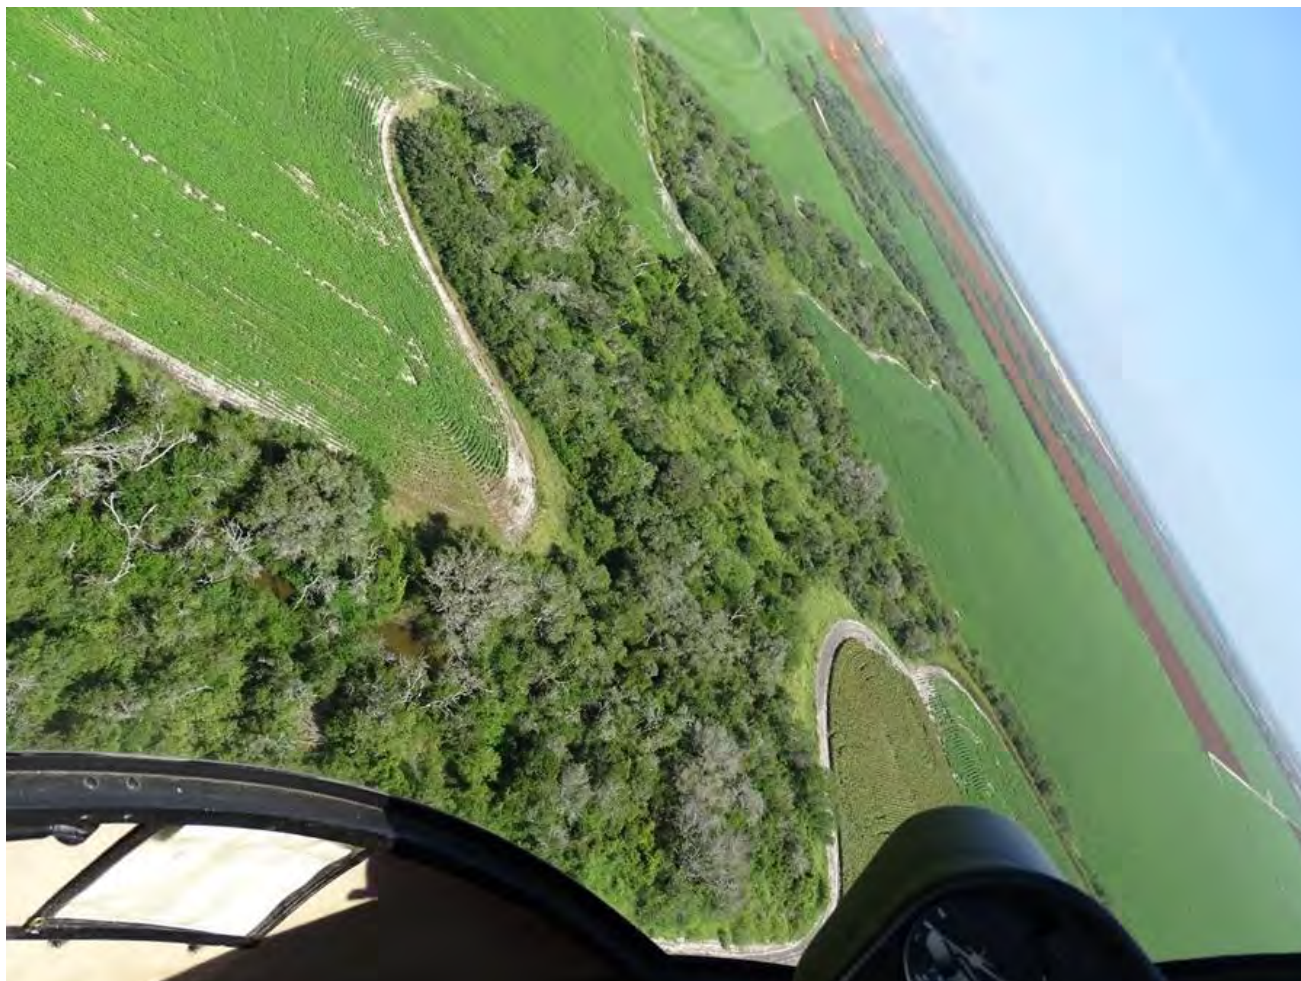
**Figure 81** This image shows the heavily wooded and functional condition of the riparian area along most of the Banquete reach of Petronila Creek.

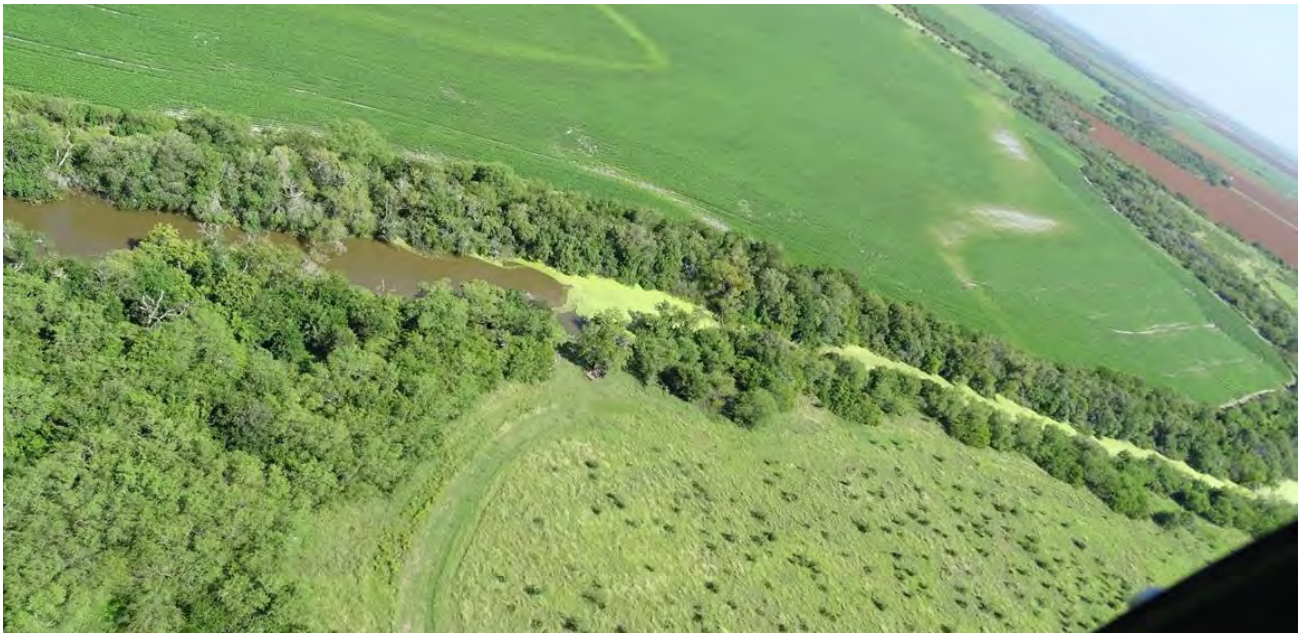
**Figure 82** Towards the top of the reach, a thick cover of Duck weed covers the creek's surface.

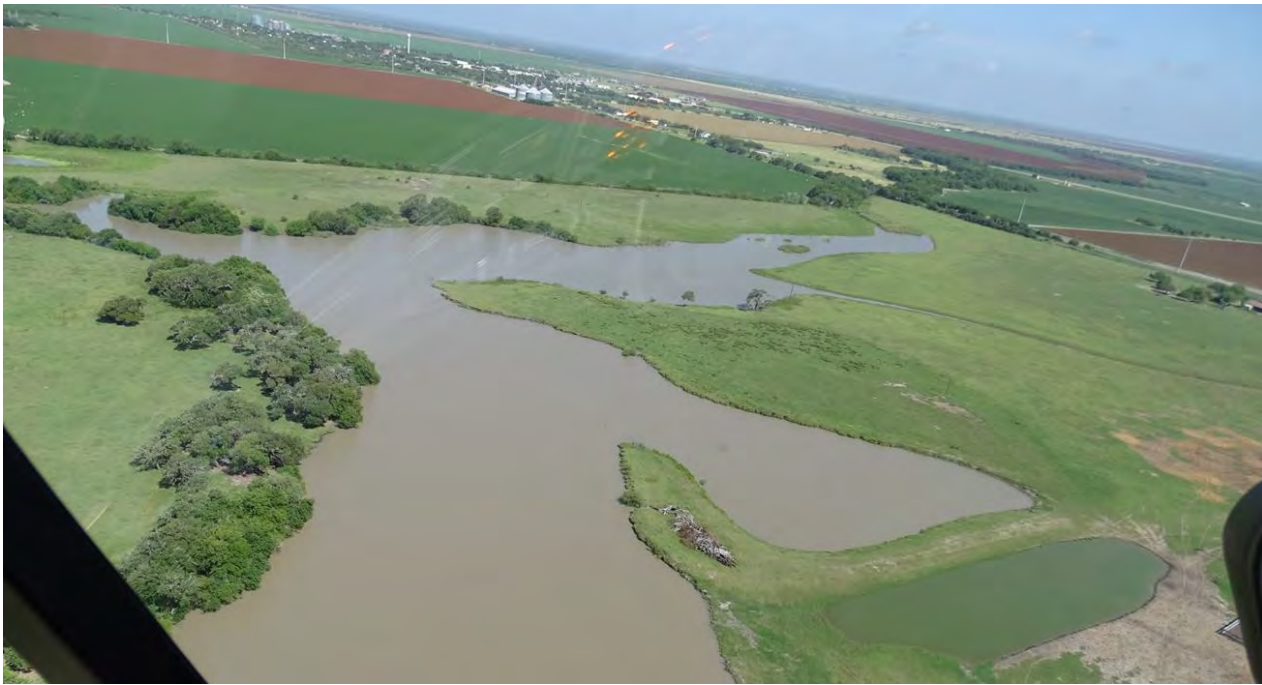
**Figure 84** Manicured and grazed riparian area at the top of the reach. The water's color at this location has become turbid and milky brown.

- 1) Work with landowners to address identified hindrances that could include a setback of pasture manicuring and an initially rest from grazing pressure on the creek banks to allow riparian plants to recover.
- 2) Without creating additional hindrances, engage the communities within the neighborhoods and the detention center in water quality and riparian issues surrounding the creek in their area.

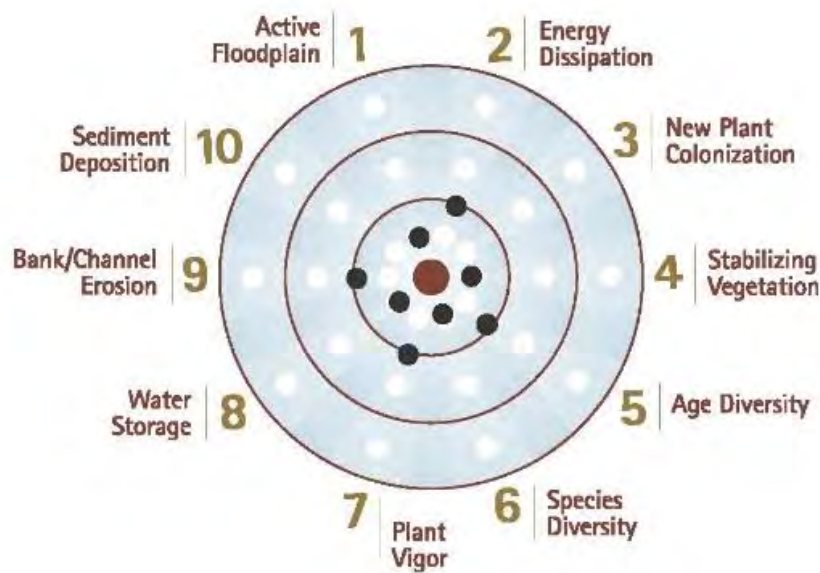
**Figure 86** Bull's-Eye evaluation target for Banquete reach of Petronila Creek.
