## **Riparian Evaluation for Baffin Bay Tributaries**

Final Report

Publication CBBEP – 132

August 2019

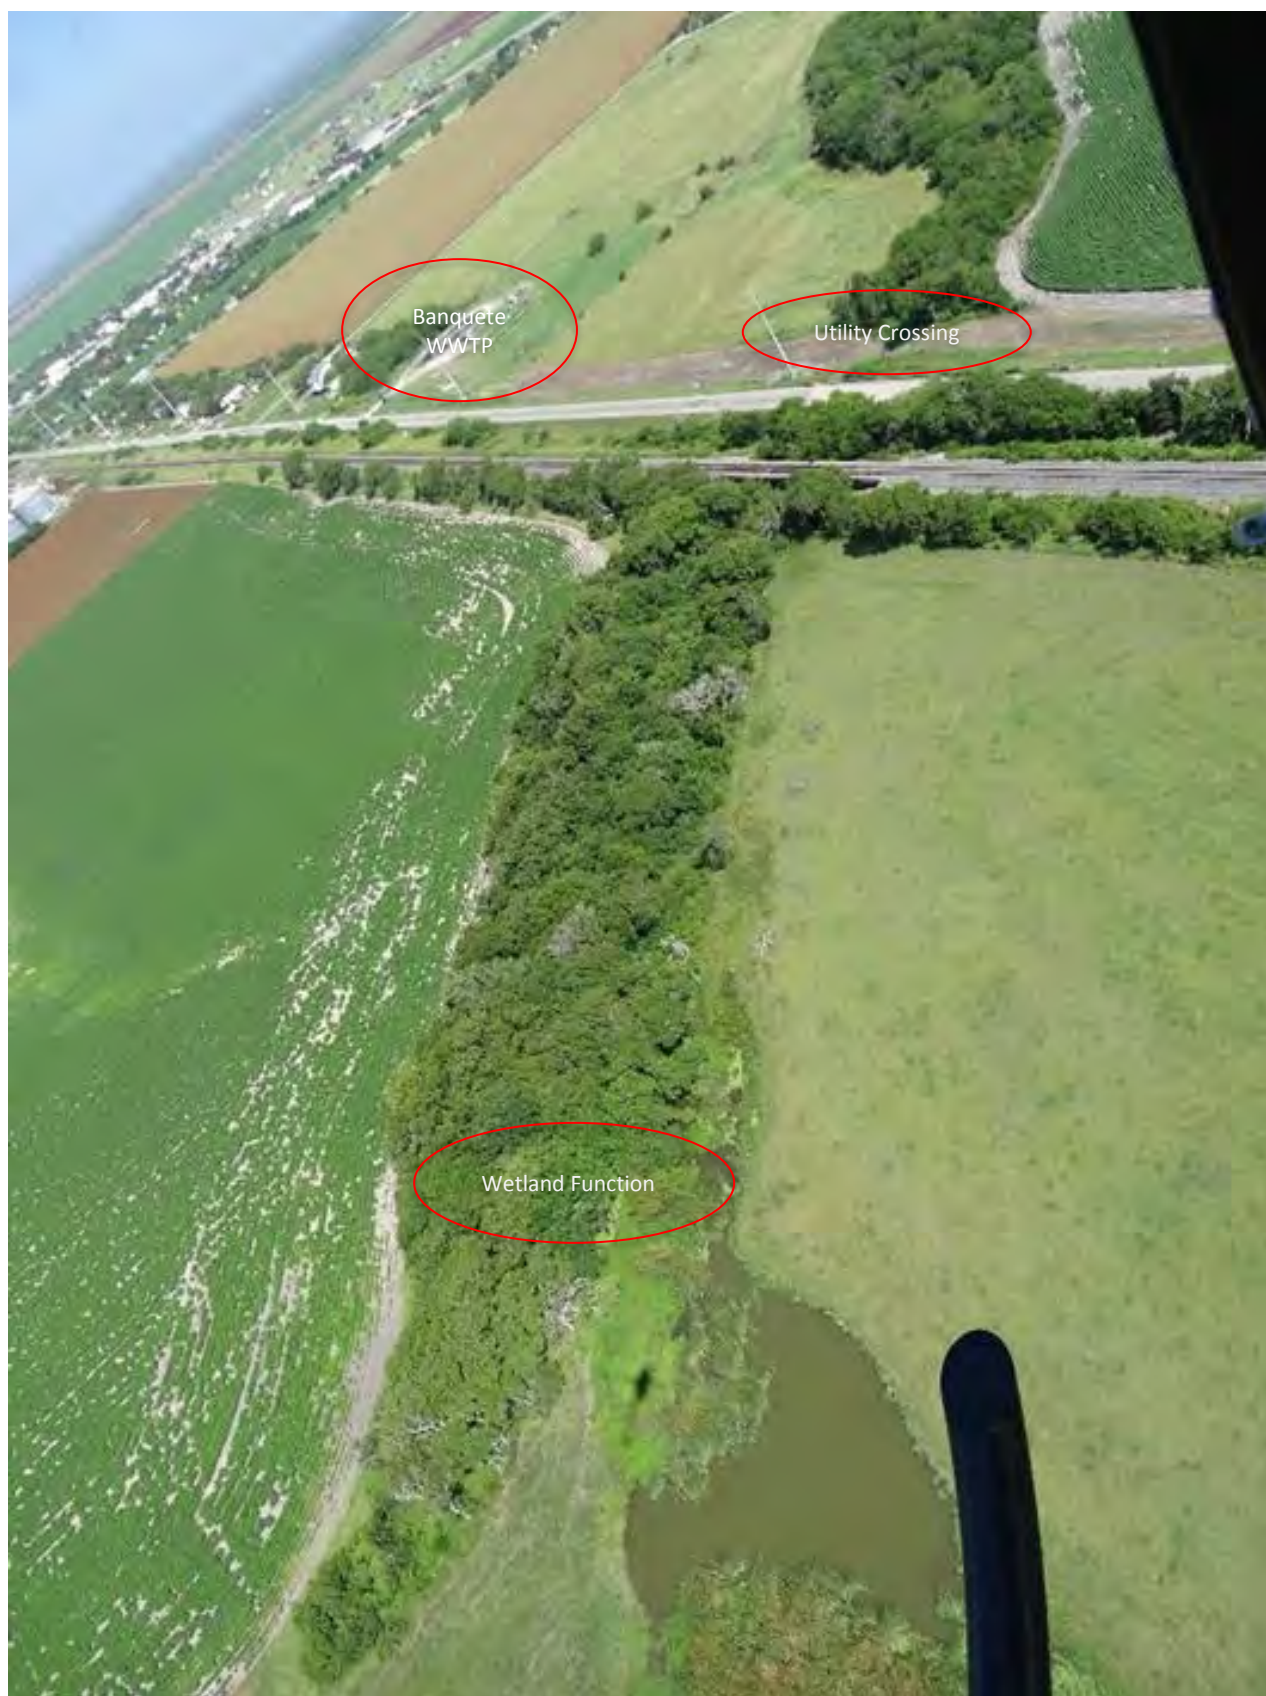
**Figure 88** Image illustrates the wetland-like conditions observed at the mouth of Banquete Creek about .1 mile below TX Hwy 40.

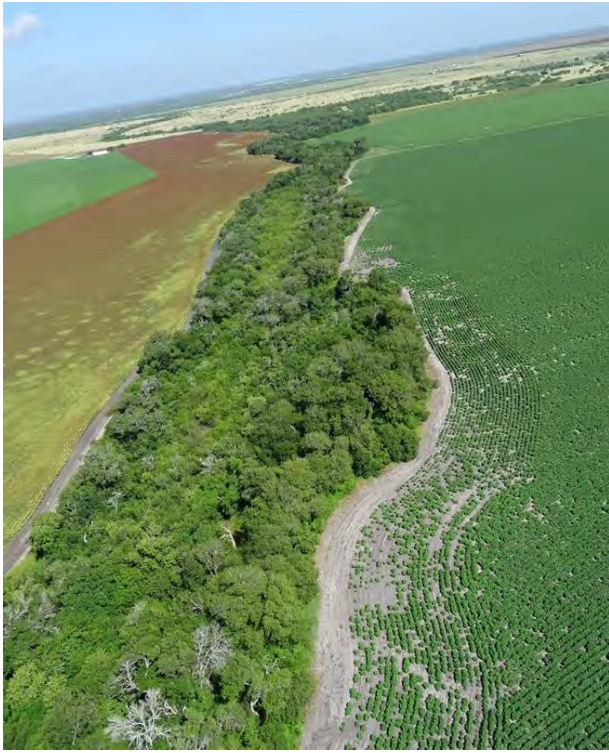
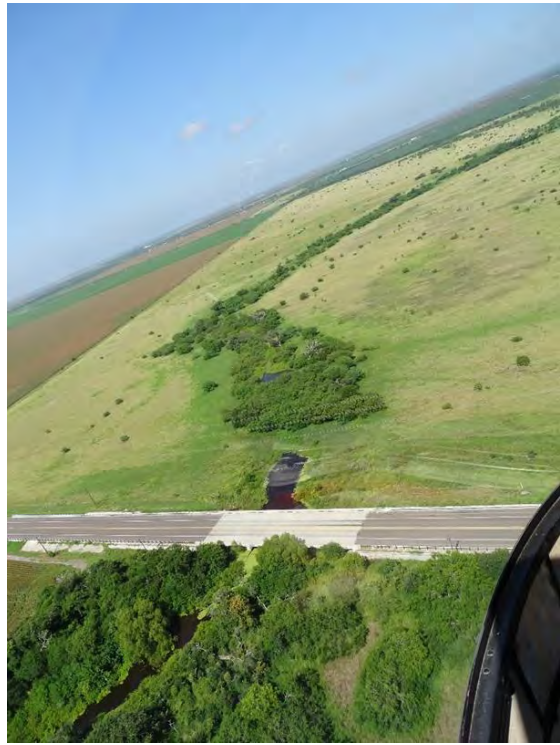
**Figure 89** Heavily wooded riparian area and water color within this functional area are pictured here. About 1.5 miles of wooded functional riparian area was observed over the 7.4 mile-long Banquette Creek.

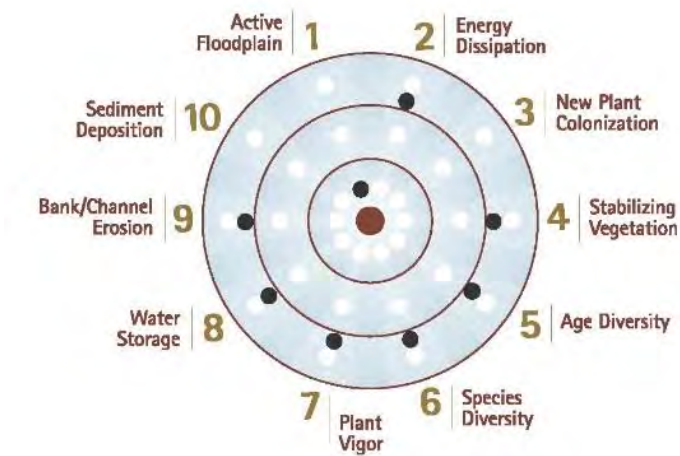
**Figure 92** Bull's-Eye evaluation target for Banquete Creek.

Observed hindrances include; farming too close and artificial manipulation of the creek bed and banks.

Work with landowners to provide incentives to address identified hindrances. Clean water could be a valuable “crop” for producers. Farmers could be paid to plant and maintain riparian vegetation for water quality benefits in downstream creeks and bays.

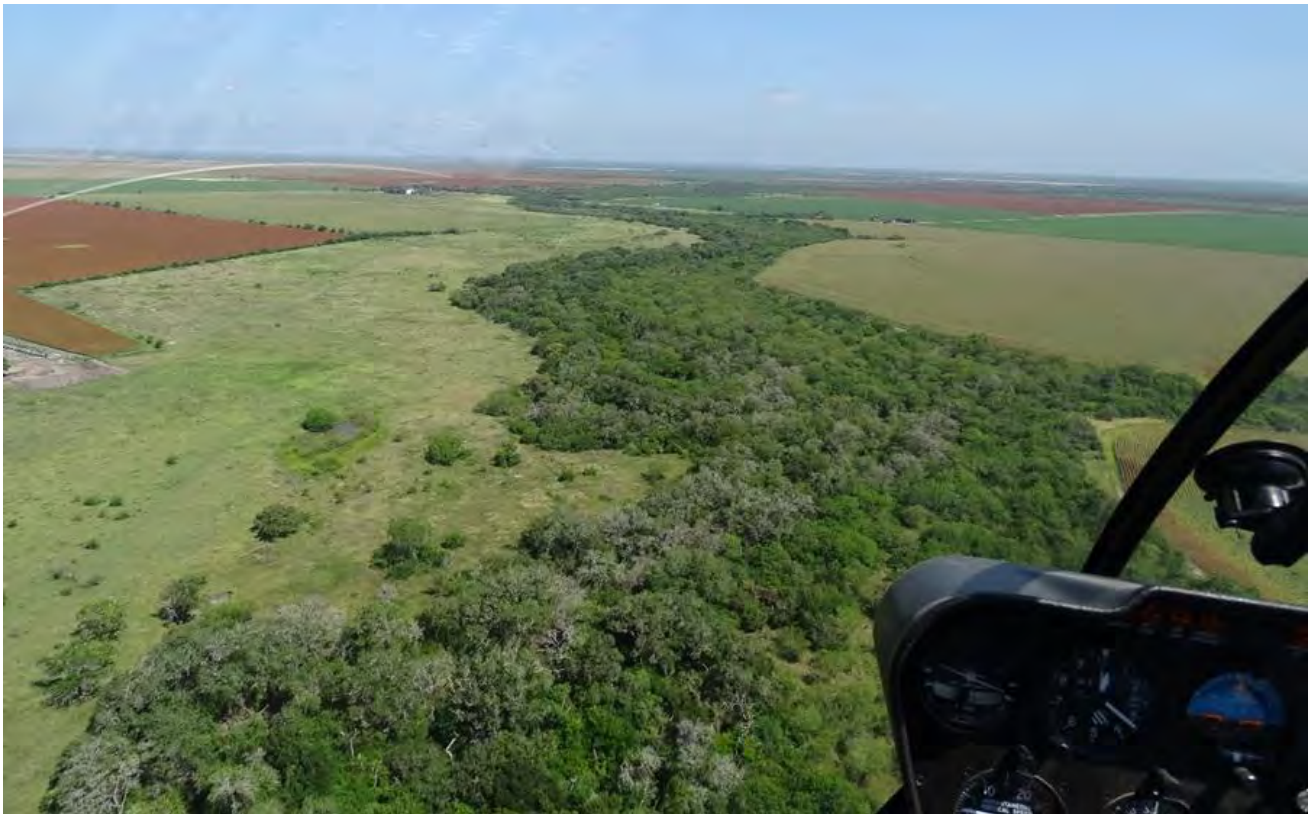
**Figure 94** This image shows the wide, forested and functional riparian area along lower reach of Aqua Dulce Creek.

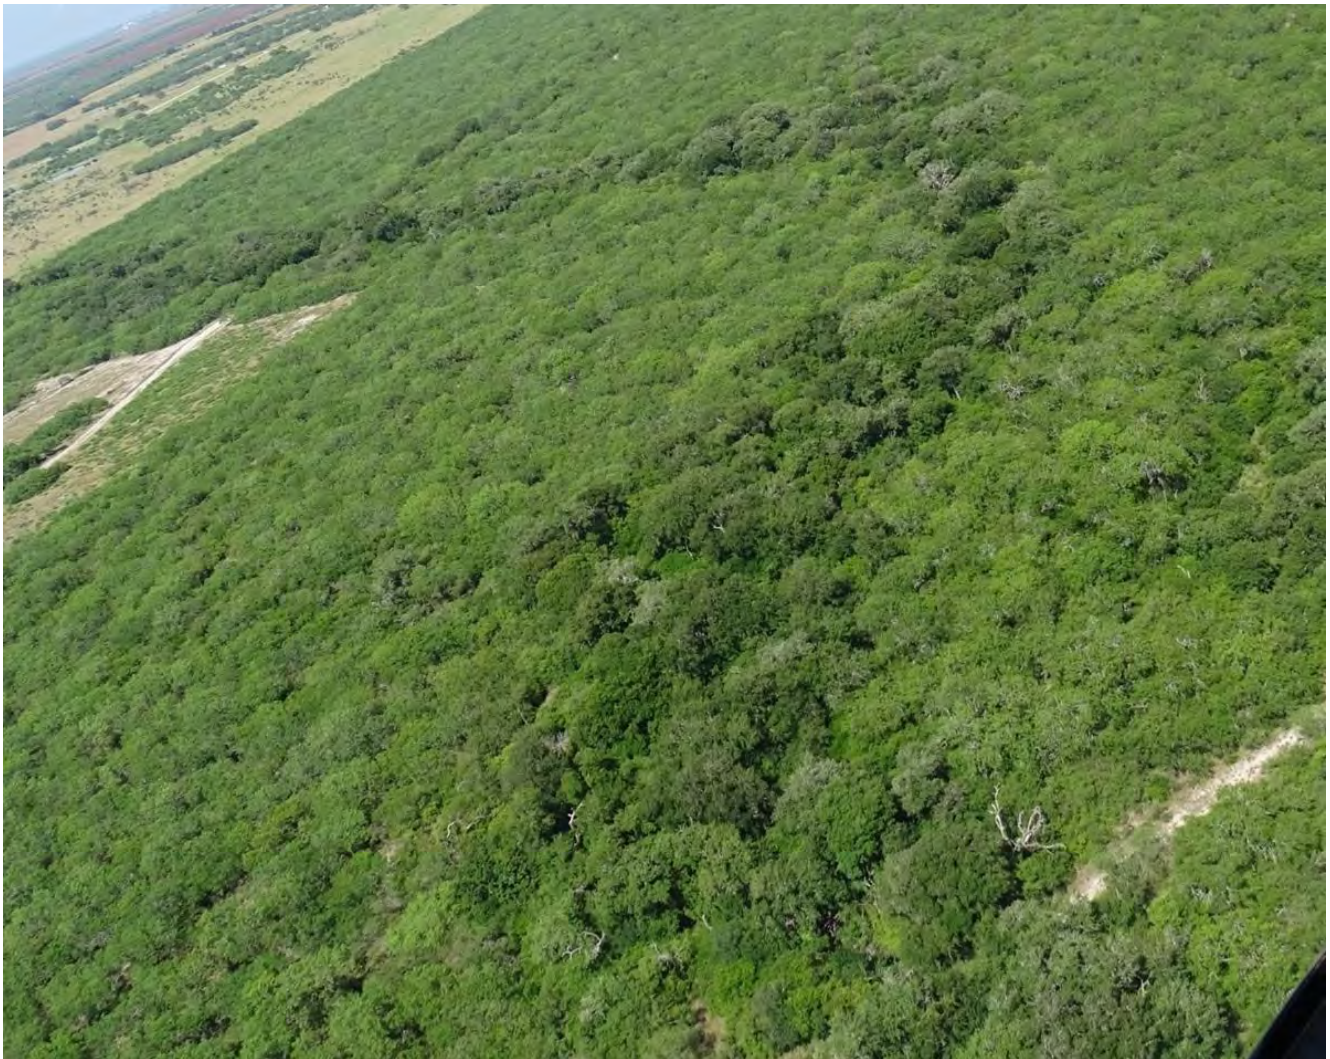
**Figure 97** Near the head of Aqua Dulce lower reach, the stream is completely shrouded in large woody plants. The creek water is not visible from the air.

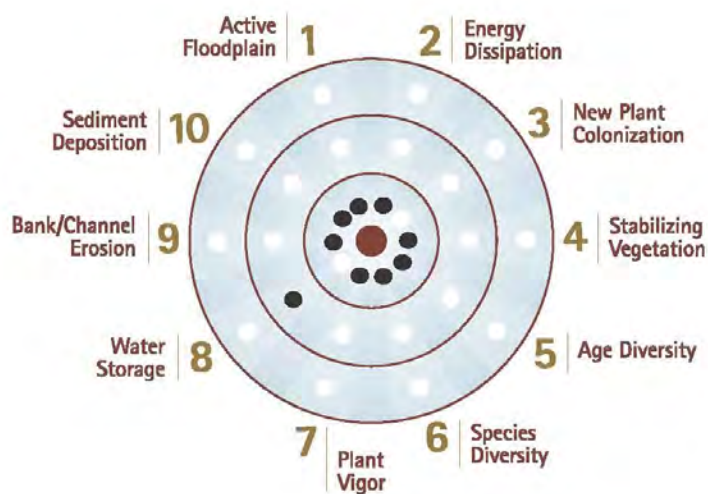
**Figure 98** Bull's-Eye evaluation target for Aqua Dulce Creek Lower Reach.

Water quality seems to be influenced by Las Quintas Creek where muddy turbid and nutrient-enriched conditions were observed.

- 1) Work with landowners to reward the current stewardship; protect and document the functional riparian condition along Aqua Dulce Creek.
- 2) Work with willing landowners to convert farmland to functional wetlands/riparian areas to help improve water quality in the vicinity of the confluence with Las Quintas Creek.

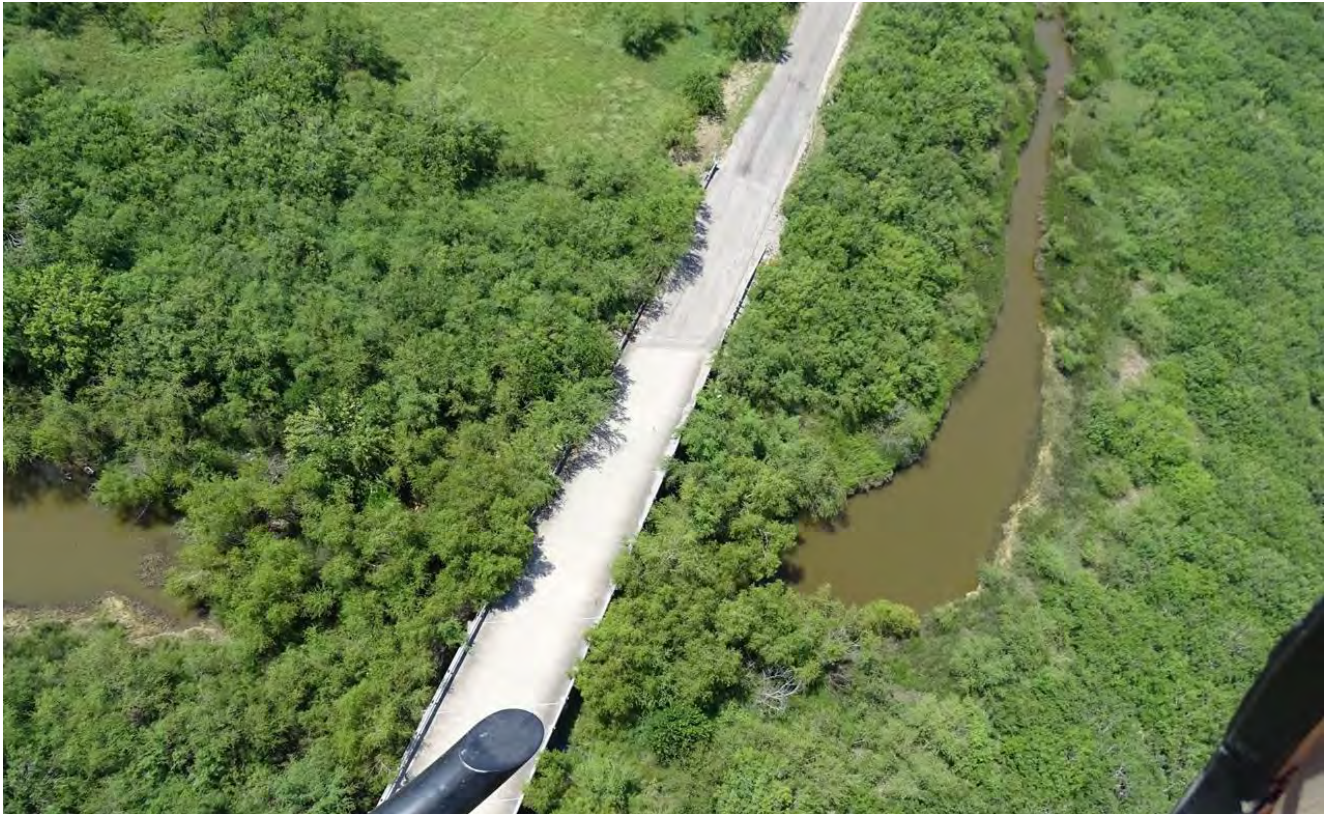
**Figure 102** Image shows the riparian condition on Pintas Creek at Texas Hwy 85 crossing. The creek is heavily wooded and riparian area highly functional.

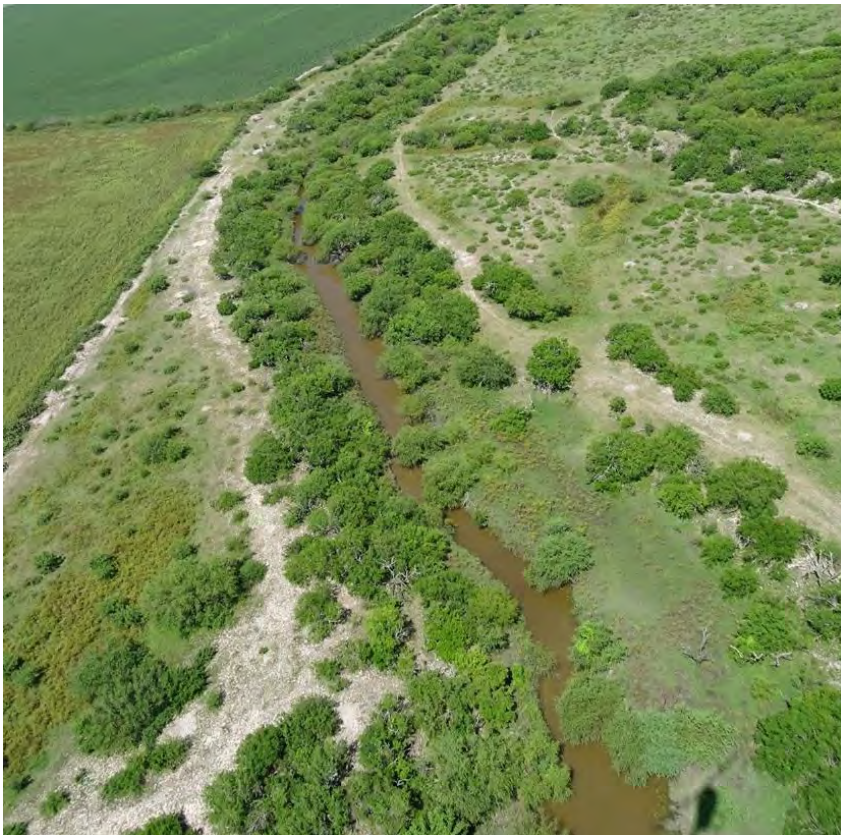
**Figure 103** Image illustrates the riparian condition along most of Pintas Creek.

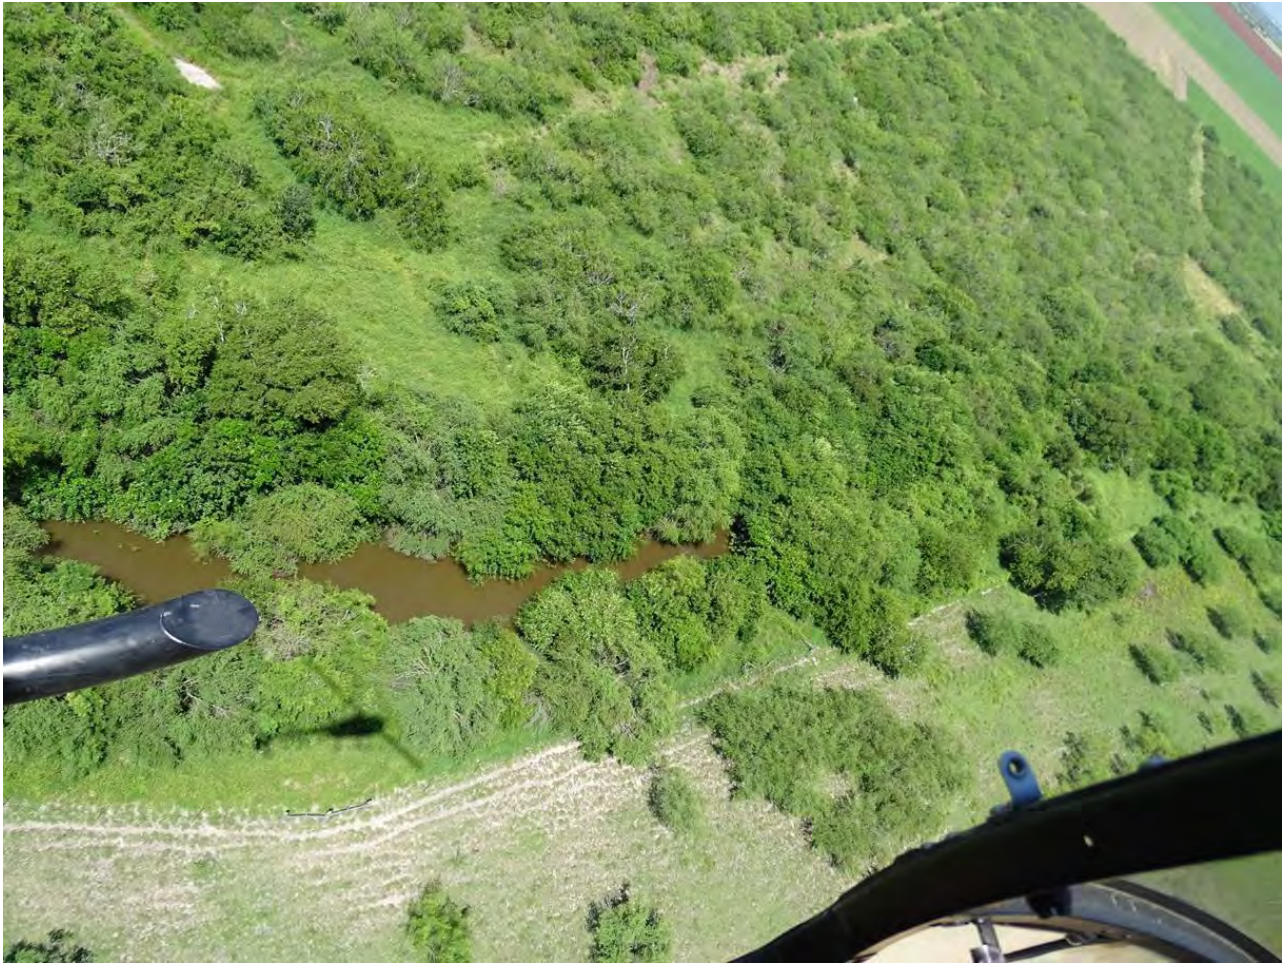
**Figure 104** This image illustrates the management of the riparian area along Pintas Creek to keep grazing livestock from hindering the riparian function along the creek.

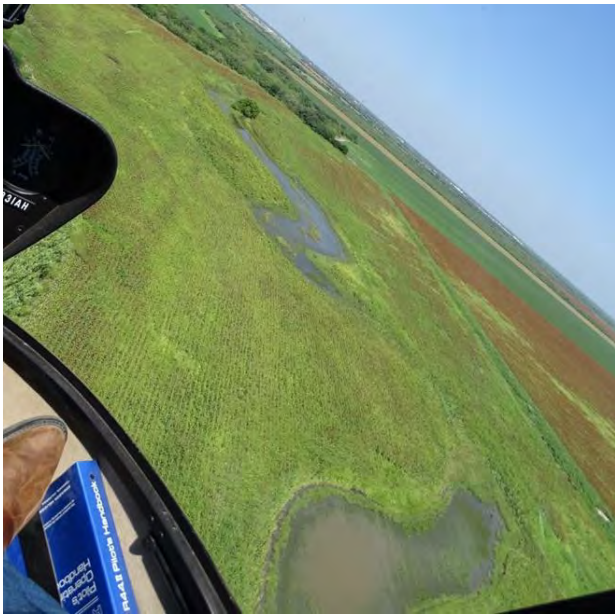
**Figure 105** This image shows an abandoned or secondary over-flow channel of Pintas Creek. Overflow channels with high functioning riparian areas can provide water quality benefits by capturing and incorporating sediments from floodwaters. The over-flow channel pictured here does not offer much riparian benefit.

- 1) Work with landowners to reward the current stewardship; protect and document the functional riparian condition along Pintas Creek.
- 2) Work with willing landowners to convert farmland to functional wetlands/riparian areas where abandoned or alternative flow paths cross existing fields.

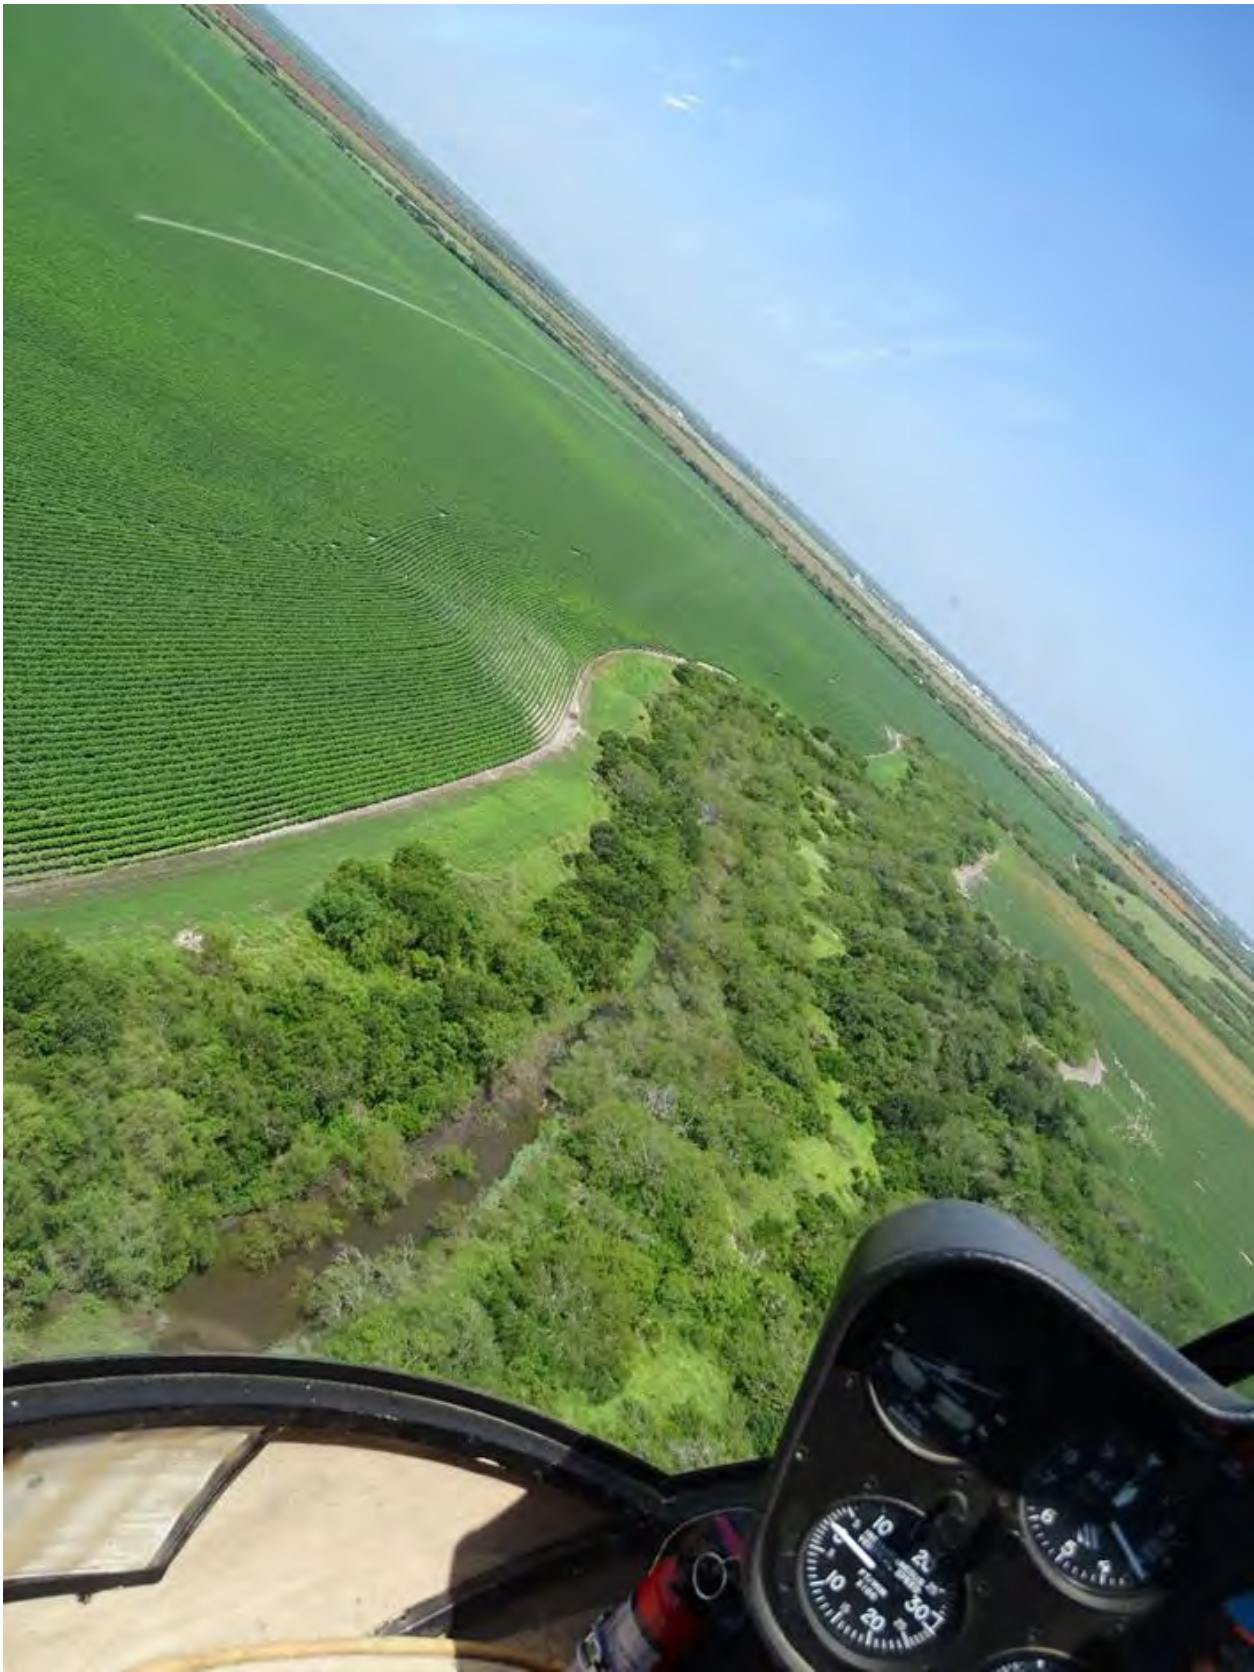
**Figure 106** Near the top of Pintas Creek the riparian area retains its woody functional condition.

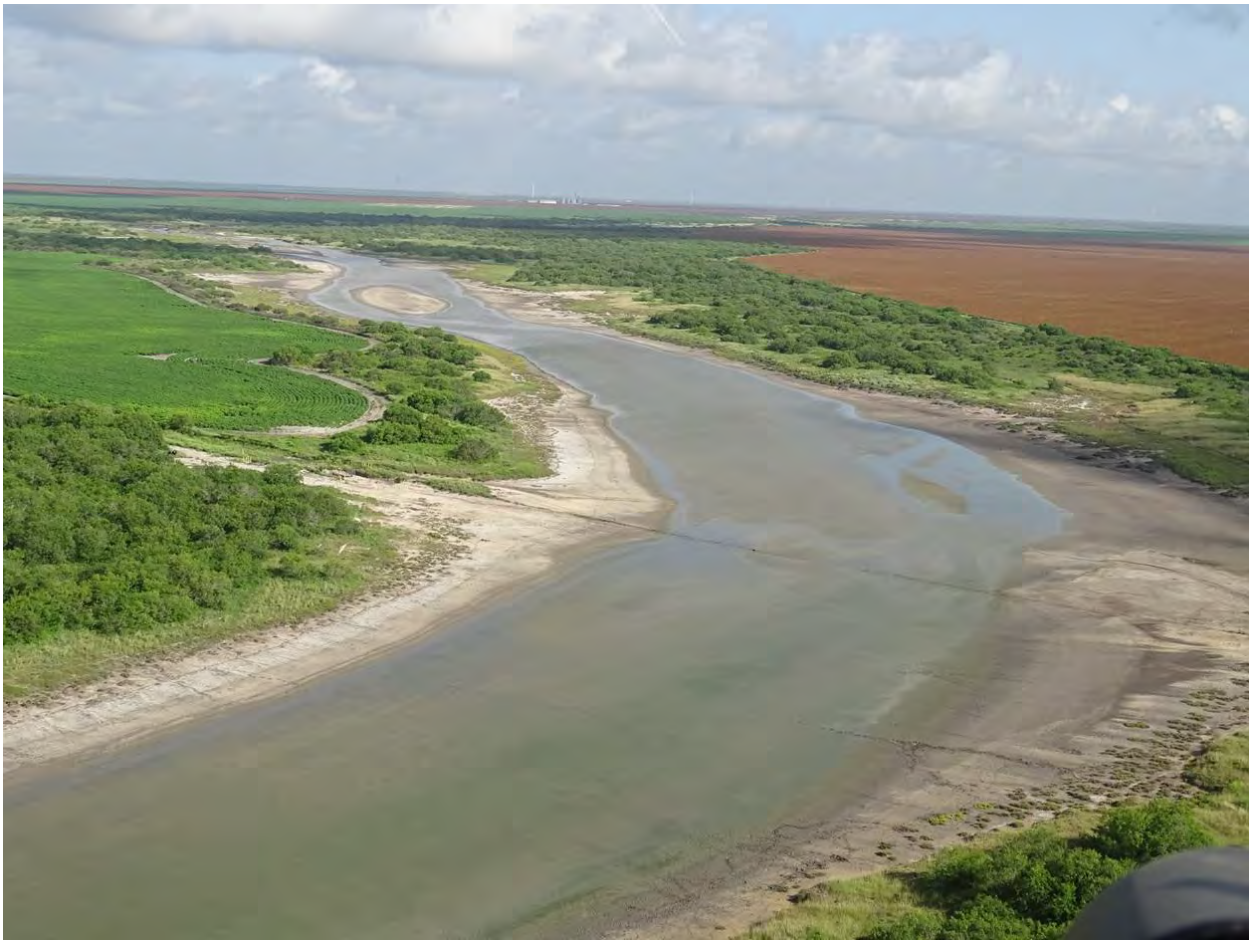
**Figure 109** Image shows wide functional riparian area flanking Los Tunas Creek at its mouth in the Cayo del Mazon. Farming activities are set back from the creek, and the wide floodplain is well vegetated.

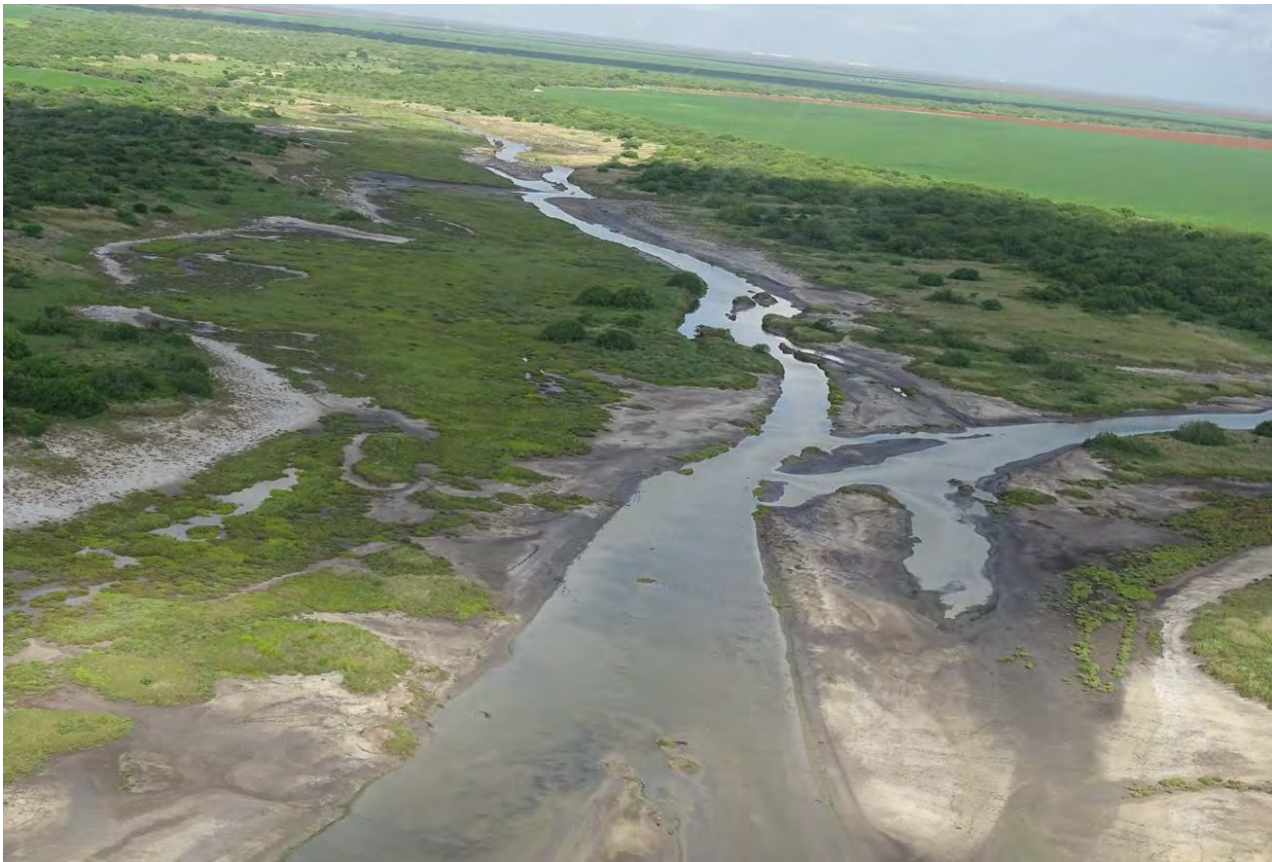
**Figure**

**110** Image shows wide functional riparian area flanking Los Tunas Creek at the confluence of Chiltipin Creek. Farming activities are set back from the creek, and the wide floodplain is well vegetated.

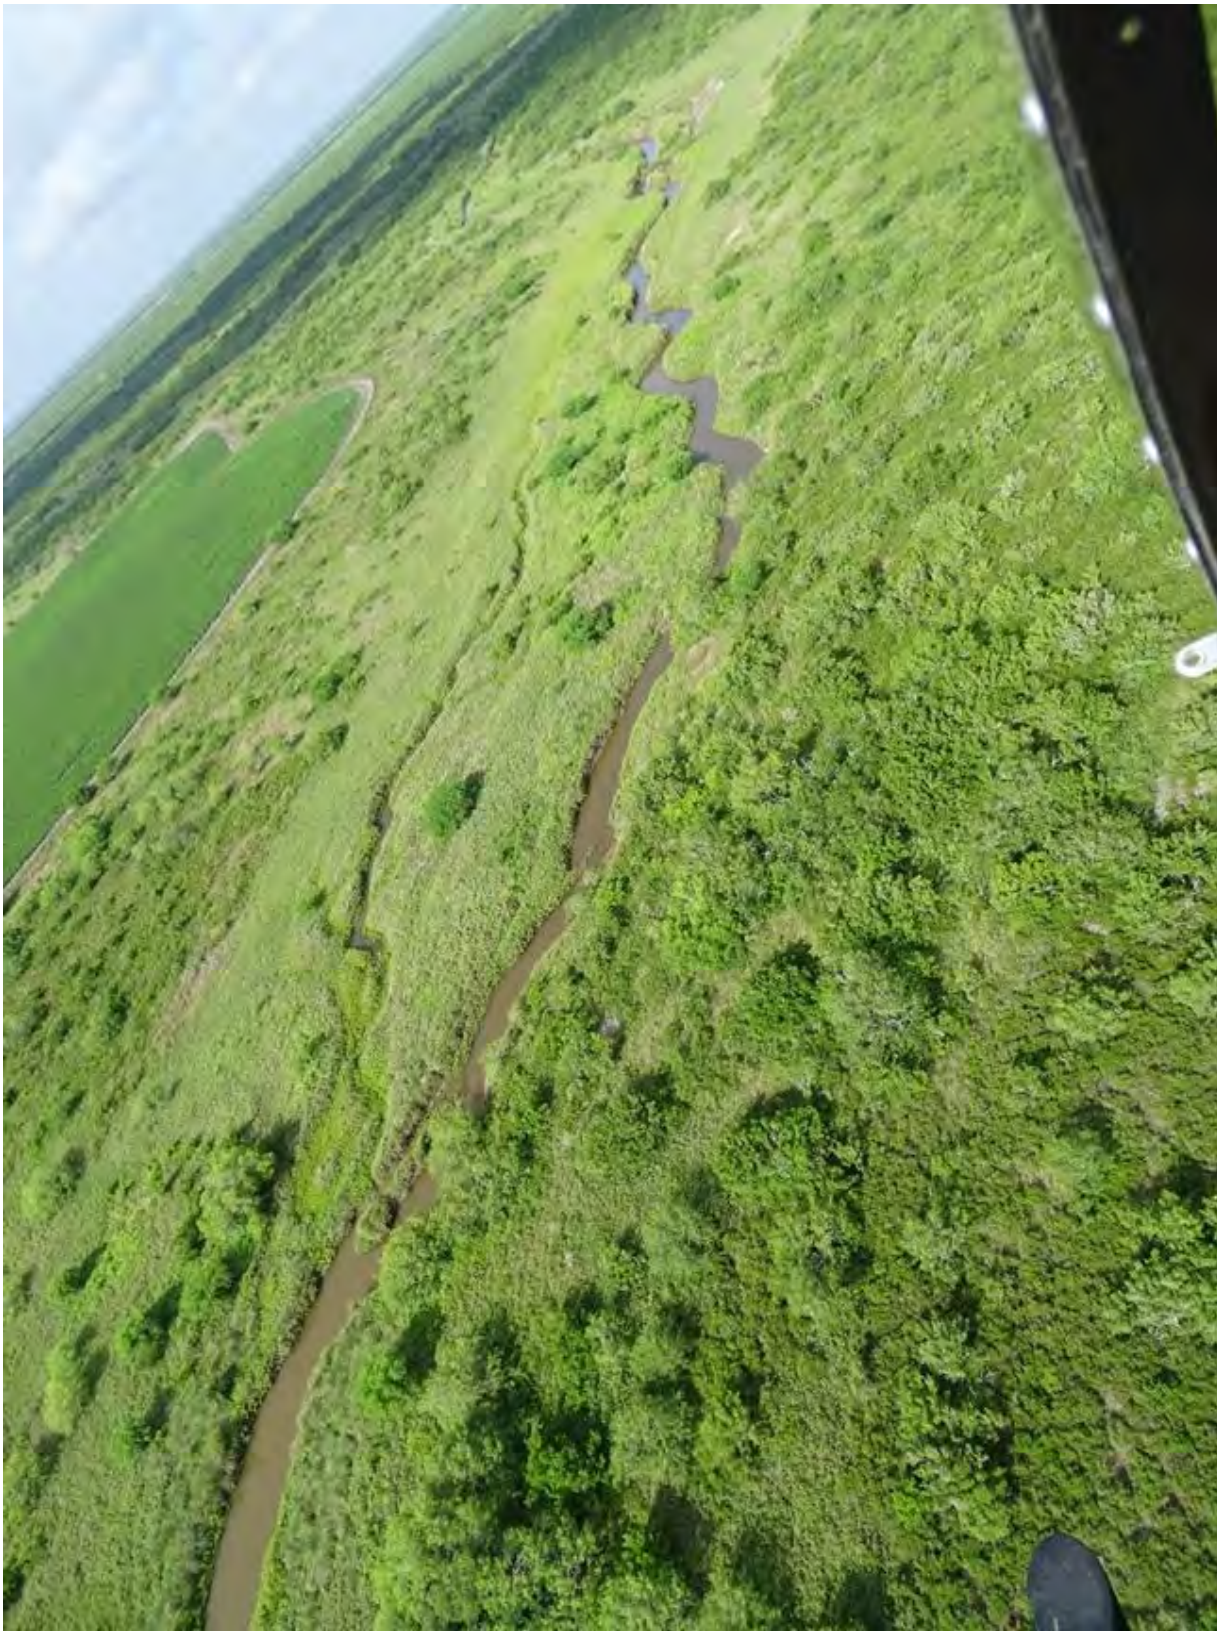
**Figure 111** Image shows wide functional riparian area flanking Los Tunas Creek further upstream. Cordgrass and other native riparian plants form a thick water-holding, sediment-trapping matt across a more than 2,000-foot-wide riparian area. Farming activities are set back from the creek and its floodplain.

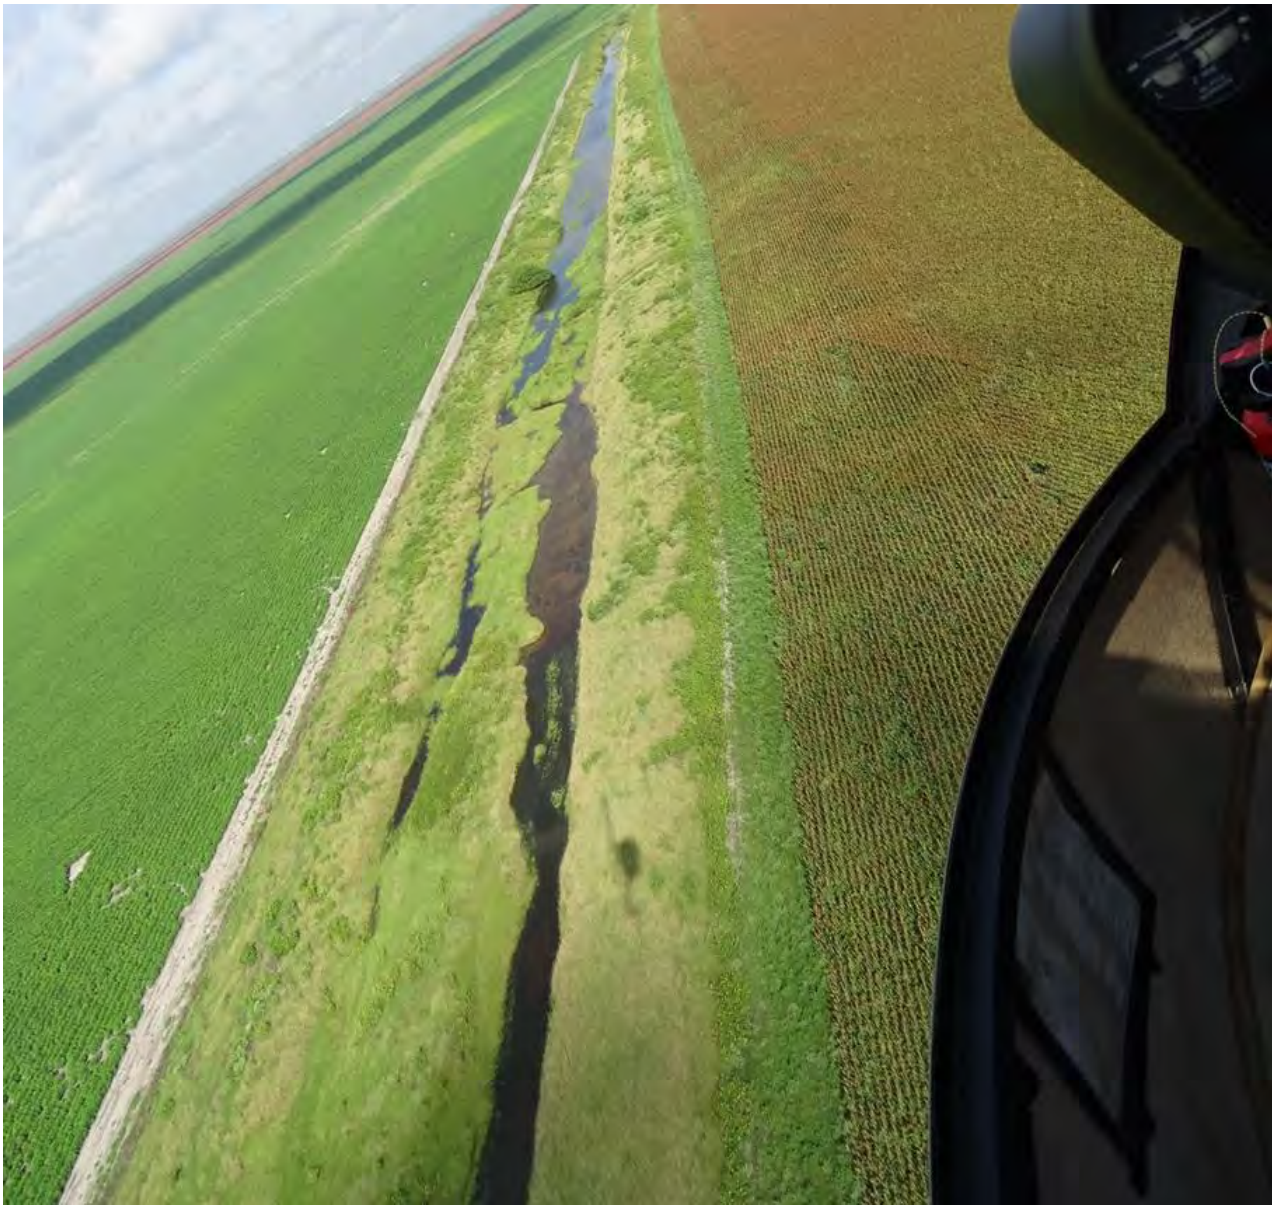
**Figure 113** *Despite channelization, the creek retains some of its riparian function with floodplain access and stabilizing vegetation covering the banks.*

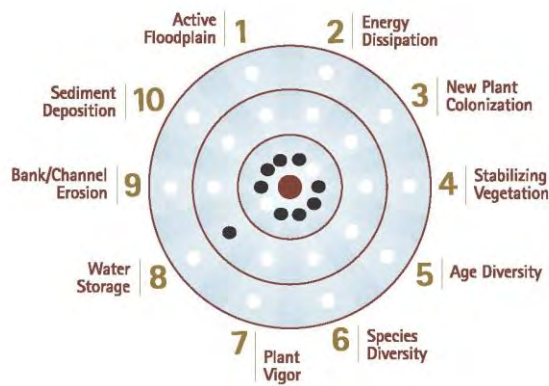
**Figure 114** Bull's-Eye evaluation target for Los Tunas Creek.

- Channelization of creek into a ditch-like drain way
- Poorly designed crossing that acts as gradient control structure, creating erosive energy with inadequate energy dissipation

- 1) Work with landowners to reward the current stewardship; protect and document the functional riparian condition along Los Tunas Creek.
- 2) Work with willing landowners to expand the setback along the upper six miles of the creek to allow for the development of meander.
- 3) Work with landowners to replace/restore road crossings to allow for energy dissipation, gradient equalization, and the free transport of sediment.

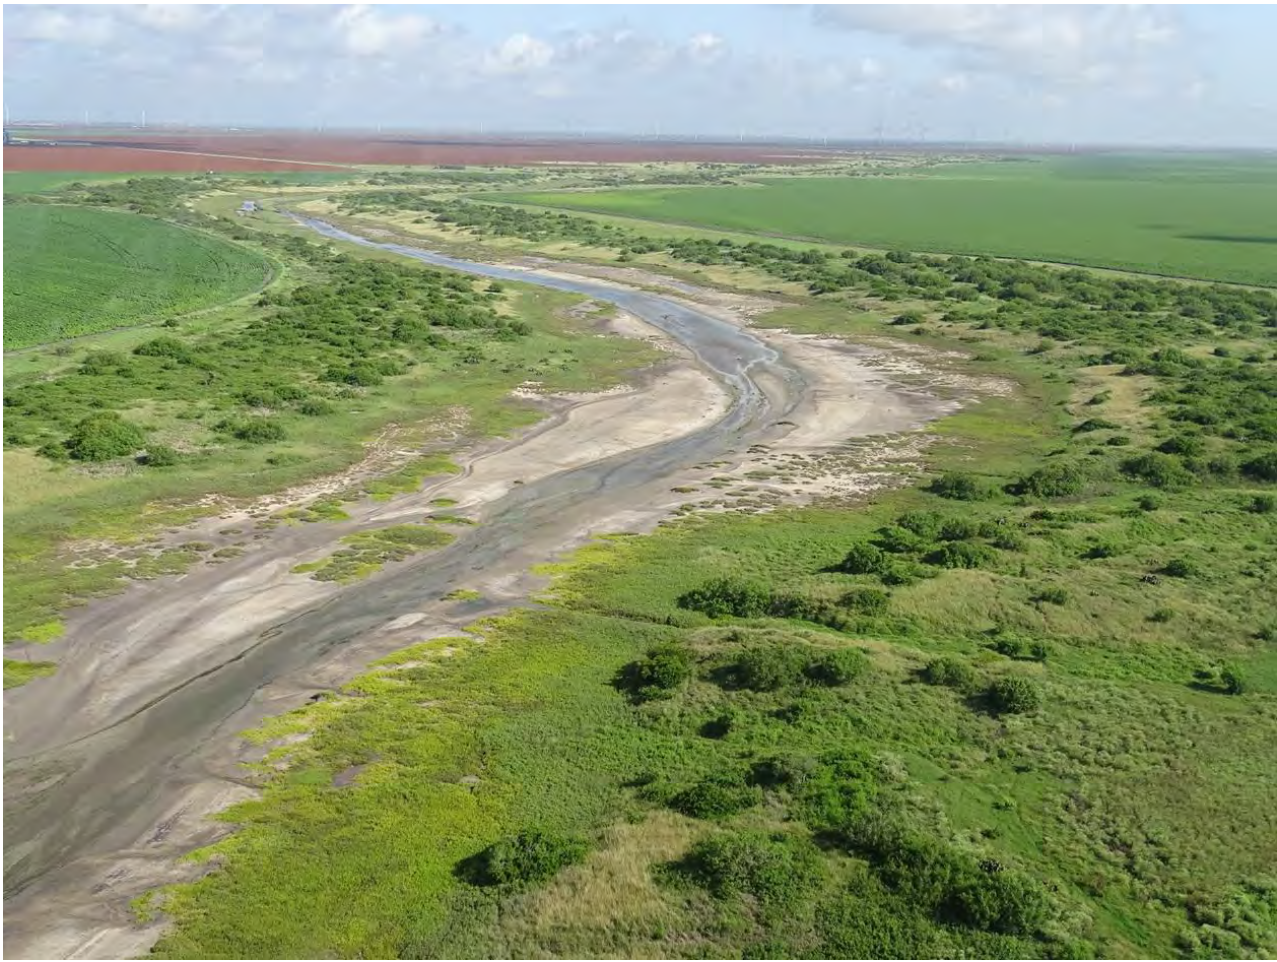
**Figure 116** Image shows wide functional riparian area flanking Chiltipin Creek near its confluence with Los Tunas Creek. Farming activities are set back from the creek, and the wide floodplain is well vegetated.

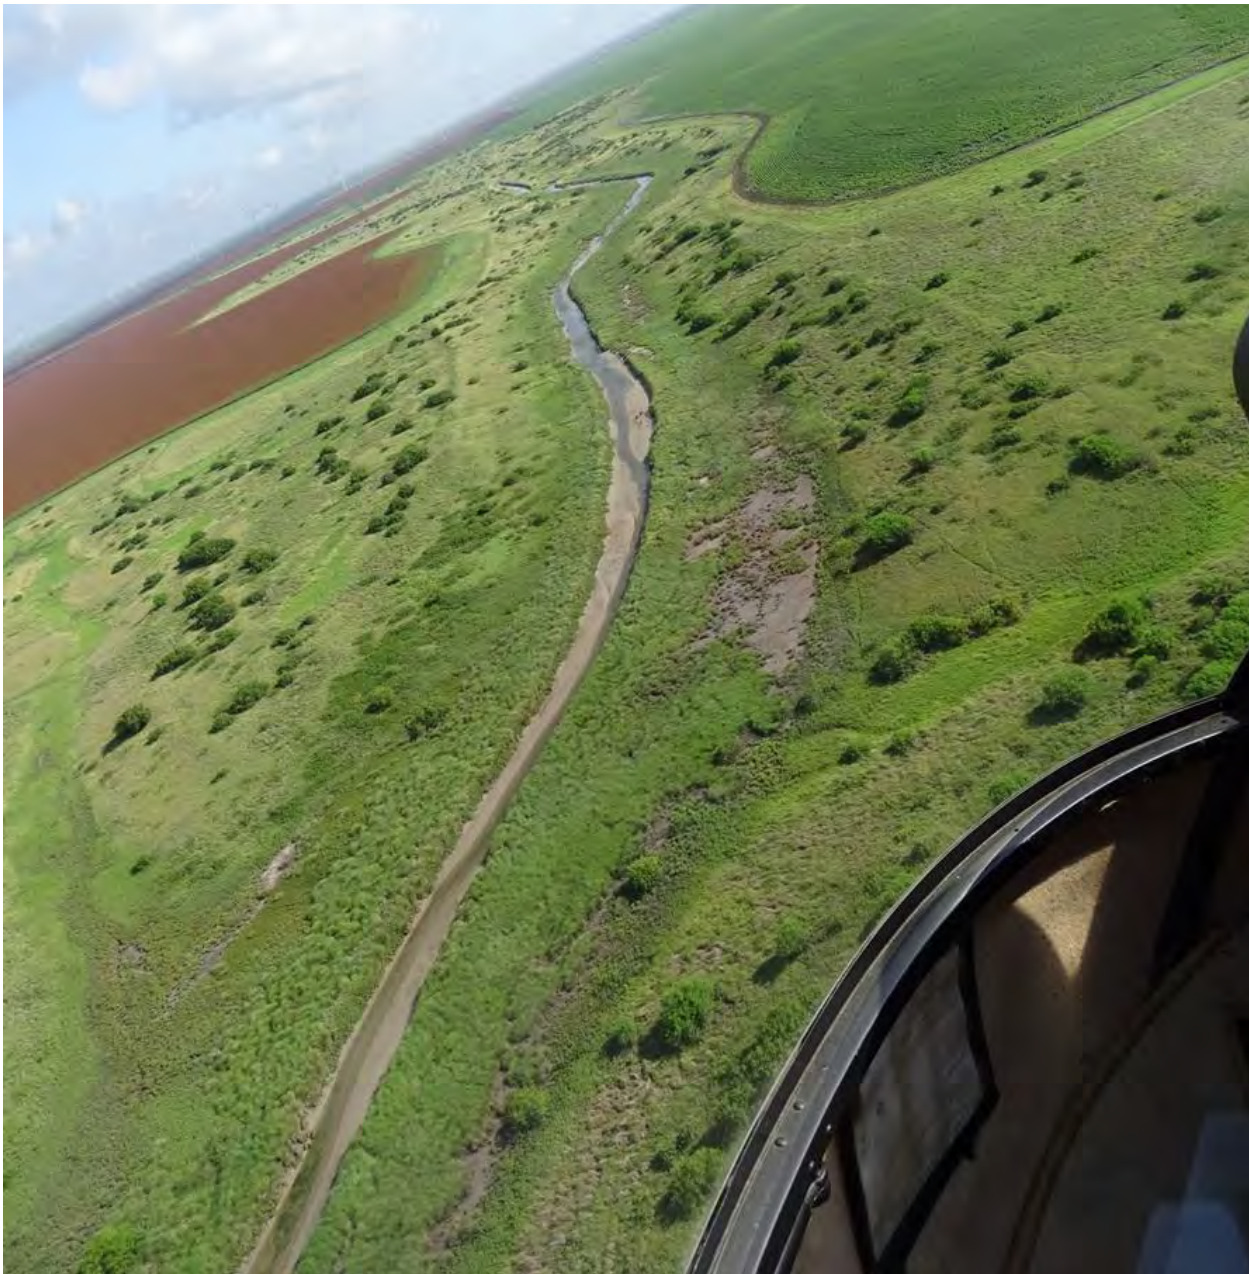
**Figure 117** Further upstream the riparian area becomes narrower. Farming activities are closer to the creek but the floodplain remains well vegetated.

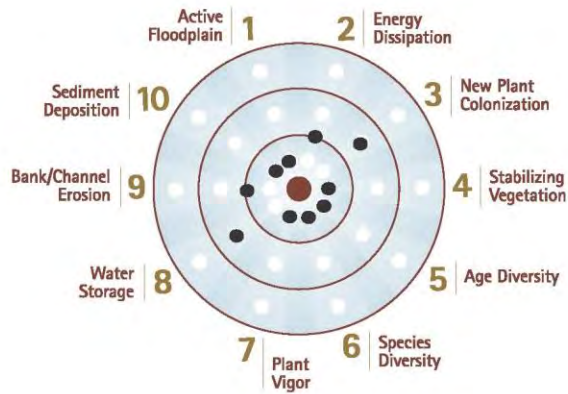
**Figure 120** Bull's-Eye evaluation target for Chiltipin Creek.

1. **Floodplain access.** The creek appears to have access to its floodplain.
2. **Energy dissipation.** An abundance of energy-dissipating features were observed in the channel and on the banks in the lower section of the creek, but upstream energy dissipation is reduced.

3. **New plant colonization.** In some areas new sediments are present and are being colonized.
4. **Stabilizing vegetation.** The creek has an abundance of stabilizing riparian vegetation (Spiny aster SR8, Cordgrass SR9), but woody plants are missing from the upper channelized reaches.

5. **Age diversity and reproduction of riparian vegetation.** All age groups were observed.
6. **Species diversity of riparian vegetation.** More than five native riparian plants were observed.

10. **Sediment deposition.** Normal and balanced sediment deposition were observed within this reach.

- 1) Work with landowners to reward the current stewardship; protect and document the functional riparian condition along Chiltipin Creek.
- 2) Work with willing landowners to expand the setback along the upper six miles of the creek to allow for the development of meander.
- 3) Work with landowners to replace/restore road crossing to allow for energy dissipation, gradient equalization, and the free transport of sediment.
