## **Riparian Evaluation for Baffin Bay Tributaries**

Final Report

Publication CBBEP – 132

August 2019

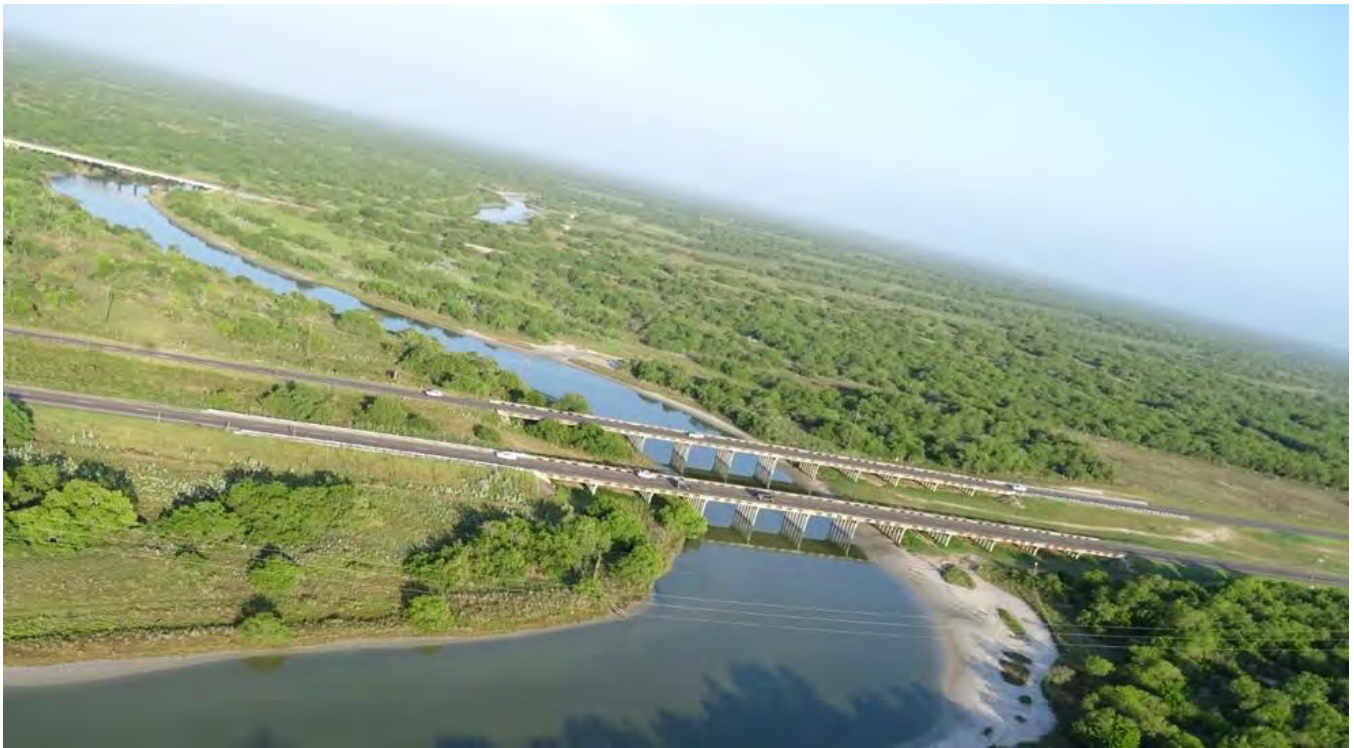
**Figure 122** Image shows wide functional riparian area flanking the lower reach of Los Olmos Creek at the U.S. Hwy 77. Livestock grazing activities are set back from the creek, and the wide floodplain is well vegetated.

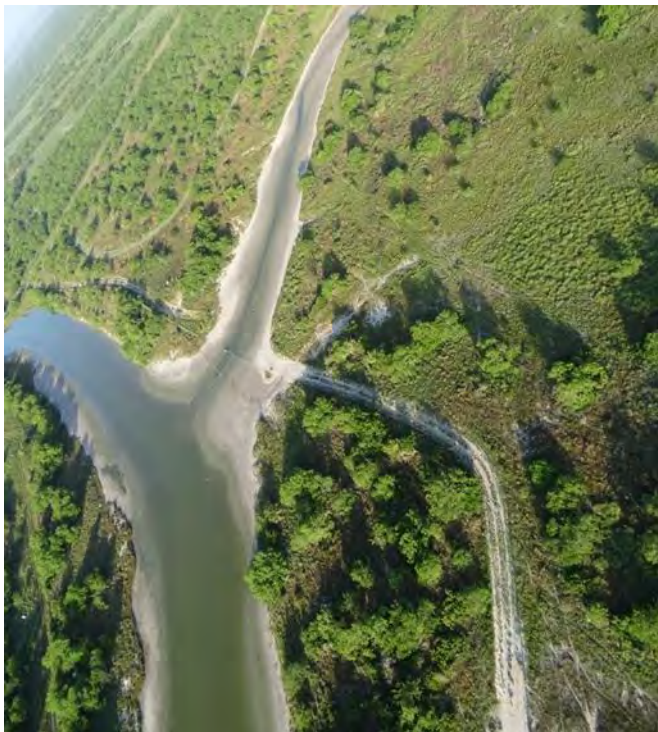
**Figure 123** Image show highly functional riparian areas along the lower reach of Los Olmos Creek at the confluence of Salado Creek. Banks are well vegetated in what appears to be Cordgrass with Retama and Mesquite. A fringe of algae is visible along the channel edge.

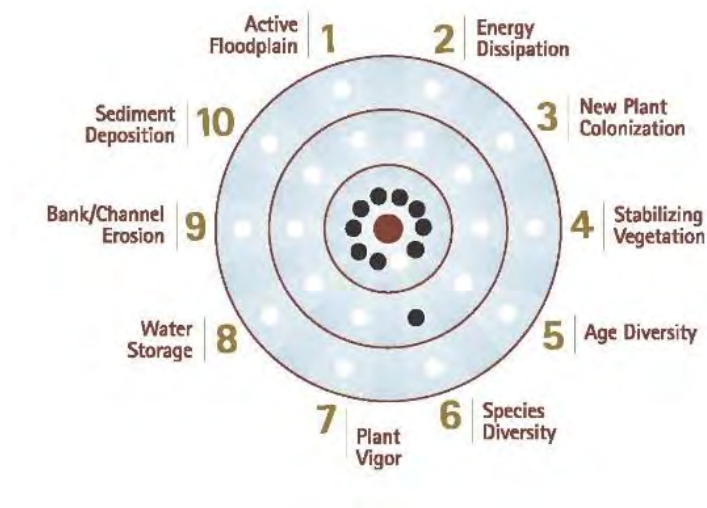
**Figure 124** Bull's-Eye evaluation target for lower reach of Los Olmos Creek.

3. **New plant colonization.** New plants were observed colonizing fresh sediments at the channel margins.
4. **Stabilizing vegetation.** Banks are covered with stabilizing vegetation. (Marshhay/Gulf cordgrass SR9, Retama SR6)

5. **Age diversity and reproduction of riparian vegetation.** All age groups were observed.
6. **Species diversity of riparian vegetation.** Only two native riparian plants were identified, however it is likely that 1 to 2 more are present. Overall, species diversity is moderate.

7. **Plant vigor.** Riparian plants appear healthy and vigorous with no signs of heavy grazing, mowing, trampling or browsing.
8. **Water storage.** A few OBL and FACW plant species were observed both at the water's edge and on the floodplain. (Marshhay/Gulf cordgrass FACW/OBL, Retama FACW)

9. **Bank and channel erosion.** Erosion and deposition appear balanced, and channel size and shape appear of size and depth to manage sediment.
10. **Sediment deposition.** Normal and balanced sediment deposition were observed within this reach.

Work with landowners to reward the current stewardship; protect and document the functional riparian condition along the lower reach of Los Olmos Creek.

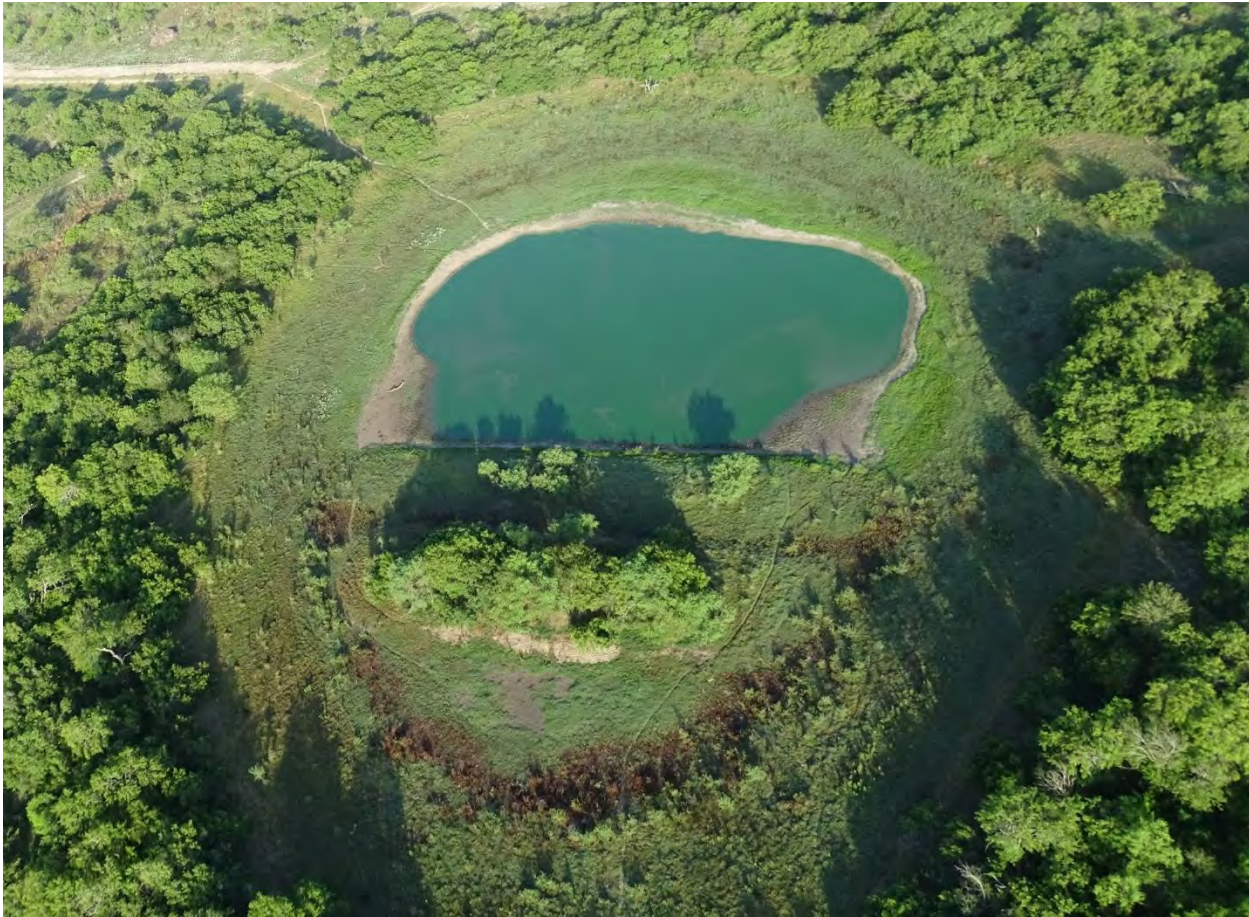
**Figure 129** The pond shown in this image appears to be nutrient-rich and may be in communication with Salado Creek.

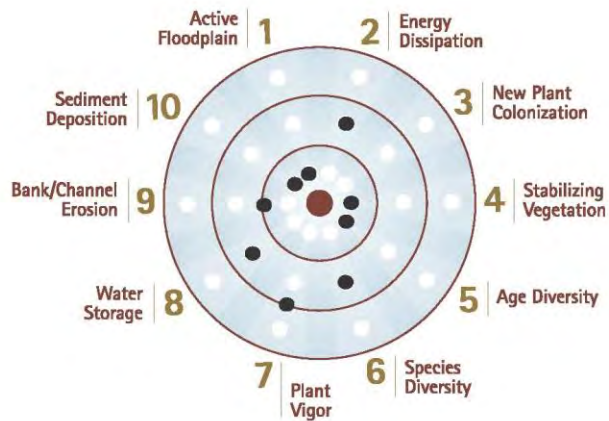
**Figure 130** Bull's-Eye evaluation target for Salado Creek.

1. **Floodplain access.** The creek appears to have unimpeded access to its floodplain throughout the reach.
2. **Energy dissipation.** The channel, banks and floodplain host an abundance of energy-dissipating features, but their energy-dissipating ability has been impaired by reduced vigor.
3. **New plant colonization.** NA No sediment deposition was observed.

4. **Stabilizing vegetation.** Banks are covered with stabilizing vegetation. (Marshhay/Gulf cordgrass SR9, Spiny aster SR8)
5. **Age diversity and reproduction of riparian vegetation.** The riparian grasses noted may be remnants of older populations. Young cordgrass and even aster can be palatable.

7. **Plant vigor.** Riparian plants appear trampled with some signs of heavy grazing and browsing in the area.
8. **Water storage.** A few OBL and FACW plant species were observed both at the water's edge and on the floodplain. (Marshhay/Gulf cordgrass FACW/OBL, Spiny aster FACW, Retama FACW)

- 1) Work with landowners to control grazing in the riparian areas along Salado Creek and allow vegetation to grow along the entire length of the creek.
- 2) Work with the community of Rivera to focus on the WWTP discharge as a valuable resource to be utilized for wildlife and water quality benefit. Consider possible off-channel wetlands for tertiary treatment for the purpose of improving water quality in the creek before it reaches the bay.
