# **Mapping Potential Habitat Restoration Sites to Restore Hydrologic Connectivity**

Annual Report

Publication CBBEP – 137

Report by the International Crane Foundation for the Coastal Bend Bays & Estuaries Program  
CBBEP No. 1918  
12-09-2019

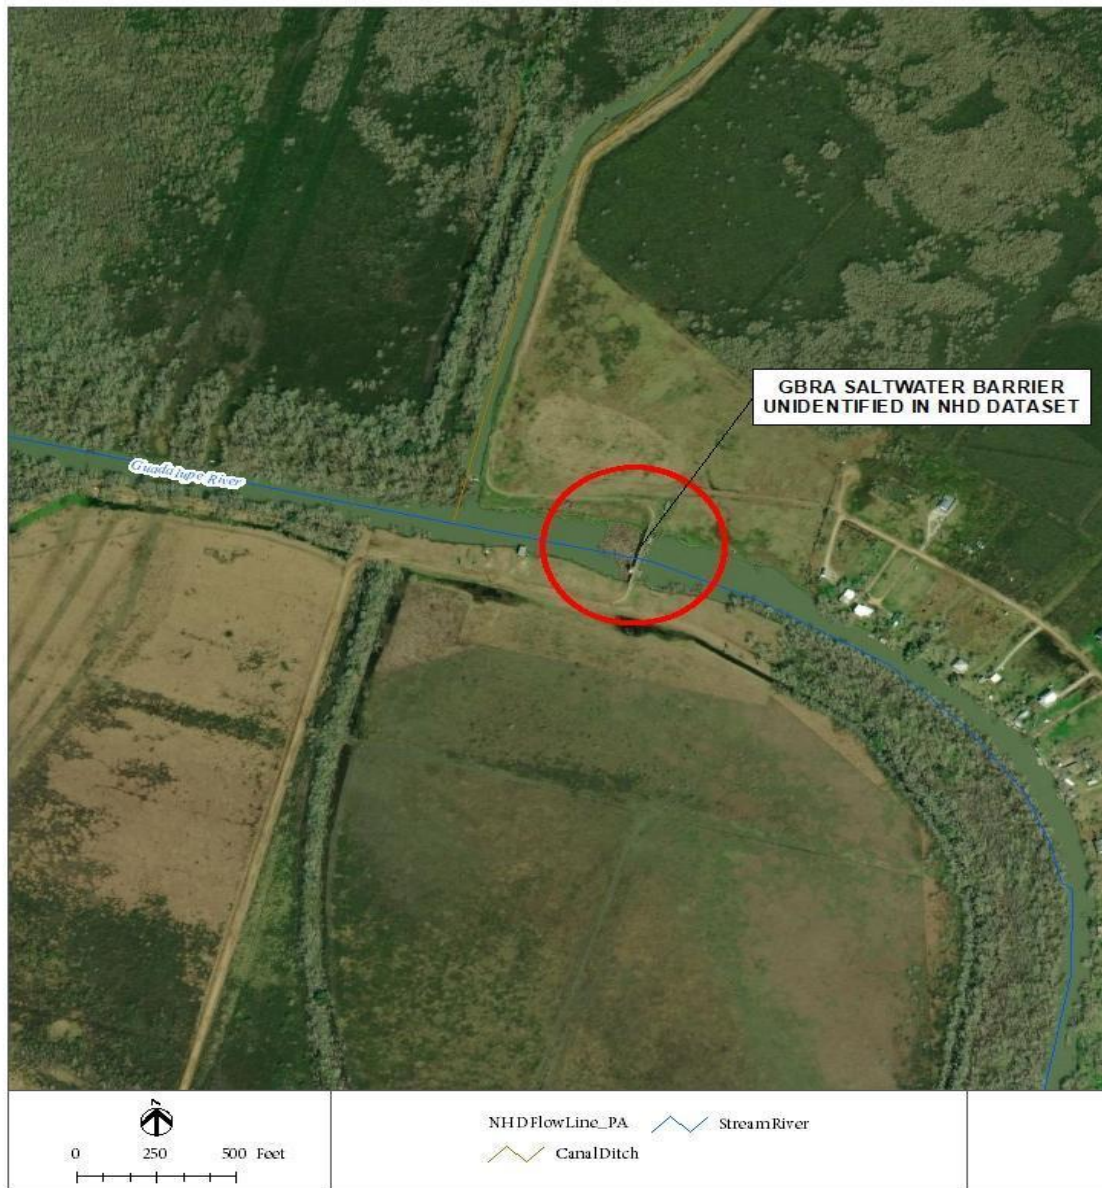
Figure 4. Example of unidentified dam on the lower Guadalupe River.

Since the NWI and NHD datasets are mapped at a large scale, imperfections occur at the regional level. For example, multiple man-made modifications to the landscape, such as ditches, canals, and earthen dams or levees, located within the CBBEP study area are not identified in the NWI or NHD datasets. A good example is the Guadalupe Blanco River Authority (GBRA) saltwater barrier located in the lower Guadalupe River. This water management feature is not identified as a dam, gate, weir, or other type of hydrologic feature in the NHD datasets (Figure 4).

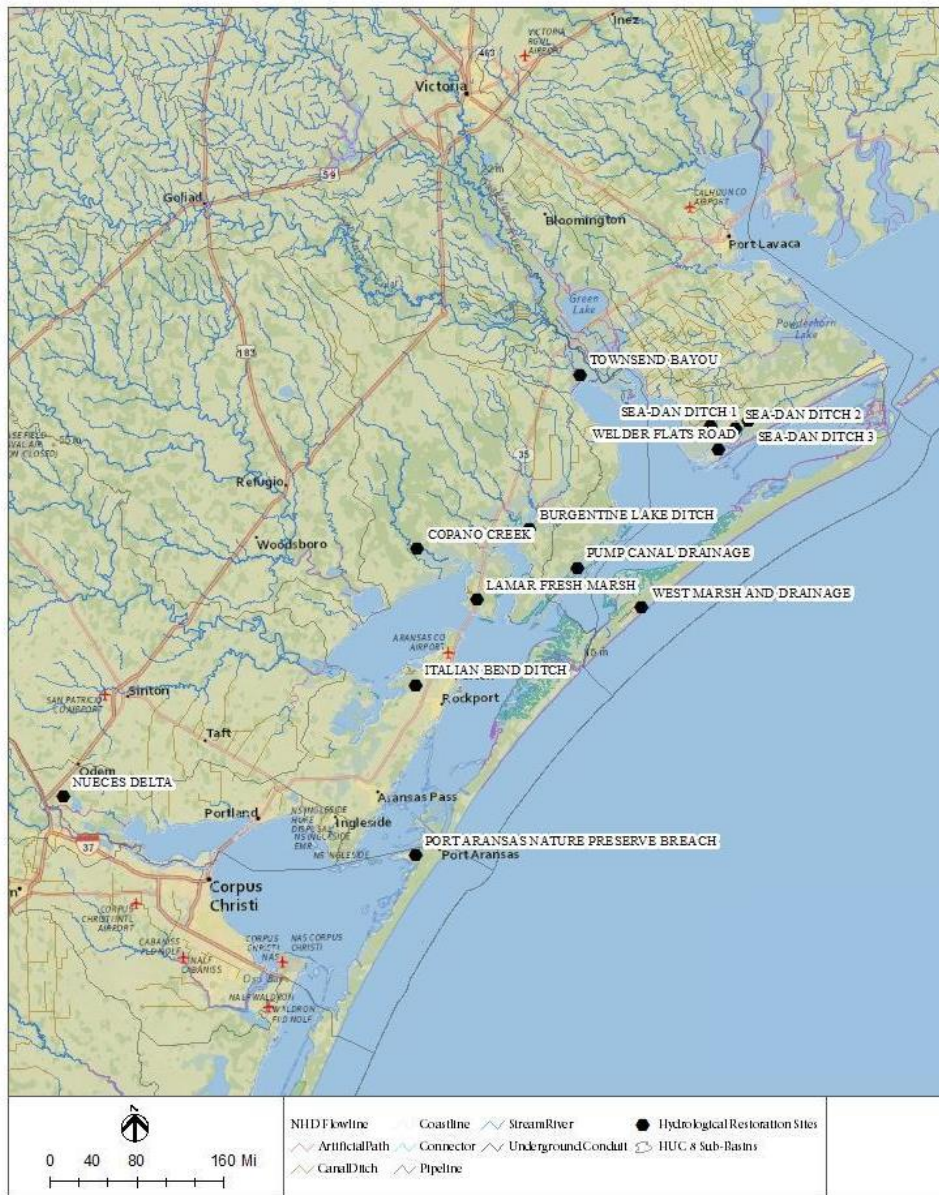
Figure 8. Newly identified hydrologic restoration sites within the study area.

The International Crane Foundation (ICF) met with multiple stakeholders individually to review and identify areas within the CBBEP area they recommend hydrologic restoration occur to improve ecosystem function. Stakeholder involvement included the San Antonio Bay Partnership, the U.S. Fish and Wildlife Service's (USFWS's) Aransas National Wildlife Refuge (ANWR), USFWS's Gulf Restoration Program, Texas Parks and Wildlife Department and the Coastal Bend Bays & Estuaries Program. Potential restoration activities could include small to large efforts, such as replacing inept culverts under a single road or rerouting drainage ditches across a larger landscape. CBBEP stakeholders for restorative action have recommended ten hydrologic sites located within seven different sub-basins (Figure 8). A summary of the hydrologic sites and relevant characteristics, such as approximate restoration acres, size range, complexity, and number of landowners is included in Table 2.

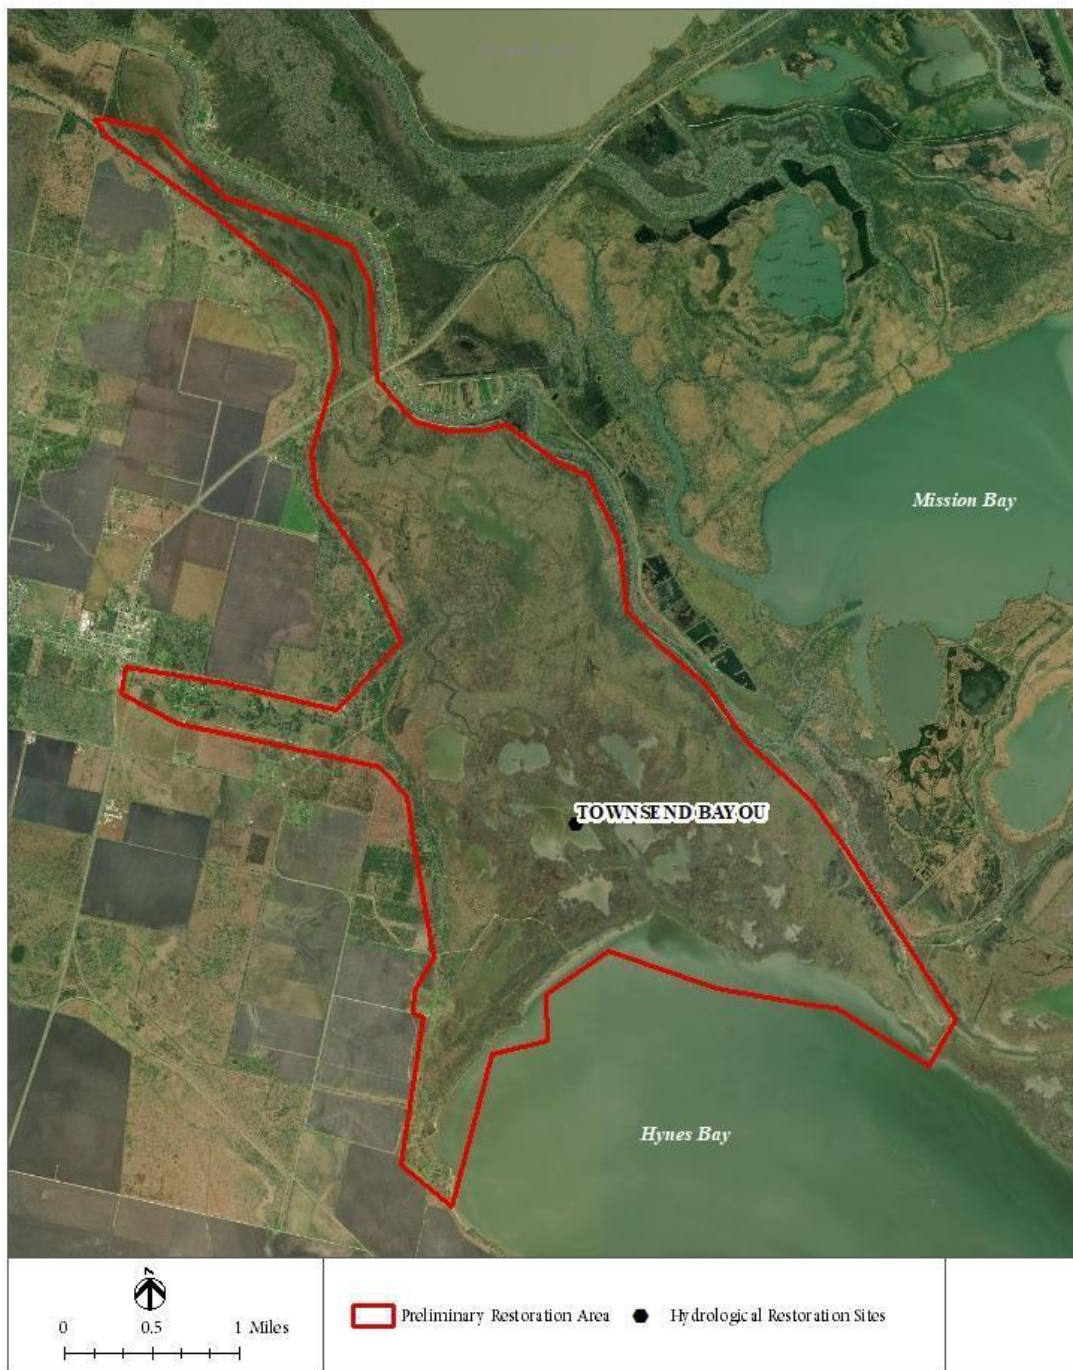
Figure 10. Aerial imagery at Townsend Bayou located along Hynes Bay in the Guadalupe River Delta area of San Antonio Bay.

A portion of Townsend Bayou is located within the Hynes Bay Unit of the Guadalupe Delta Wildlife Management Area in the West San Antonio Bay sub-basin (HUC 12100404) (Figure 10). Townsend Bayou is mapped as a stream by the NHD Flowline dataset (Figure 10A). The stream flows into Hynes Bay, a secondary bay that is part of the San Antonio Bay estuary system. Townsend Bayou is characterized as having expansive brackish- and saltwater ponds and marshes (Tremblay and Calnan 2011) (Figure 10B).

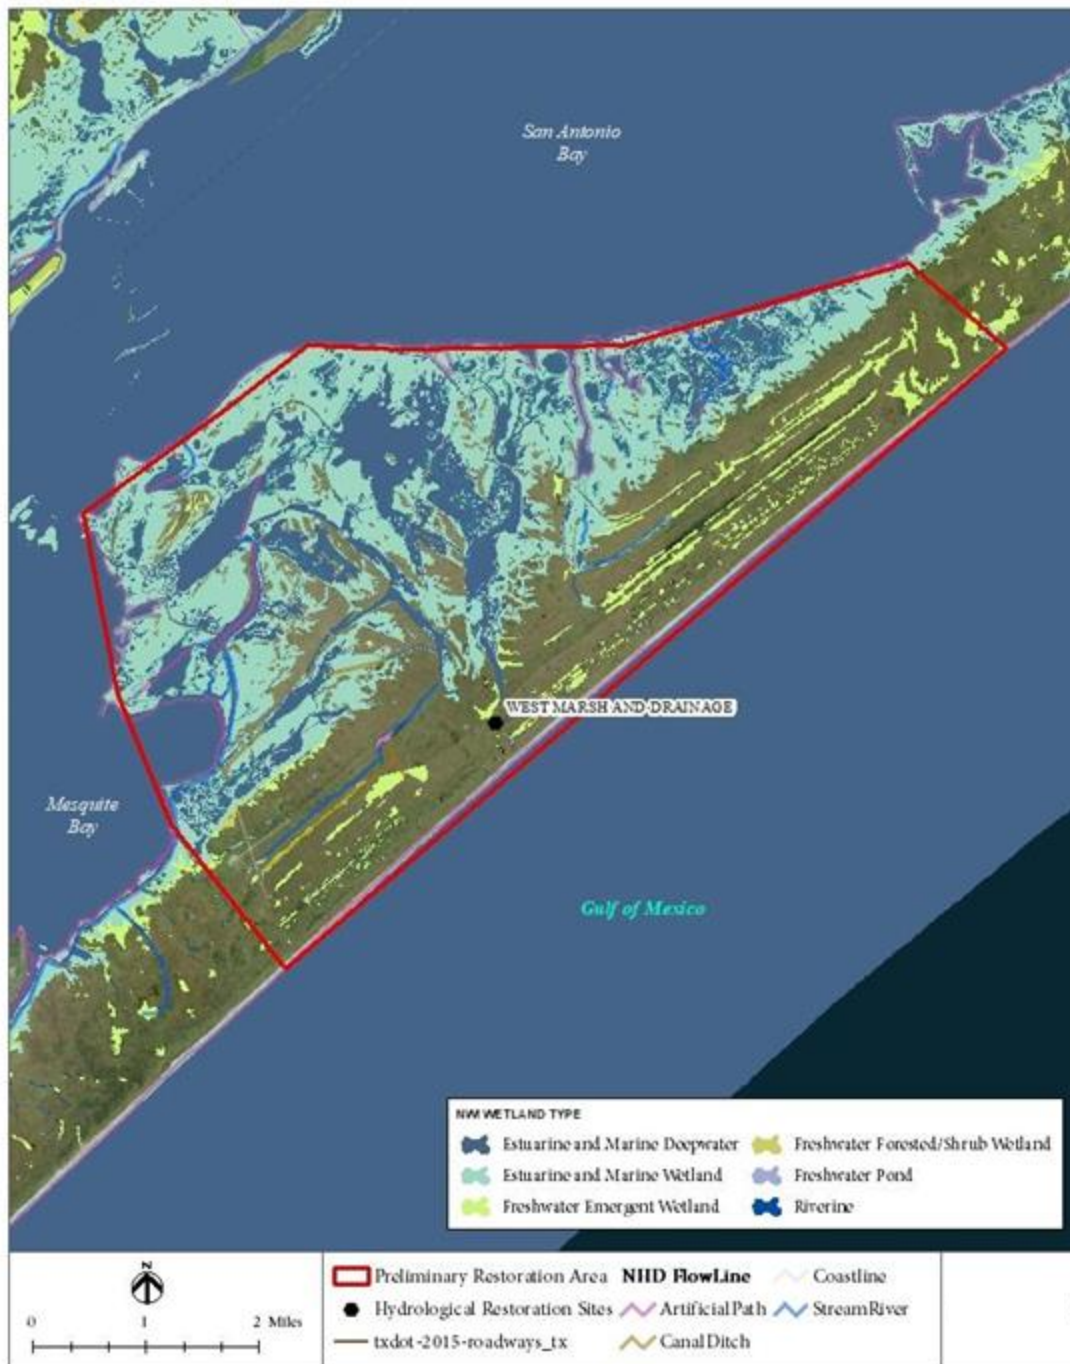
Figure 11A. NHD and NWI data for West Marsh on the backside of Matagorda Island.

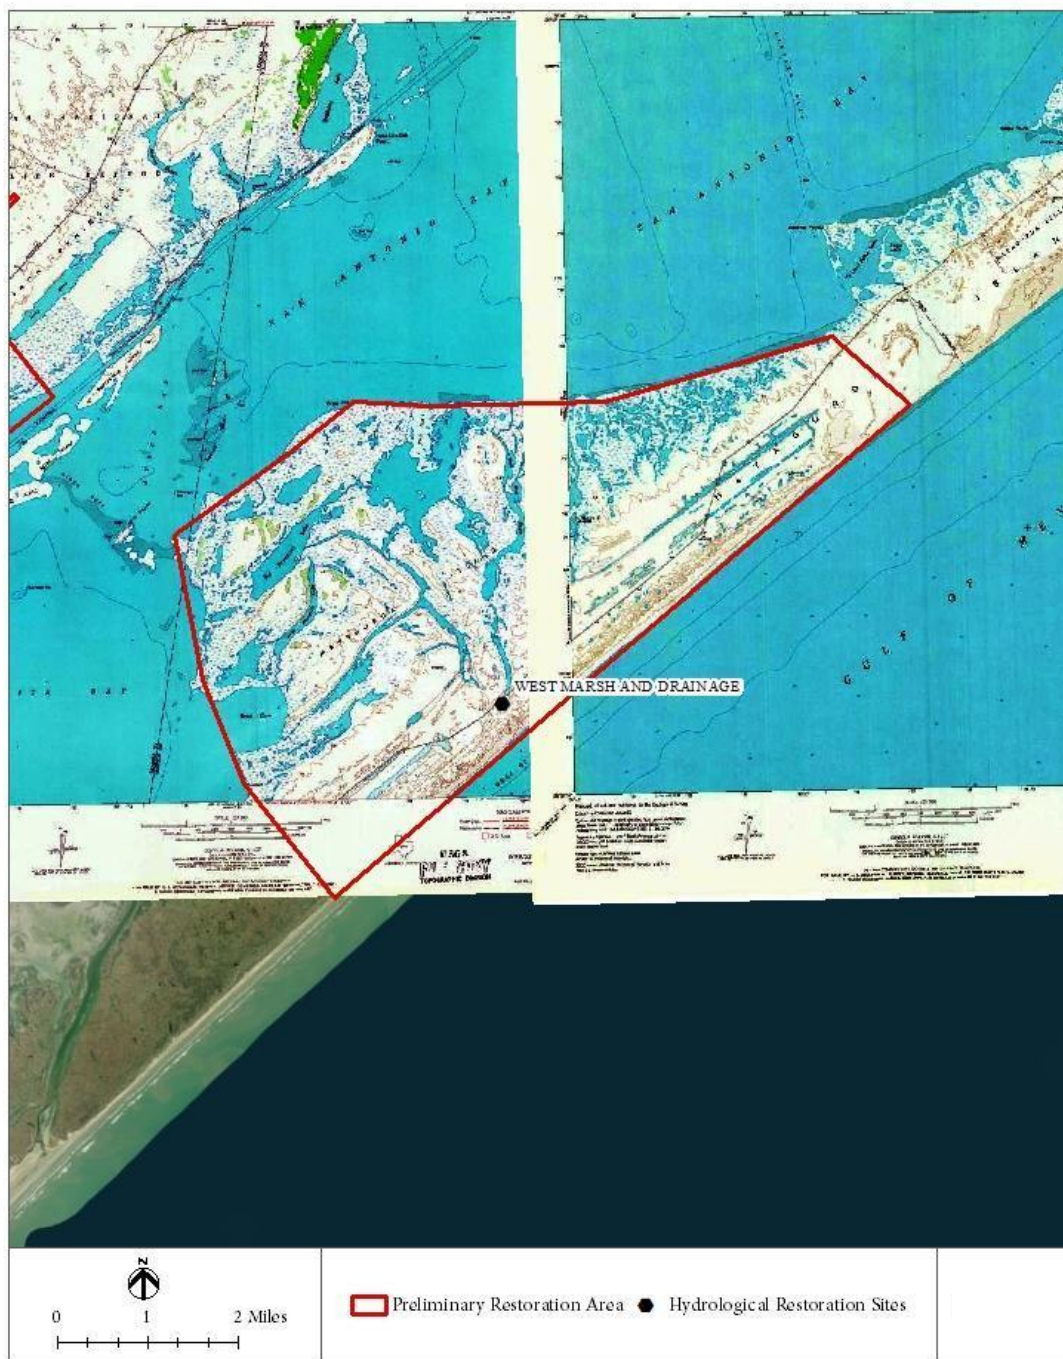
Figure 11B. Historical USGS topographic quadrangles (1:24,000) for West Marsh.

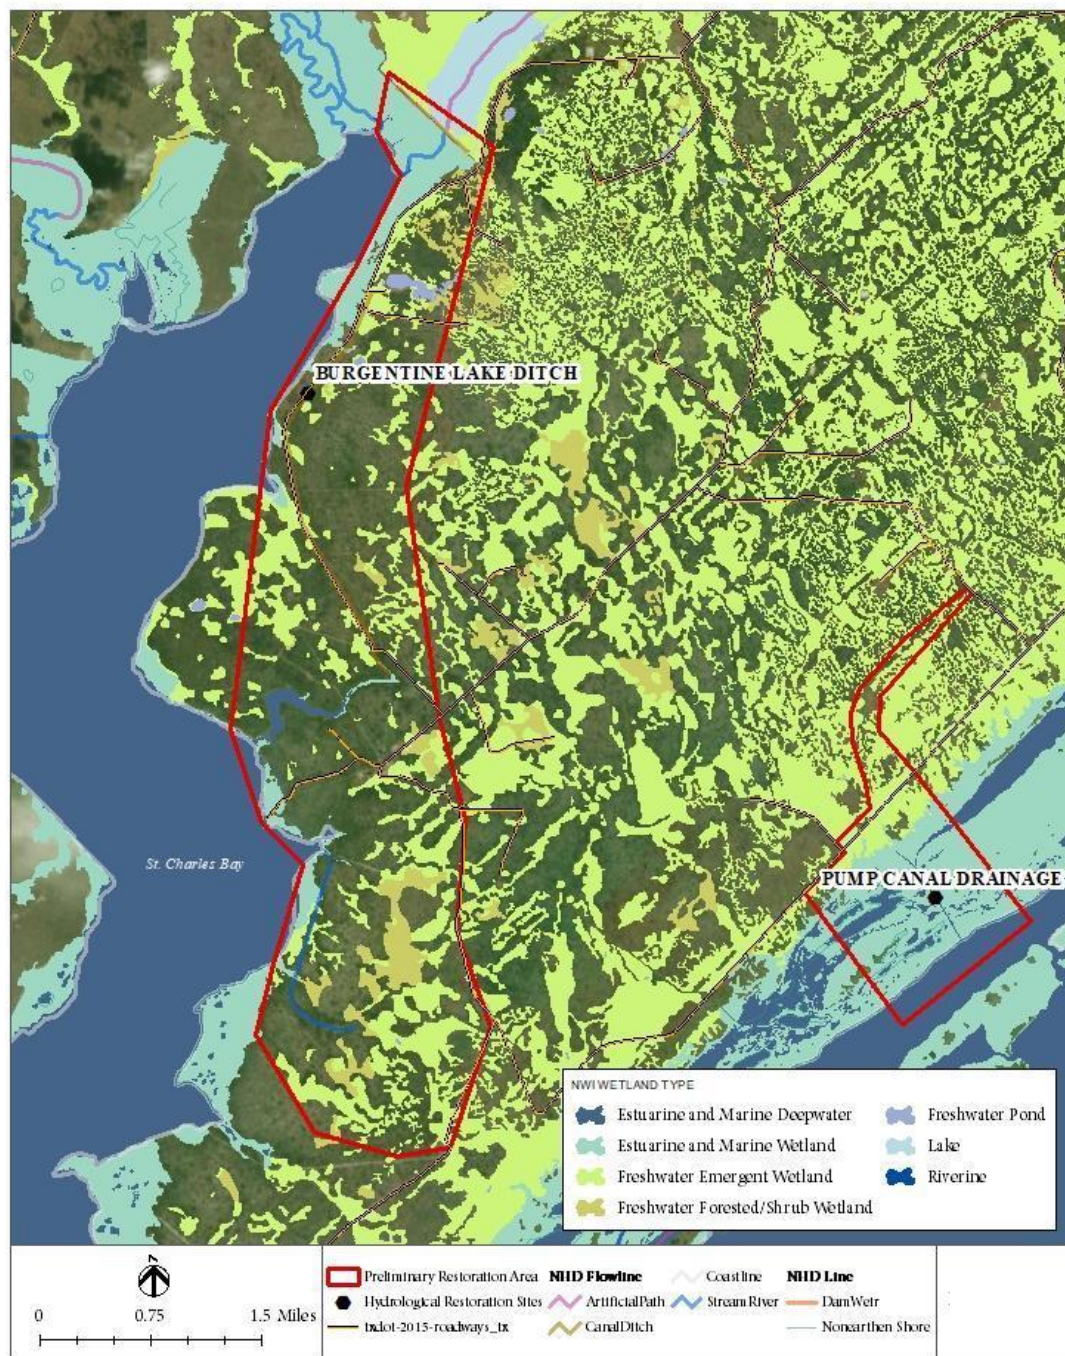
Figure 13A. NHD and NWI data at Burgentine Lake Ditch located on Blackjack Peninsula within the Aransas National Wildlife Refuge.

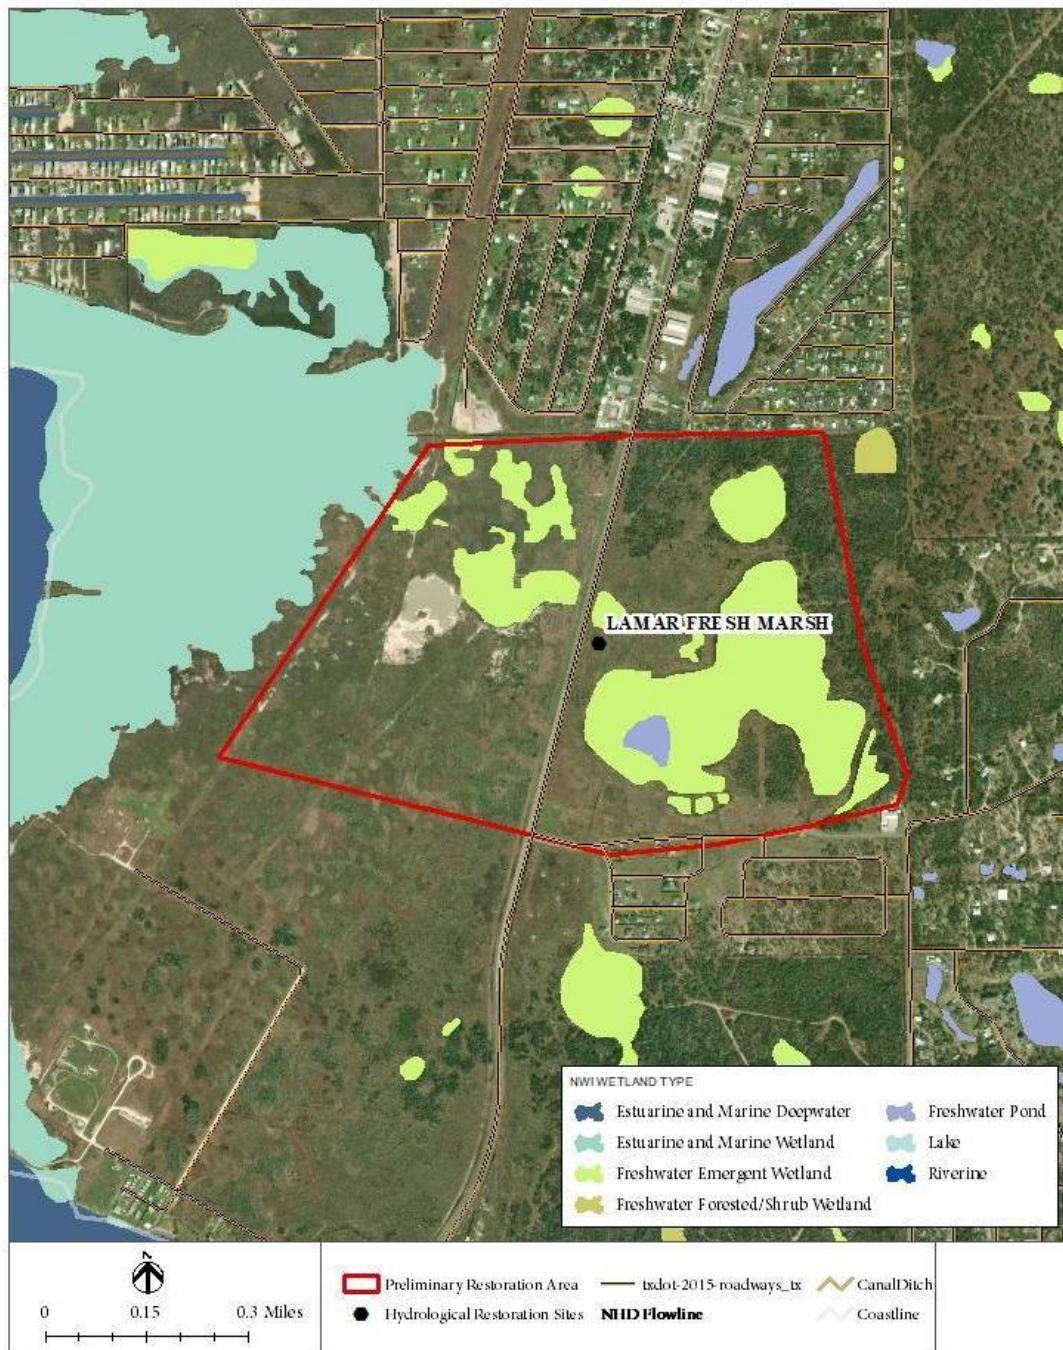
Figure 14A. NHD and NWI data at Lamar Fresh Marsh on Lamar Peninsula north of Copano Bay.

Lamar Fresh Marsh is located on Lamar Peninsula on the western side of SH-35 and north of Seaside Loop and is the largest freshwater marsh on the peninsula (Figure 14). The marsh is mapped by the NWI as a palustrine emergent, persistent, seasonally flooded wetland (PEM1C) (Figure 14A), and has persisted since 1979 based on USGS topographic maps (Lamar, TX) (Figure 14B). Sometime between 2003 and 2008, multiple drainage features appear on the aerial imagery within this area, and one of these features appears to be draining Lamar Fresh Marsh towards the west through a culvert constructed under Hwy 35. A pond was excavated in the uplands to capture water and provide potential waterfowl habitat in 2016.

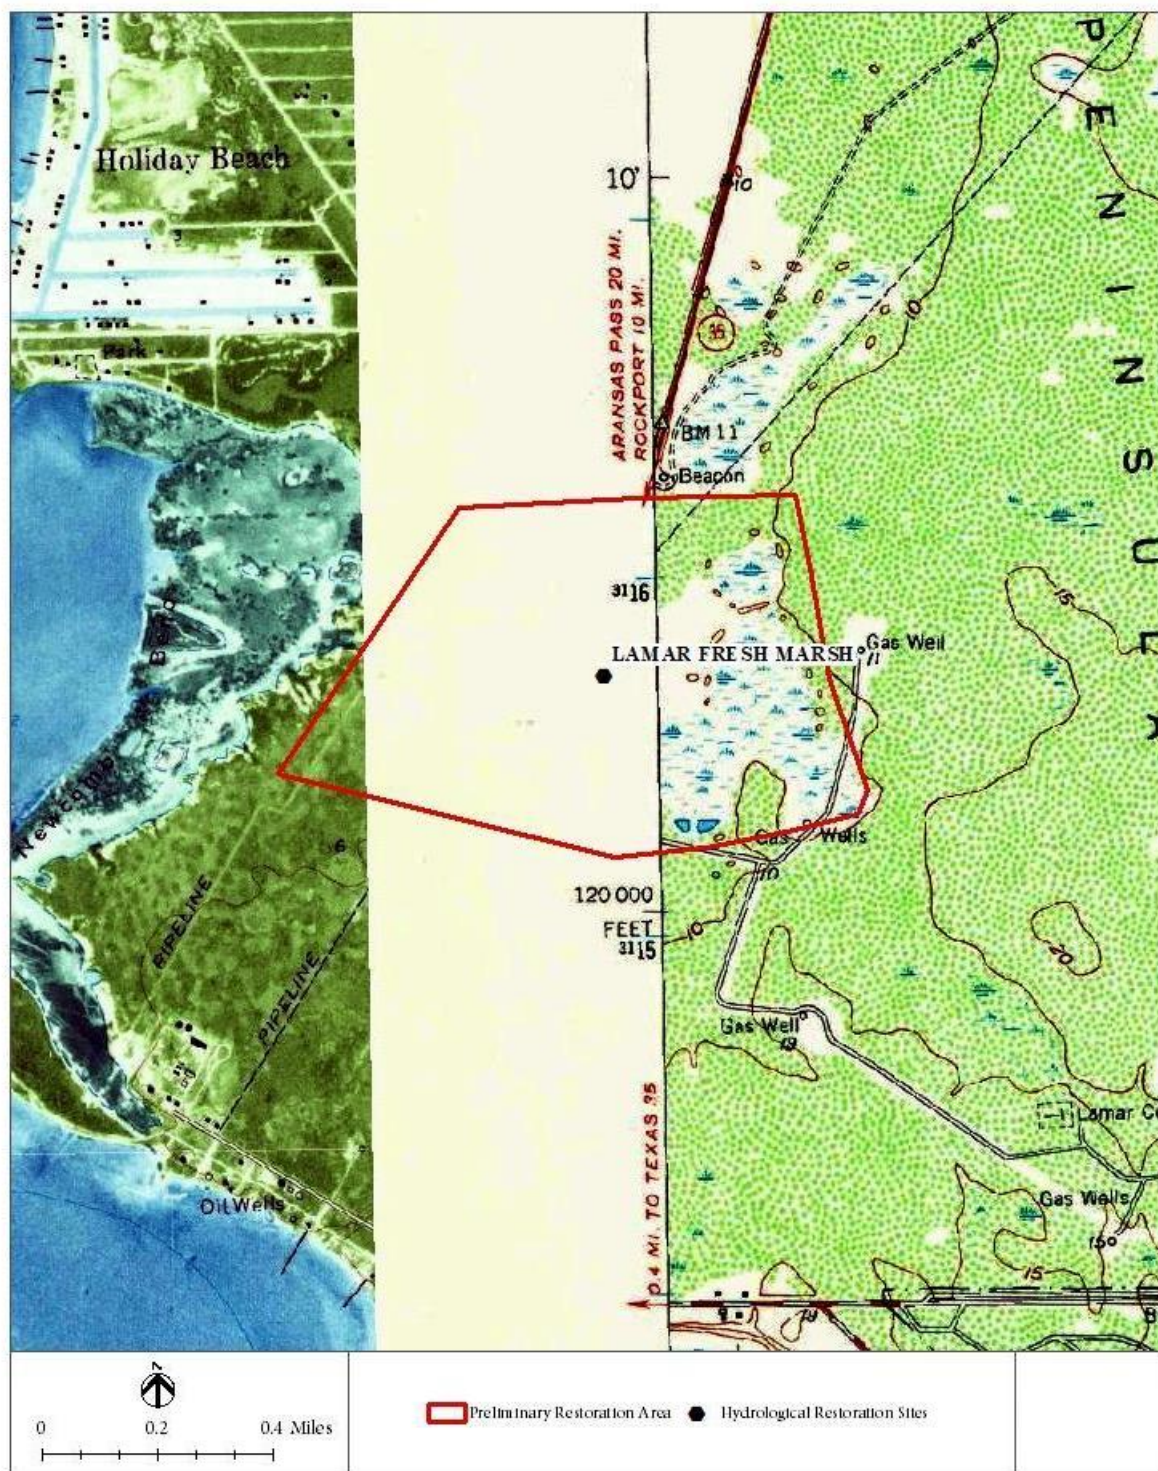
Figure 14B. Historical USGS topographic quadrangle (1:24,000) at Lamar Fresh Marsh on Lamar Peninsula north of Copano Bay.

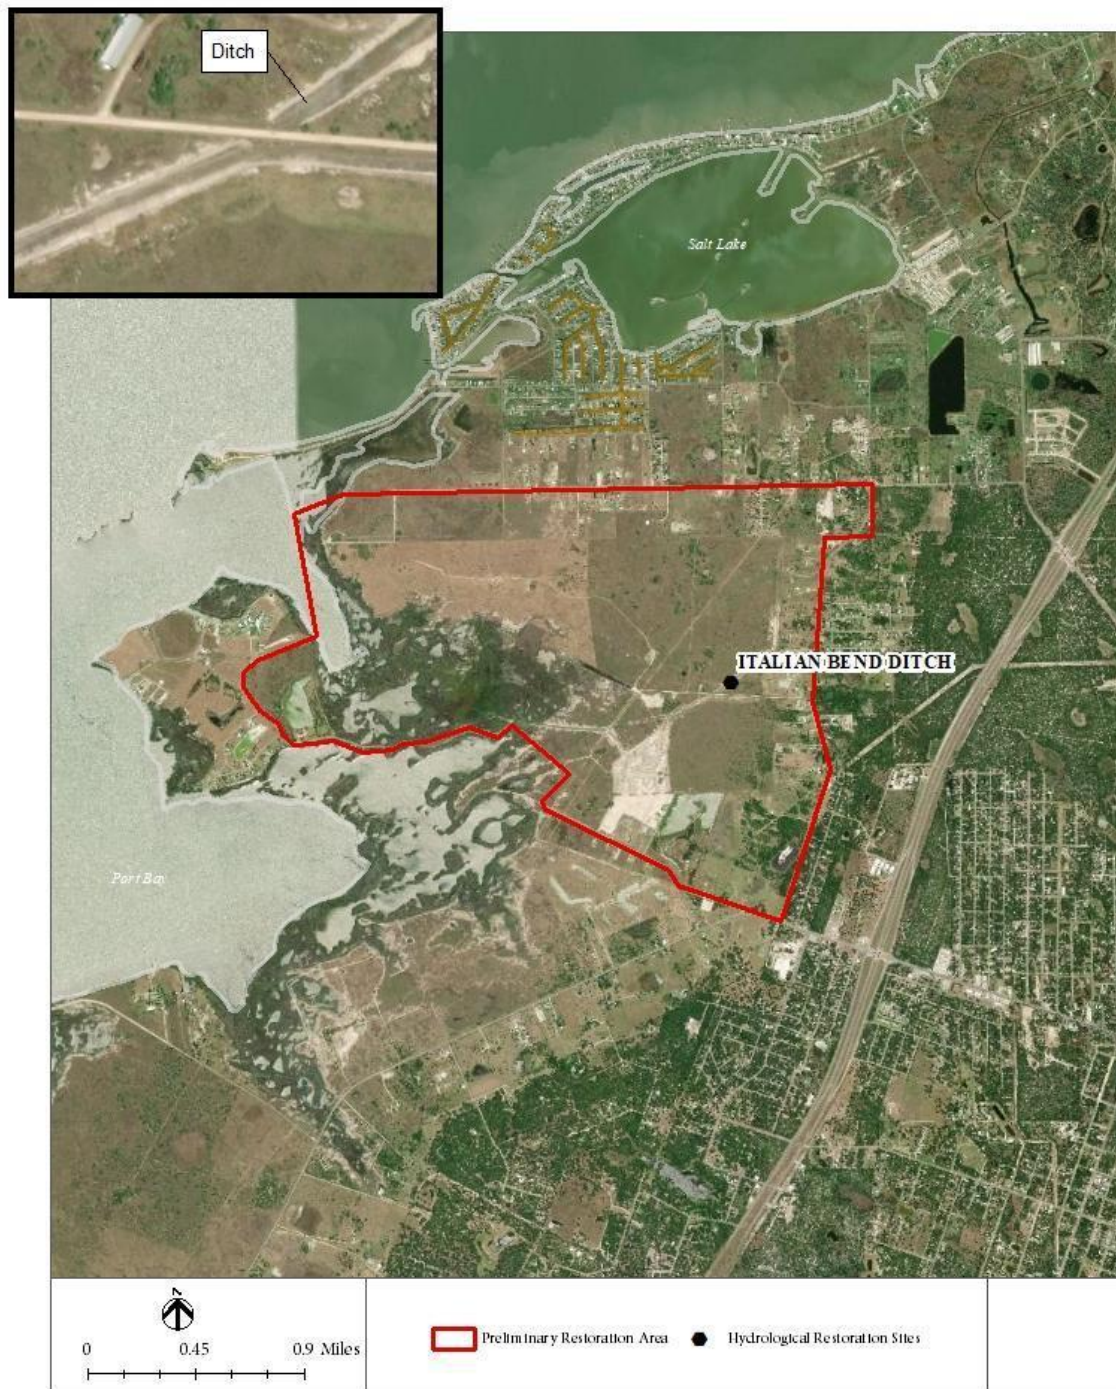
Figure 16. Aerial imagery of Italian Bed Ditch on Live Oak Peninsula.

Italian Bend Ditch is located within an extensive, low-elevation, coastal prairie area on the western side of Live Oak Peninsula east of Port Bay between Rattlesnake Point Road and Cape Valero Drive (Figure 16). Development has continued to occur on poorly-drained soils along the county roads, and the Ditch was excavated through the prairie to reduce drainage issues. Adjacent wetlands have been disconnected from natural sheetflow and have been invaded with brush and upland vegetation. While continued sea-level rise will inundate this area in the coming decades, storm surge from hurricanes can readily inundate this area today (as in the case of Hurricane Harvey). Ditches constructed as linear water conduit can also transport bay water into previously freshwater wetlands and neighborhoods and kill freshwater vegetation as well as upland trees and landscaping plants.

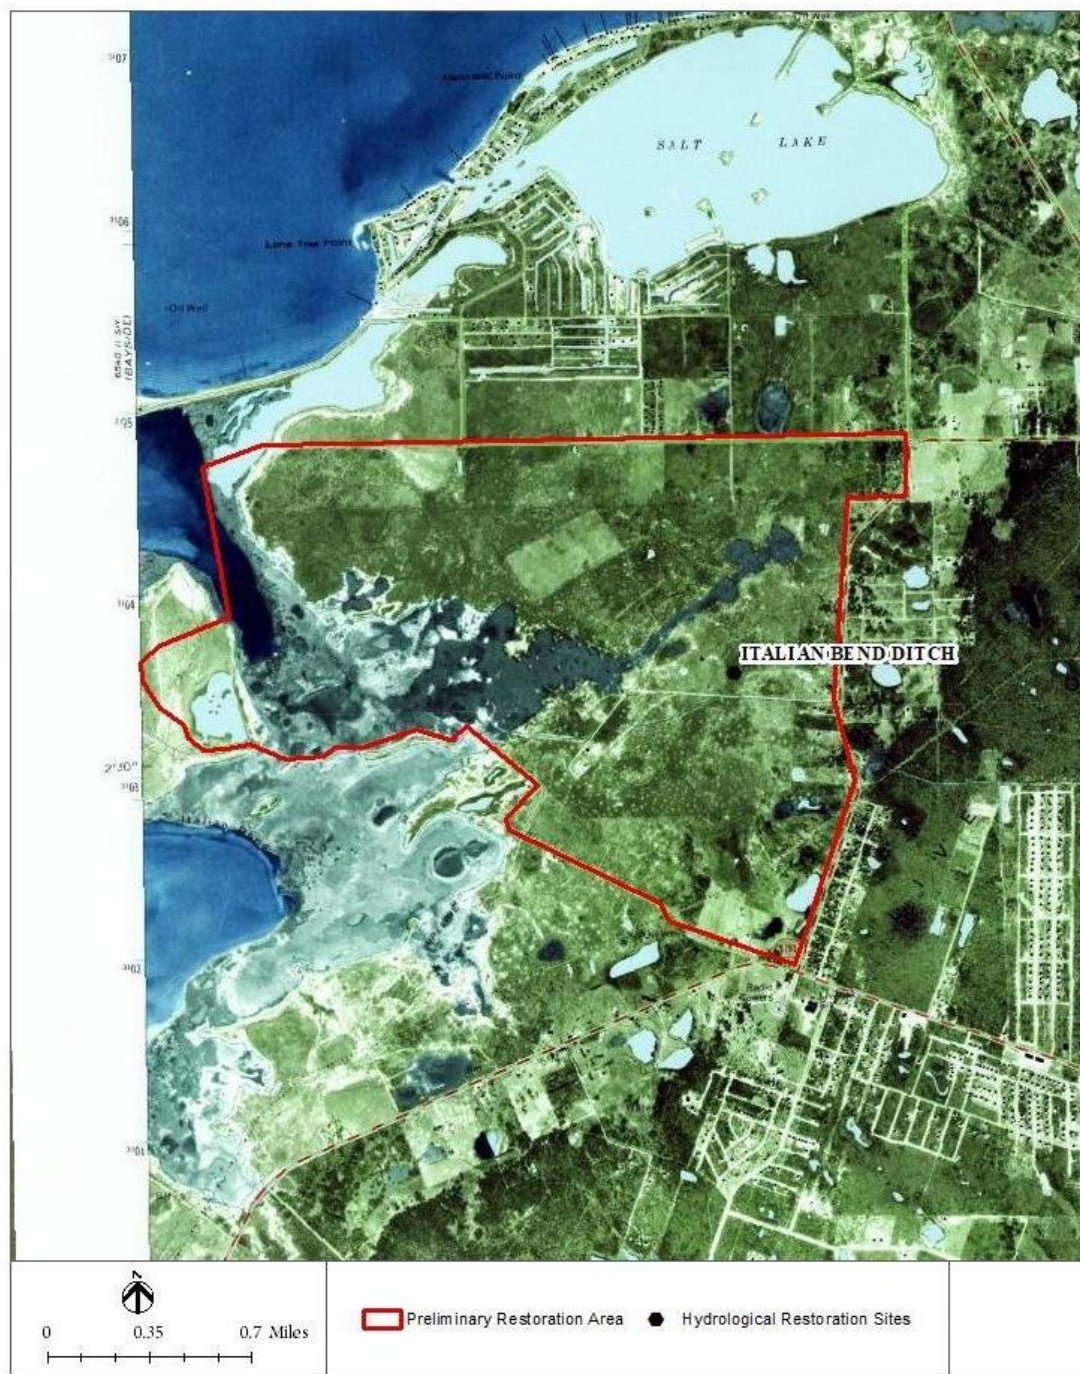
Figure 16B. Historical USGS topographic quadrangle (1:24,000) of Italian Bed Ditch on Live Oak Peninsula.

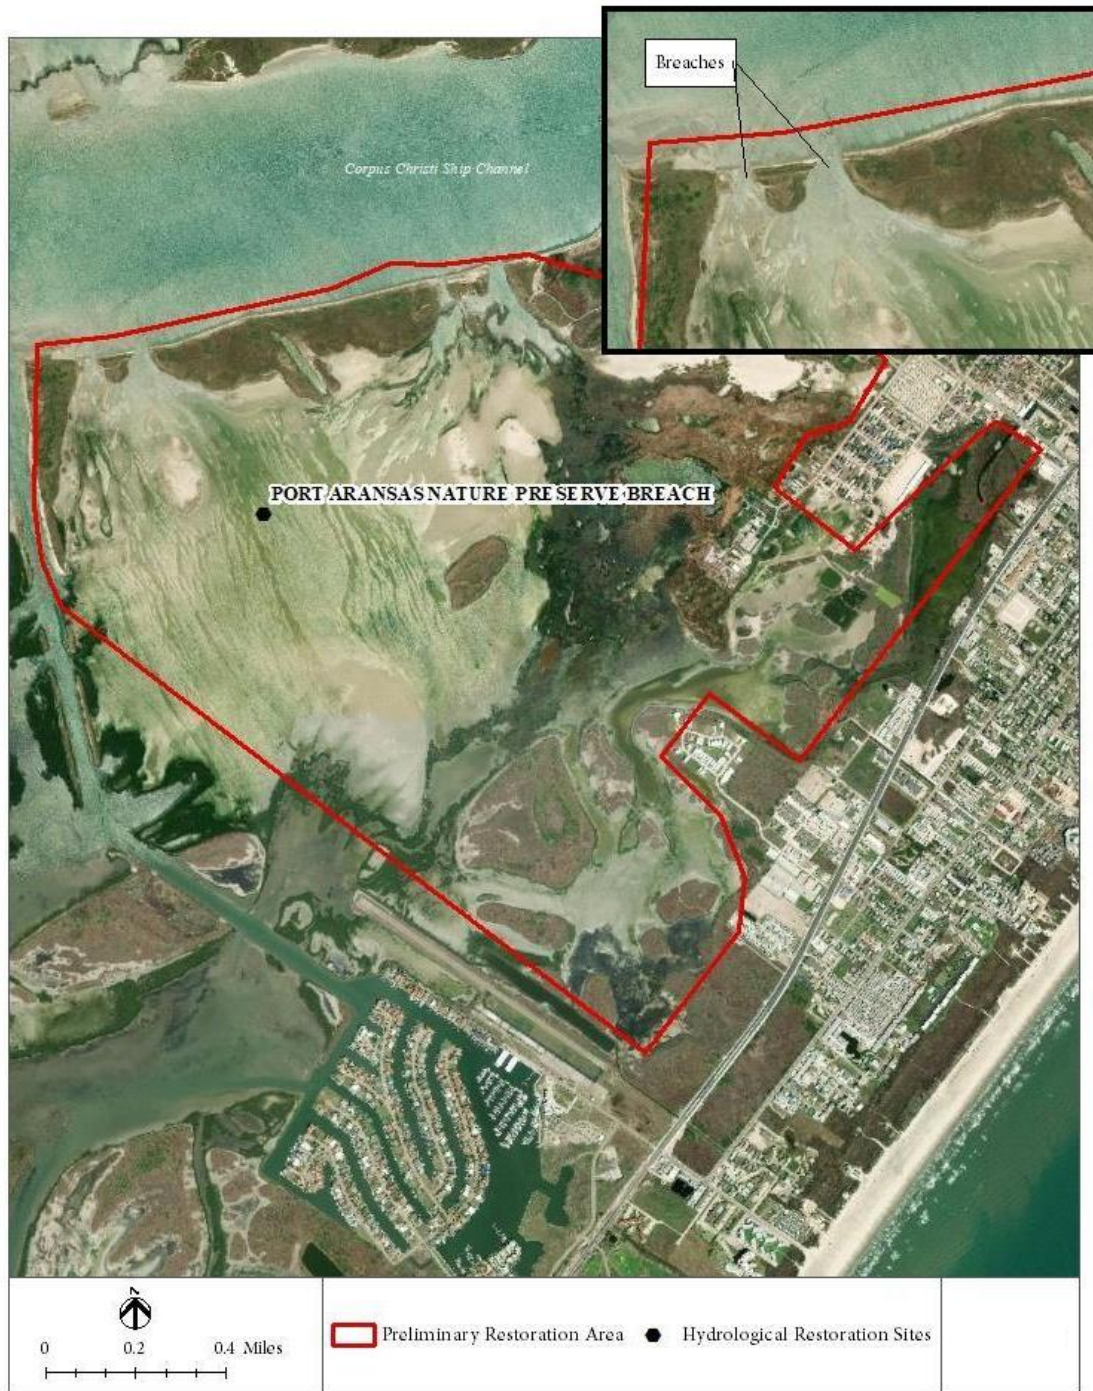
Figure 17. Aerial imagery of the Port Aransas Nature Preserve.

The Port Aransas Nature Preserve (the Park) protects approximately 1,280 acres and encompasses an area formerly known as Charlie's Pasture (Figure 17). Coastal habitats within the Port Aransas Nature Preserve provide a unique refuge for wildlife within the City of Port Aransas, a highly developed coastal town within the Nueces-Corpus Christi Bay system. The Park is situated on the backside of Mustang Island with the northern boundary located along the southern shoreline of the Corpus Christi Ship Channel (Figure 17). This shoreline is reinforced from the ship channel by concrete bulkhead and large rock revetment to prevent erosion of coastal habitats within the Park. During Hurricane Harvey in 2017, the northern shoreline of the Park was breached by strong storm waves that damaged the shoreline protection and has allowed continuous exposure of the Park to ship wakes, high tides, and storm events. The lack of shoreline protection along the northern boundary has affected algal flats previously protected by upland and prairies now being eroded by wind and waves effects (Simpson 2019).

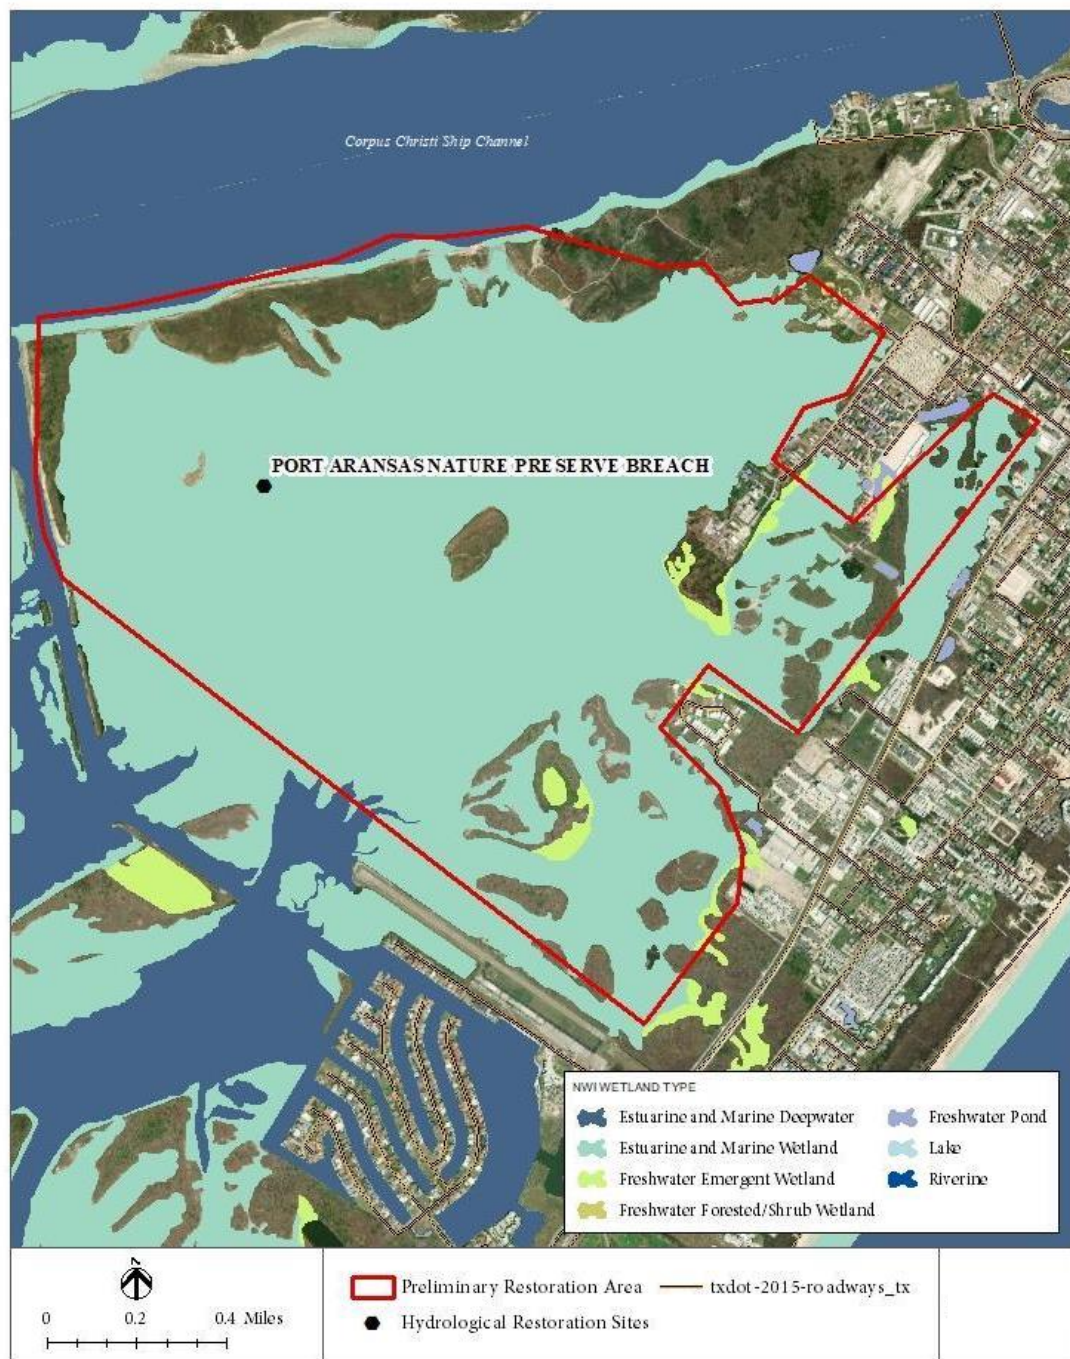
Figure 17A. NHD and NWI data at the Port Aransas Nature Preserve.

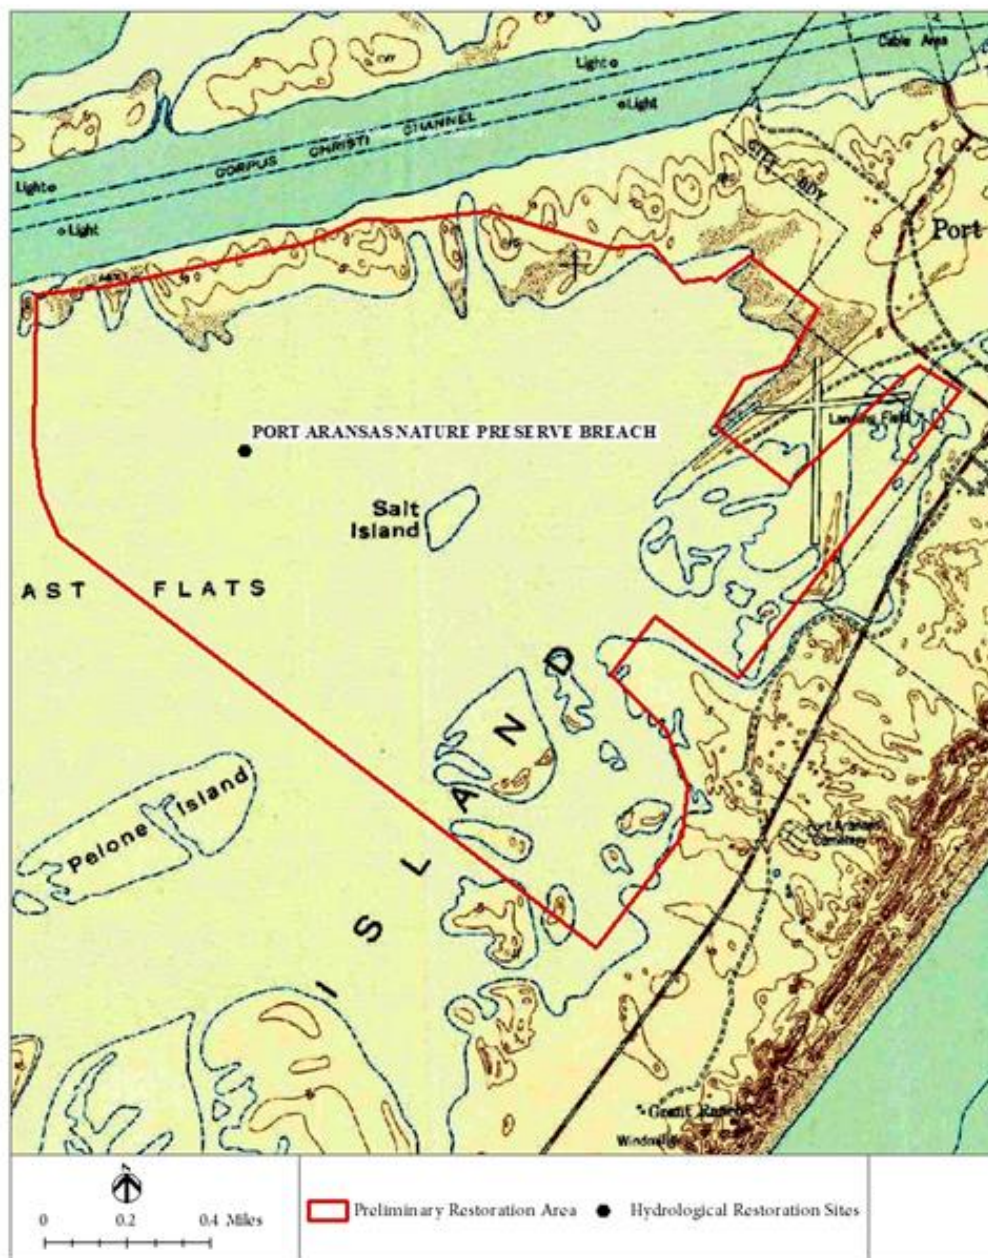
Figure 17B. Historical USGS topographic quadrangle (1:24,000) of the Port Aransas Nature Preserve.

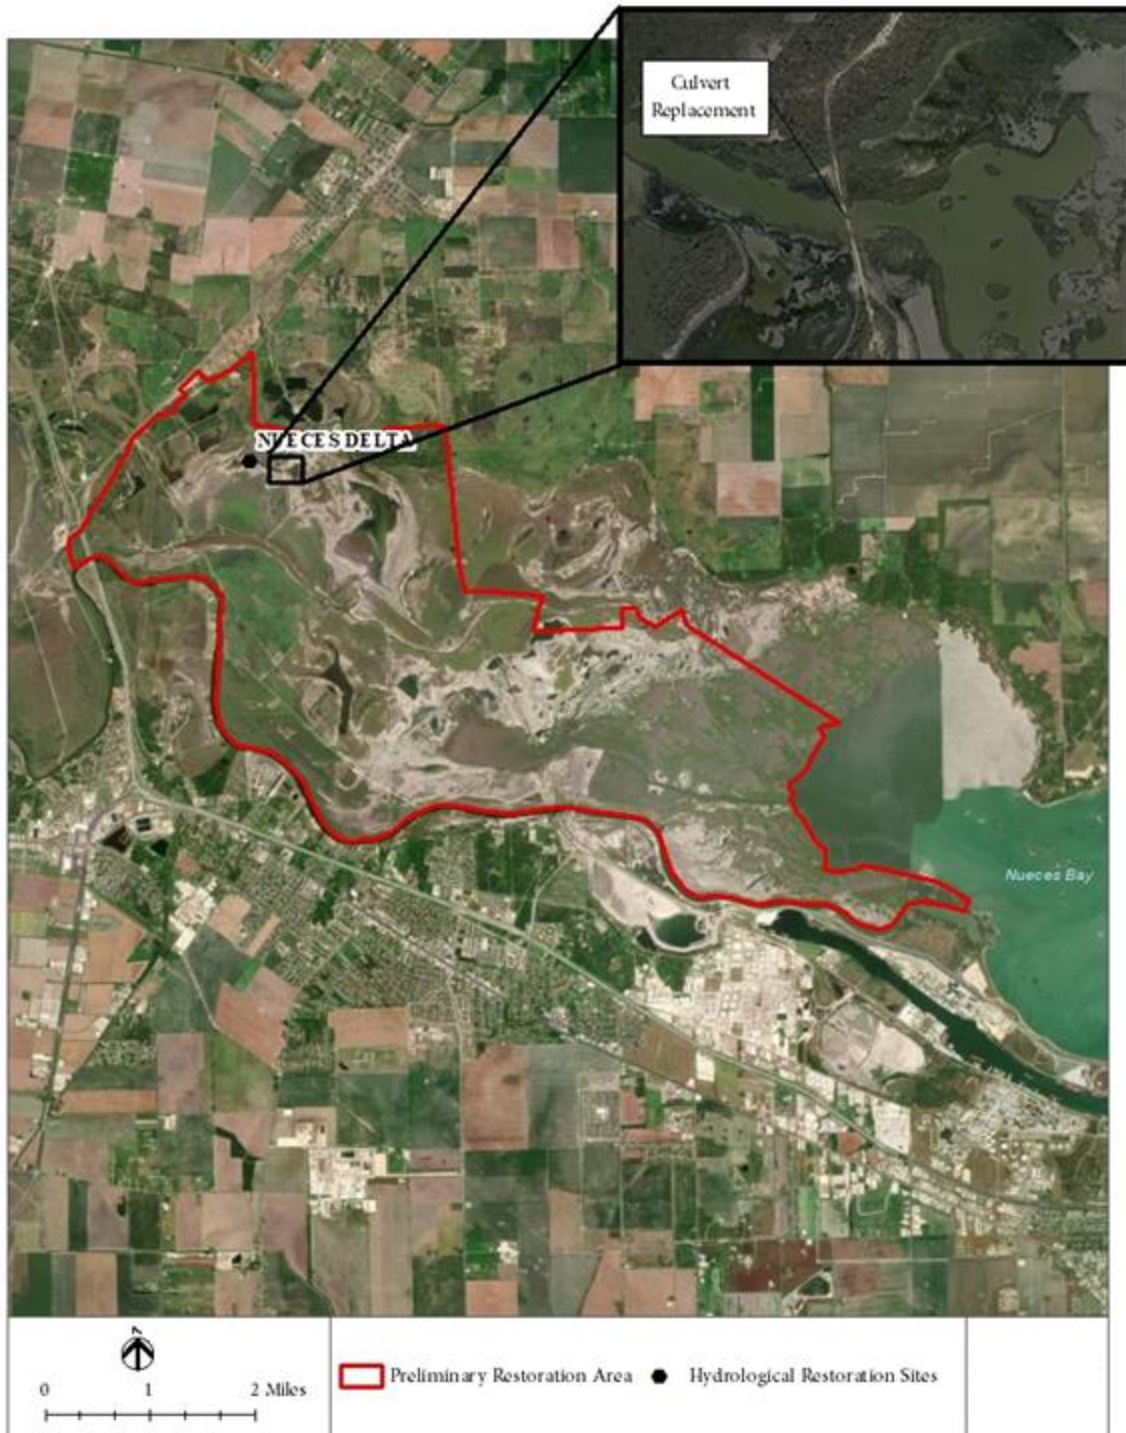
Figure 18. Aerial imagery of the CBBEP Nueces Delta Preserve (approximate).
