January 2025

Restoration Efforts of the Nueces Delta

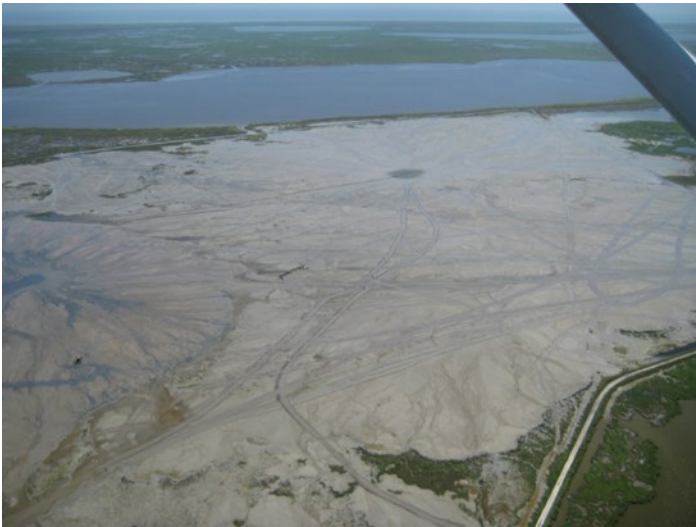
Left Photo - JD Murphee WMA in 2010, immediately following placement of dredge material (photo credit Ducks Unlimited)

To see a good example of how successful these types of projects can be, we just have to look up the coast a bit to Texas Parks and Wildlife Department's JD Murphee Wildlife Management Area. At the WMA located near Port Arthur, Ducks Unlimited partnered with TPWD to beneficially use dredged sediment to rebuild lost habitat, restoring 1,500 acres of marsh that had been battered by a busy hurricane season. The difference of the landscape just days after the sediment was placed compared to several years later is incredible, with native vegetation and wildlife returning to the area and public recreation growing along with them.

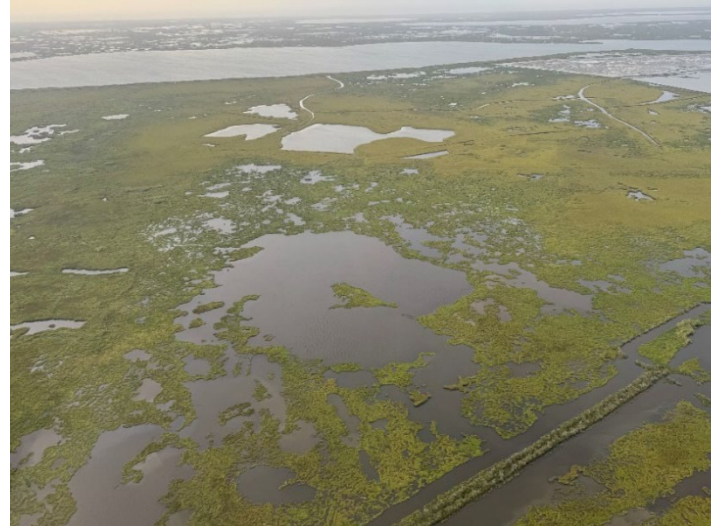
Right Photo - JD Murphee WMA in 2024, 14 years following placement of dredge material (photo credit Ducks Unlimited)
